Building Inspection

320-417 East St., Victoria.

Date of Inspection: July 17, 2012

Client: Jack Duckworth

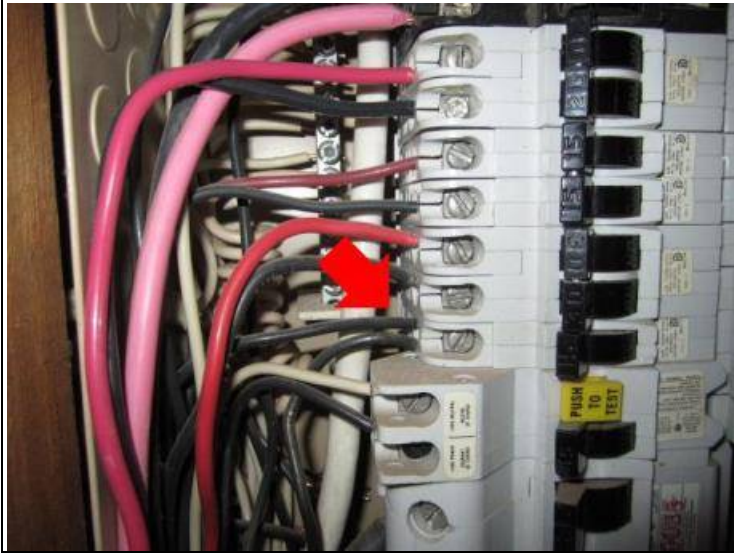
<p>Action Necessary - There are two wires to a breaker. These need to be separated so that each wire will have its own breaker.</p>

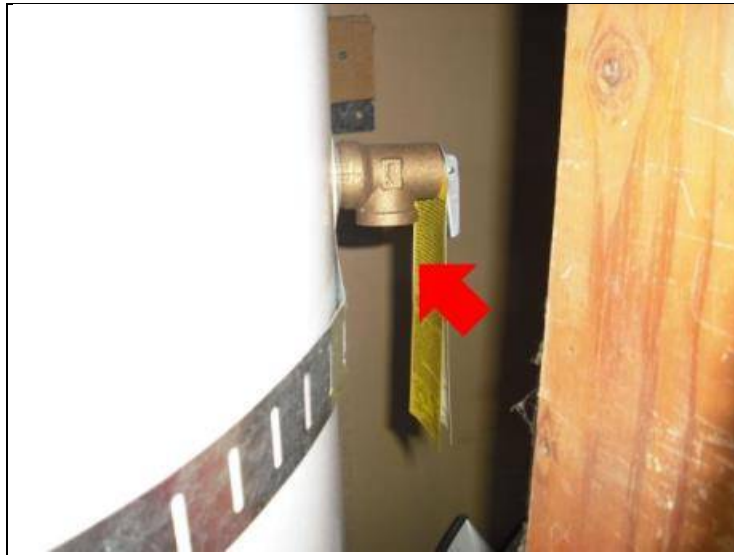
Discharge Tube:

Action Necessary -
There is no
discharge tube
installed.

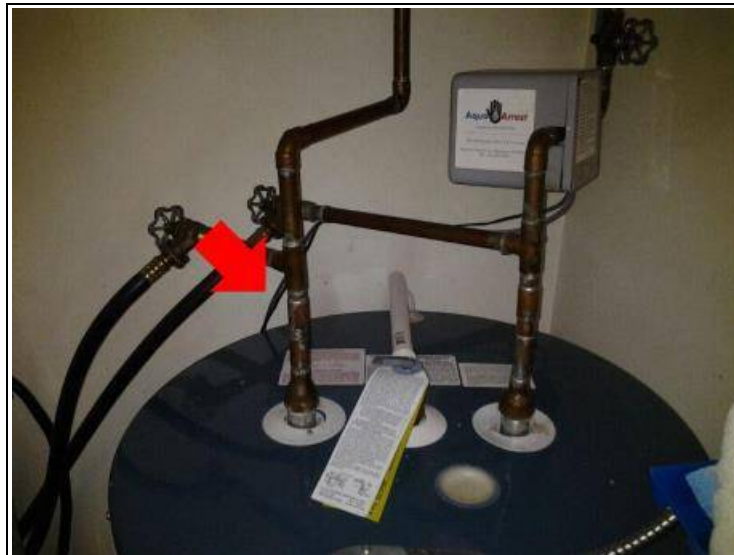
Insulated Hot Water Piping:

Recommended -
insulating the hot
water piping to
reduce water
heating costs and to
get hotter water to
the fixture quicker.
Up to 30% of the
heat losses in a
domestic hot water
system are from the
delivery piping
system.

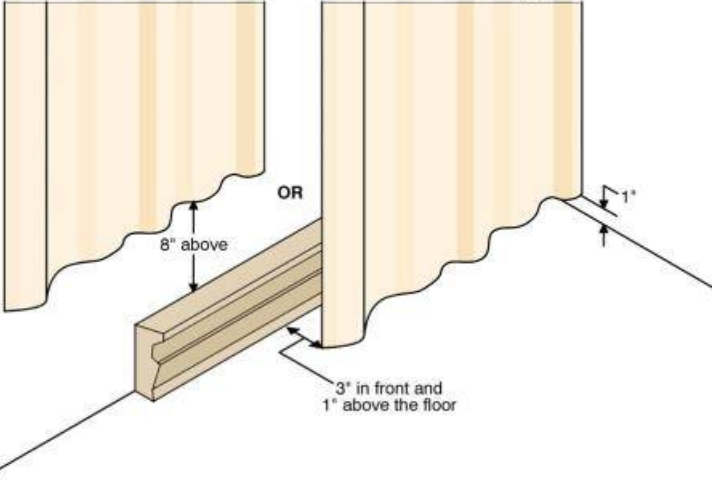
Electric baseboard heaters - clearances to draperies

To reduce the risk of fires always ensure that there is a minimum clearance of 8 inches above baseboard heaters and 3 inches in front eg proximity of curtains, beds etc. Also keep electrical cables away from the heaters because they can melt.

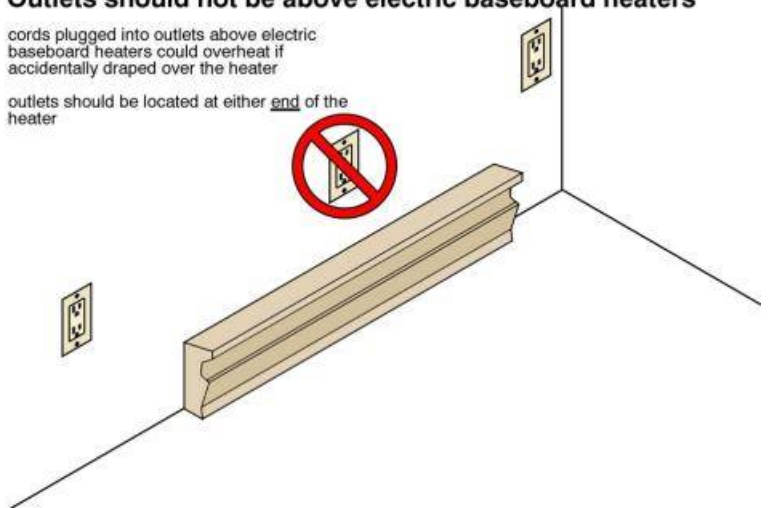
Fire Precautions - Electrical Cables

Outlets should not be above electric baseboard heaters

cords plugged into outlets above electric baseboard heaters could overheat if accidentally draped over the heater

It is poor practice to have electrical sockets located above electric baseboard heaters.

outlets should be located at either end of the heater

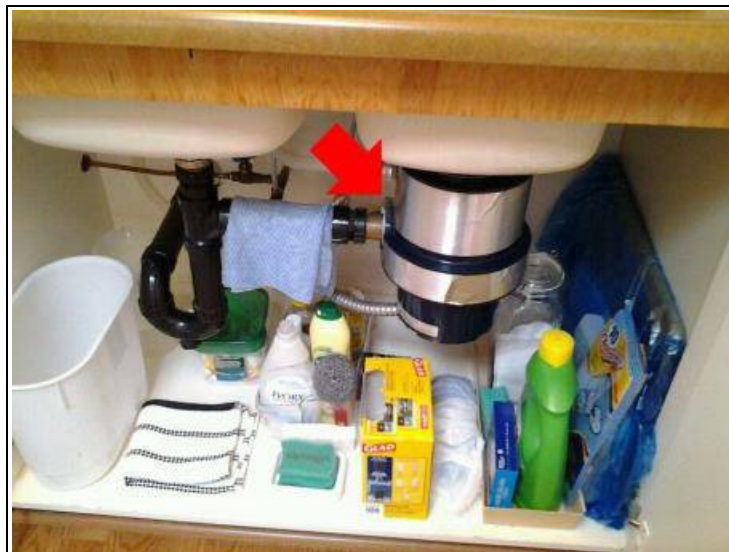
Garborator:

Action Necessary - The garborator did not activate using normal controls. Further investigation is needed to determine if repairs or replacement should be undertaken.

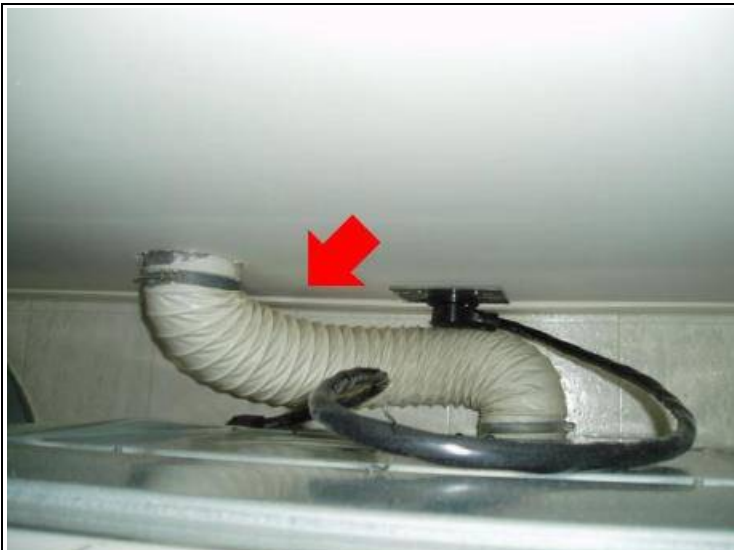
<p>Action Necessary - The dryer has a plastic vent. For safety reasons it is prudent to change this to metal to reduce the risk of fire which could be caused by a build up of lint inside the vent.</p>

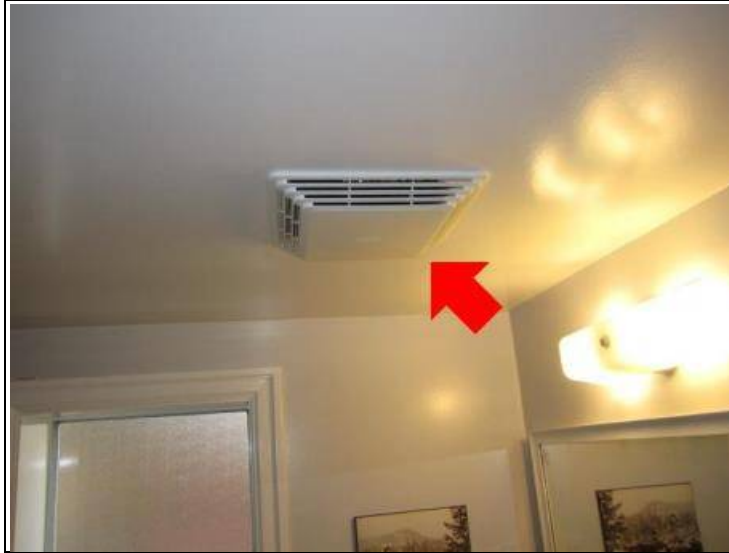
Ventilation Fans:

Action Necessary - There is an exhaust fan installed, but it would not activate using normal controls.

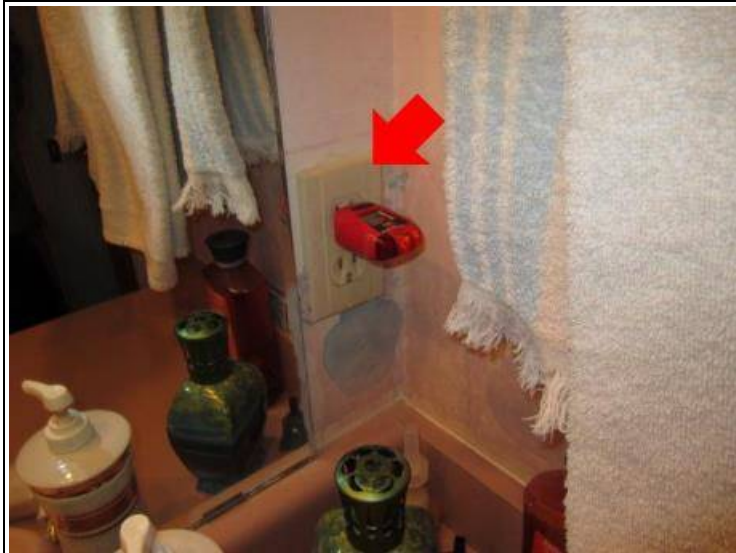
</div> <div data-bbox="1268 1184 1529 1365"> <p>Action Necessary - The outlet in the bathroom is not correctly GFCI protected.</p> </div>
<i>Light and Light Switch.</i>	Satisfactory - The light(s) and switch(es) are functional.
<i>Vanity Top:</i>	Satisfactory - The vanity top is functional.
<i>Vanity Cabinet:</i>	Satisfactory - The vanity cabinet is functional.

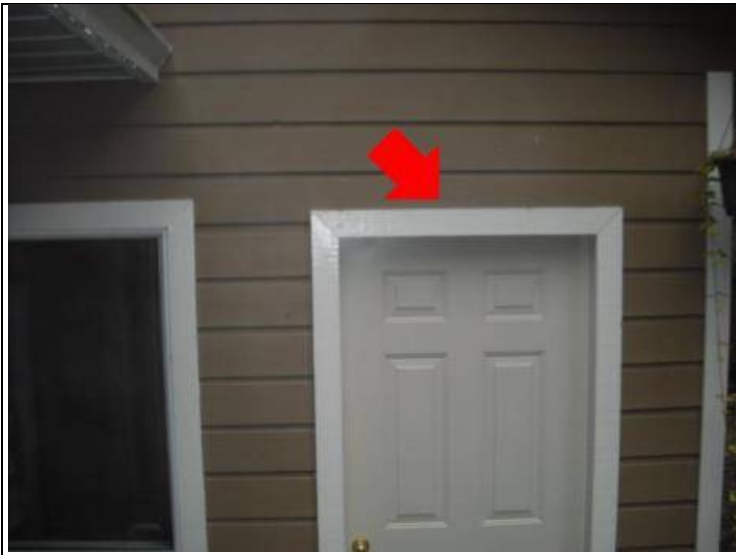
Flashings are missing on the external doors.

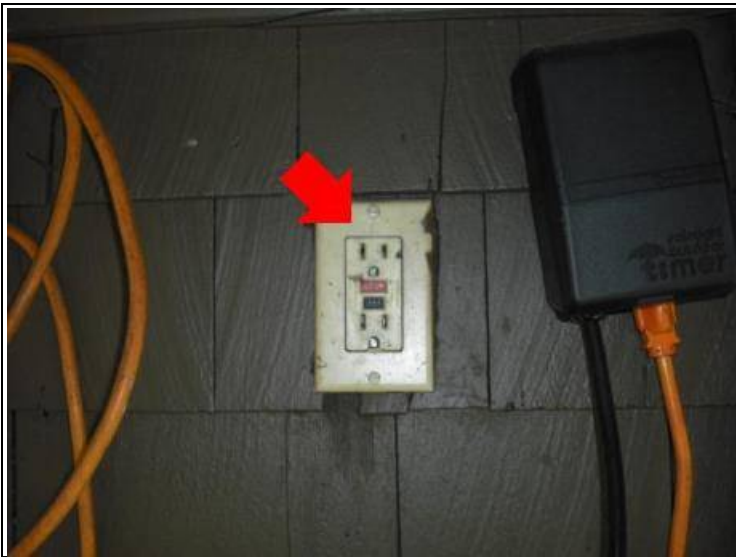
Internal GFCI's with no weather proof covers are in use externally.

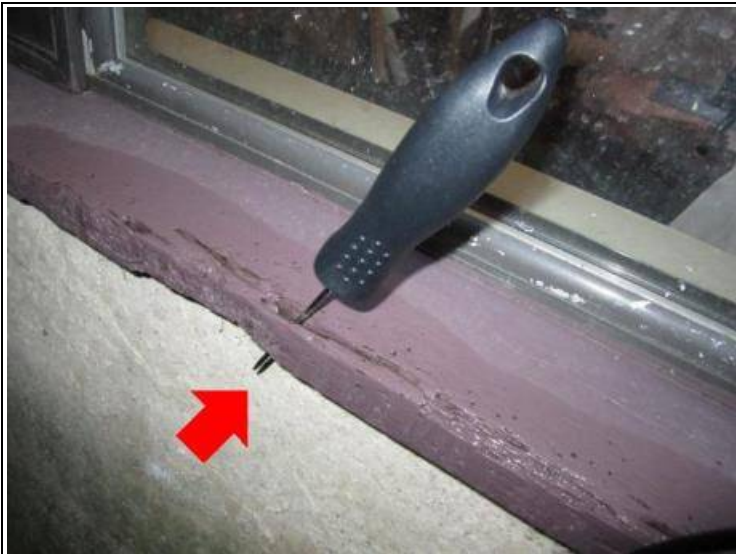
There is some rot in some window frames.

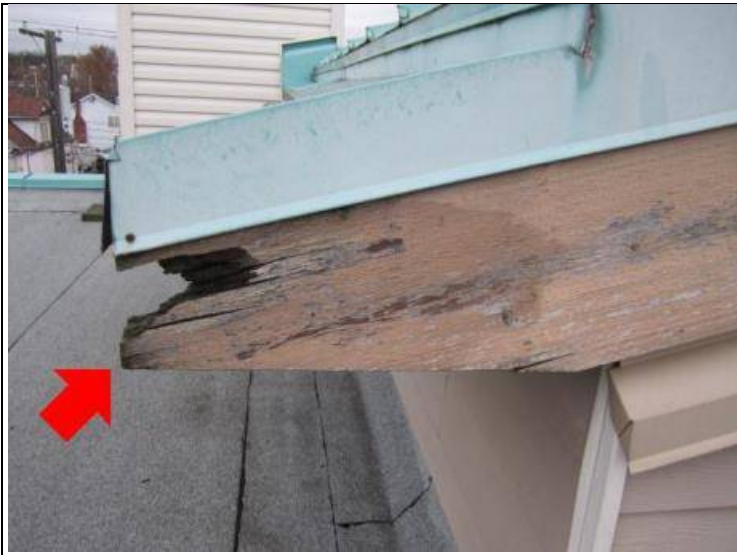
I noted rot in the ends of some of the barge boards.

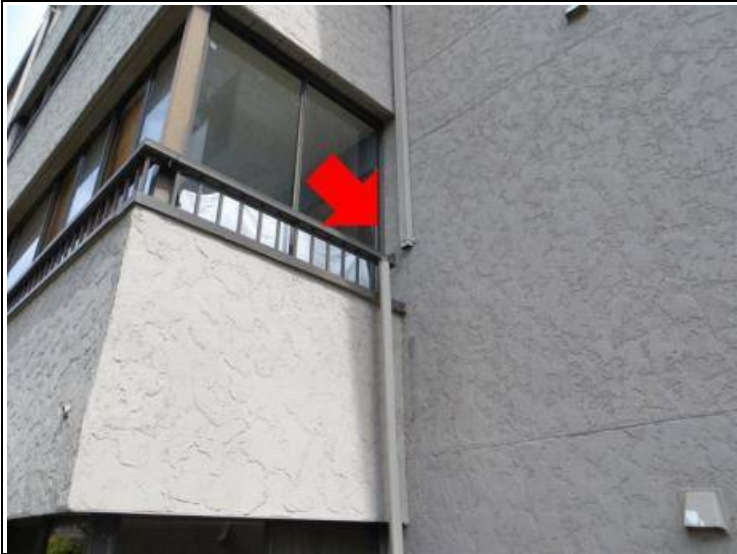
A disconnected downspout was noted.

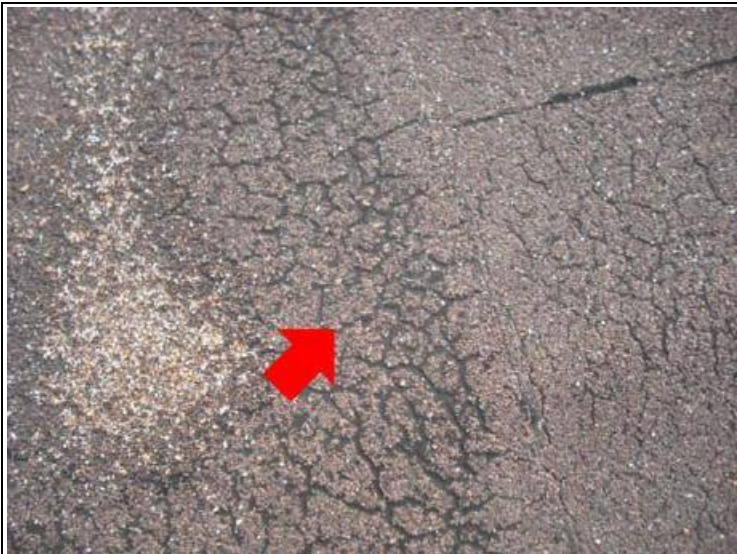
Cracking was noted in the surface of the torch on asphalt roof.

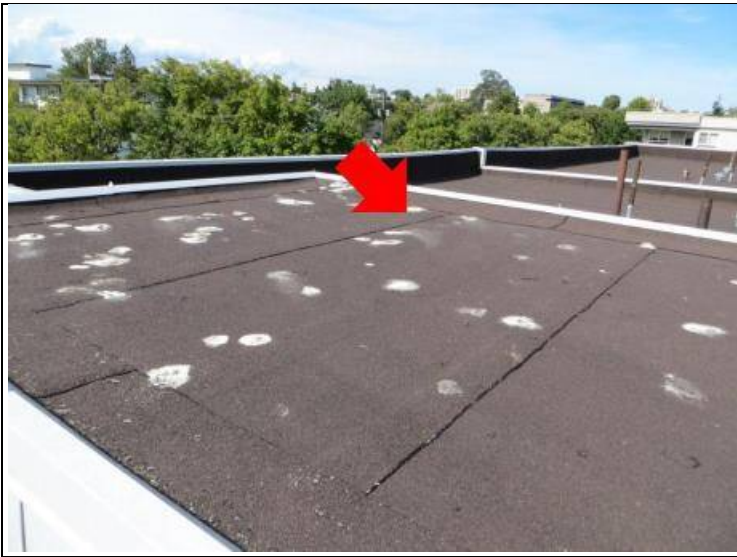
Bird droppings are causing damage to the surface of the roof covering.

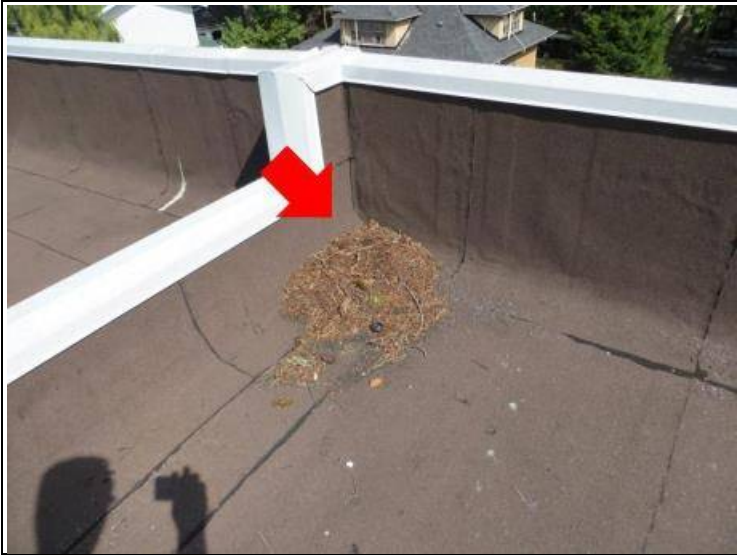
Birds nests etc should be cleaned off the roof.

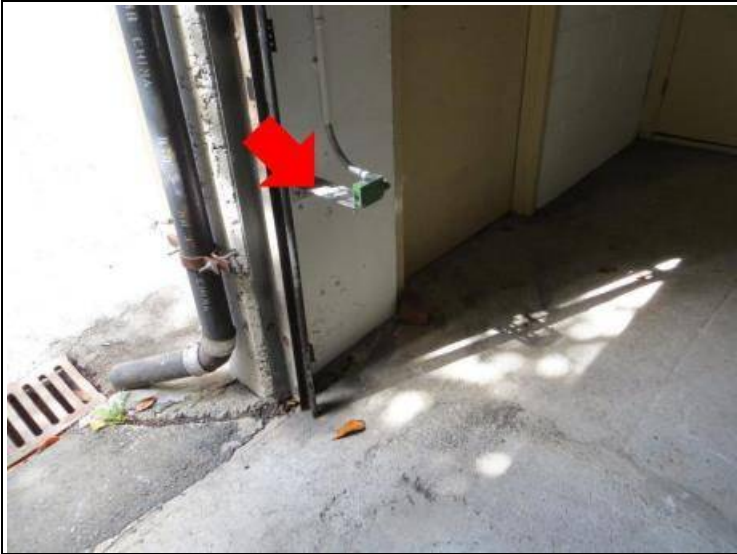
The photo eye beam is too high for the parkade door it should be within 8 inches of the floor.

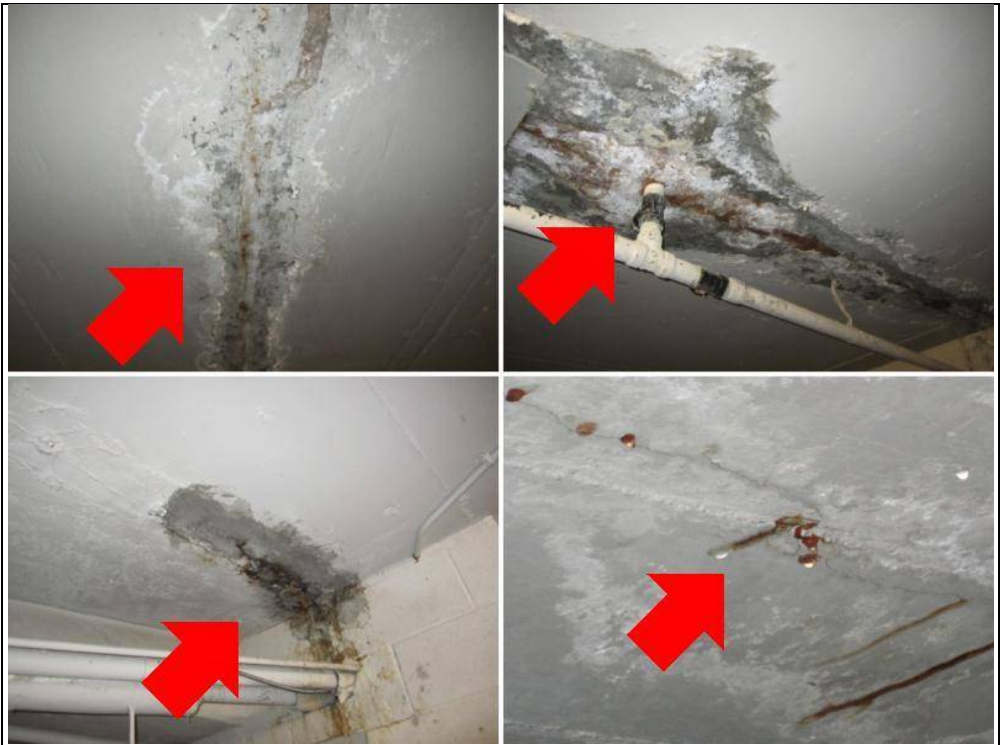
Efflorescence and water droplets were visible on the ceiling and walls of the parkade.

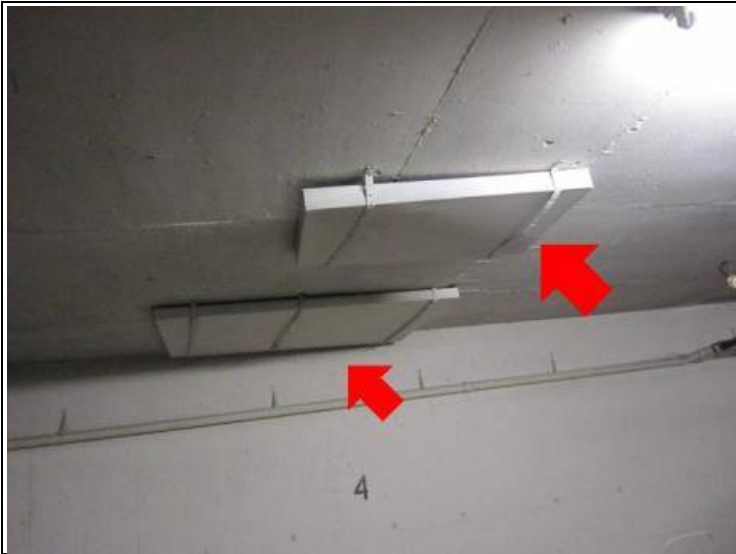
Trays have been affixed to the ceiling to collect water.

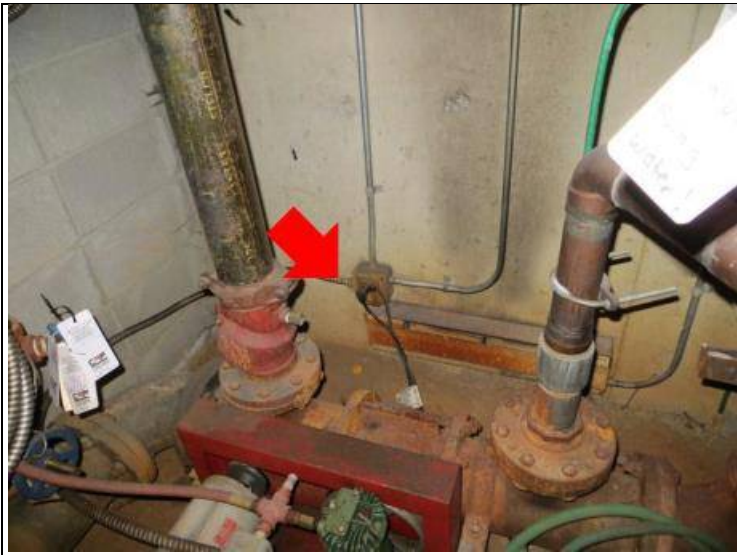
The sump pumps have no battery backups.
