# Building Inspection

1234 Franchise St, Fernwood

**Date of Inspection: December 11, 2012**

**Client: Ivan B. Project**

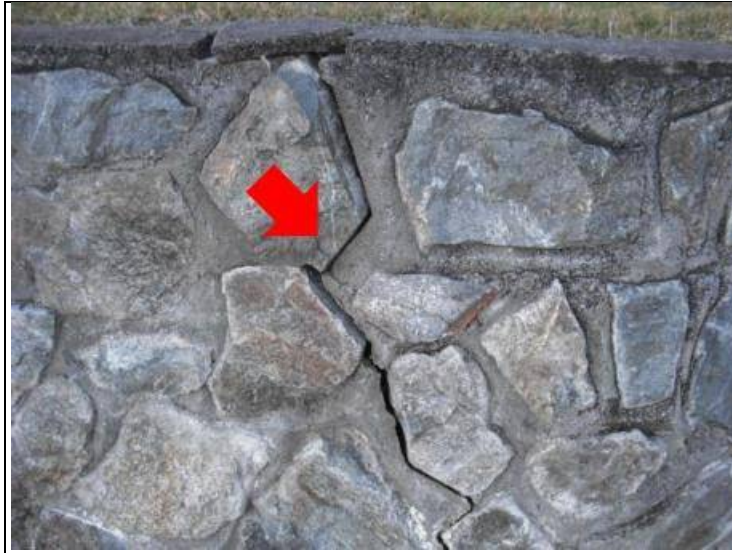
Action Necessary - Cracking was noted.

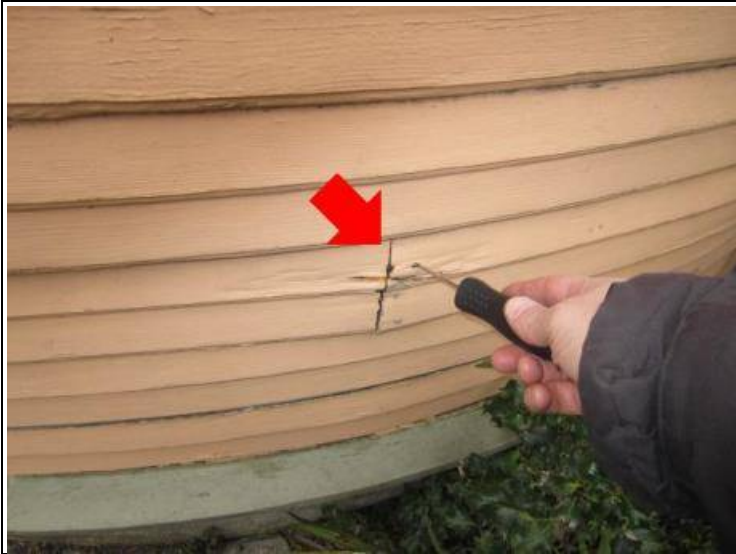
Action Necessary -  
Some sections of  
the siding are  
rotten.

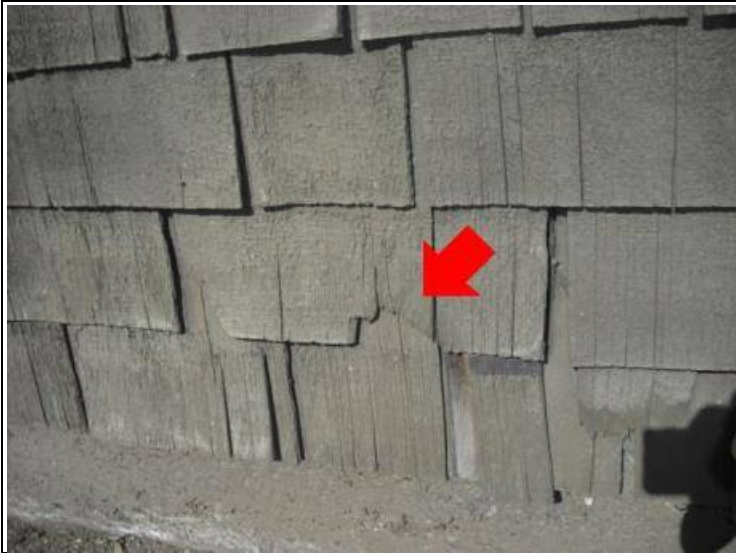
Action Necessary -  
The shingles are in  
poor condition, they  
are thin, split,  
rotting and some  
sections are missing.

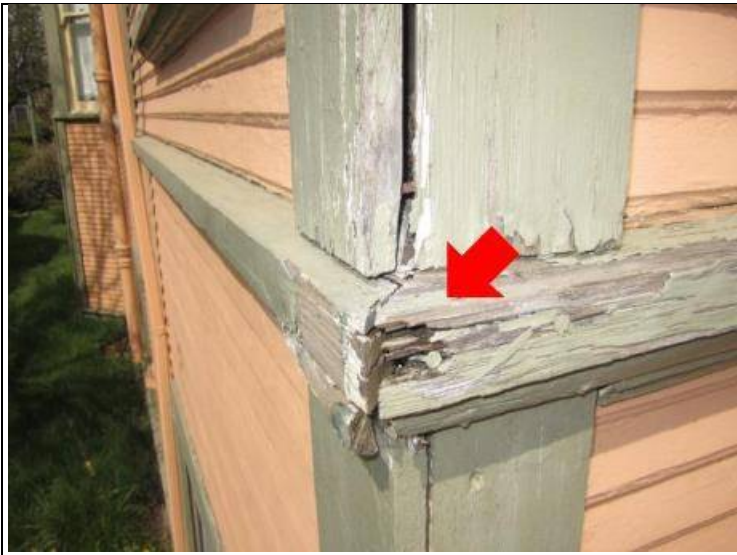
Action Necessary -  
Sections of the trim  
are rotten.

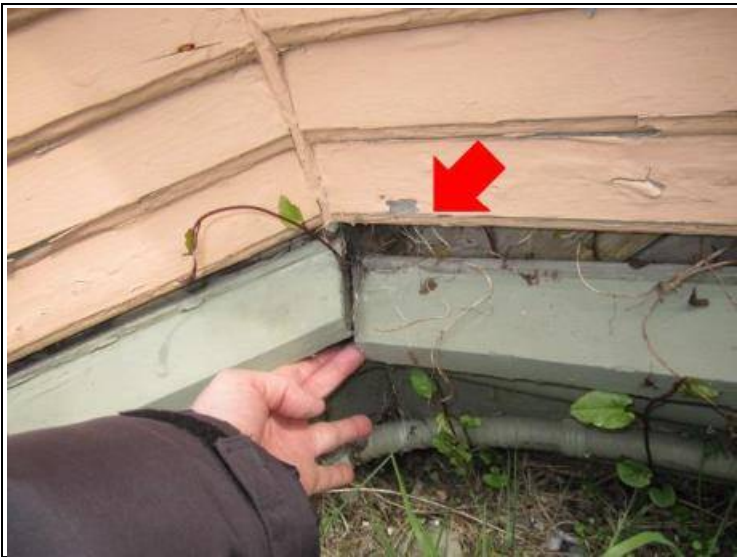
Action Necessary -  
Some sections of  
trim are loose.

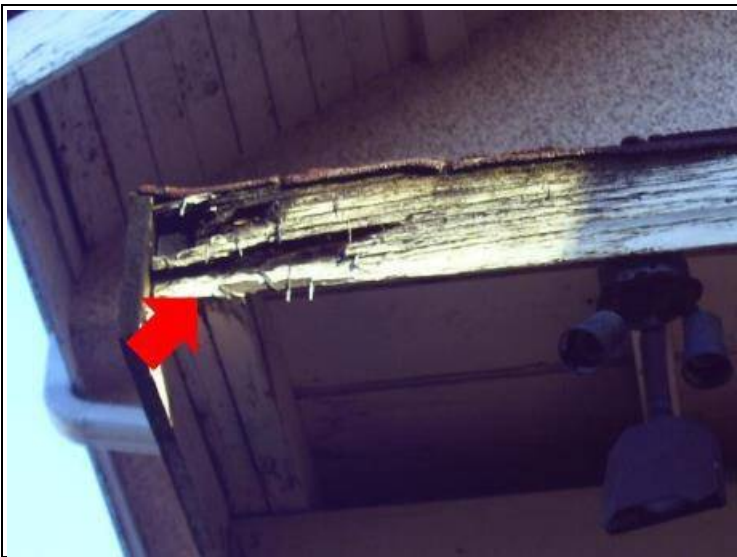
Action Necessary -  
The fascia & barge  
boards are rotting  
and the rot has  
affected the roof  
sheathing and the  
ends of the rafters.  
Repairs or partial  
replacement is  
needed.

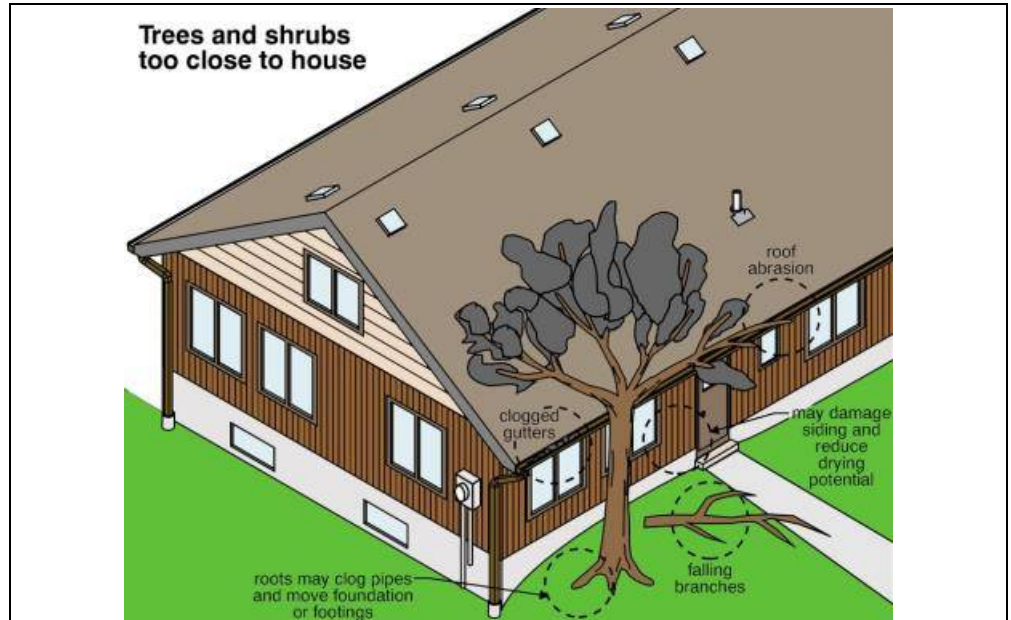
Action Necessary - Trees/Shrubs are too close to the house. Implications include, encouraging rodents onto the roof, preventing the siding from drying out, risk of blocking the drain tile with roots, risk of affecting the foundation, plugging gutters, roof abrasion etc.

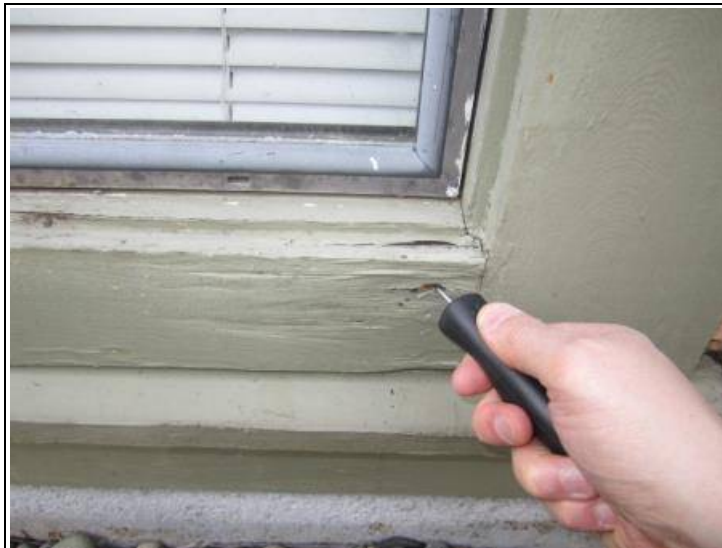
Action Necessary - There is sections of rot in some window frames.

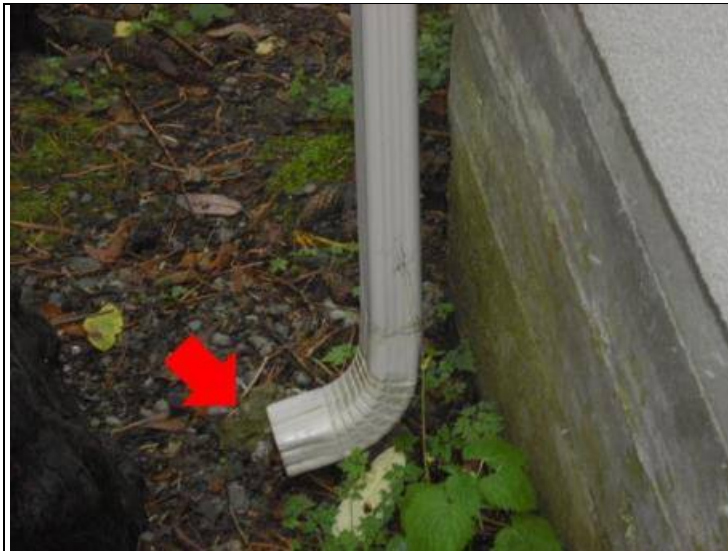
Attention Needed - Some downspouts are not discharging their run-off water correctly. Run-off water needs to flow away from the side of the building at least 6 feet. This will allow the run-off to get far enough away to not interfere with the foundation. Alternatively downspouts could

be connected into drains.

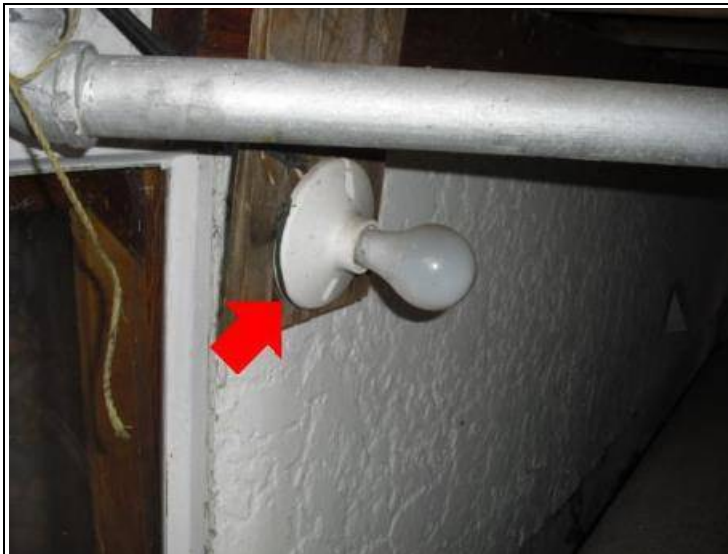
Action Necessary - At least one external light fixture is internal grade and should be changed.

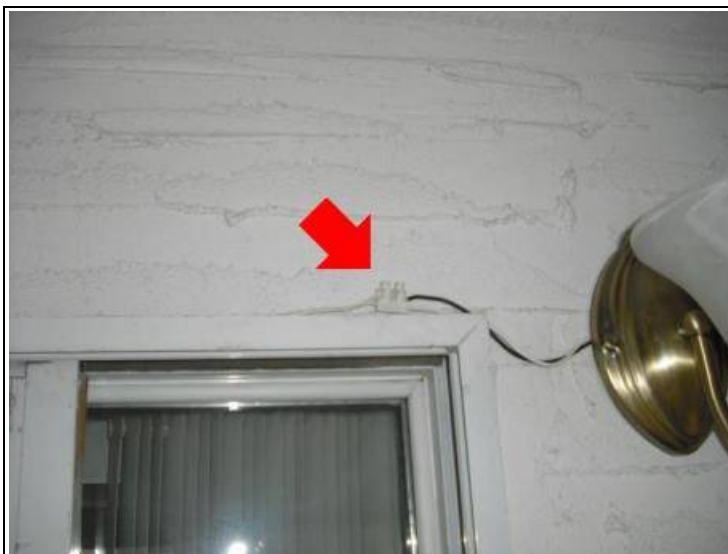
Action Necessary - An unprofessional electrical installation exists, the wrong type of wiring has been used and an inappropriate connector.

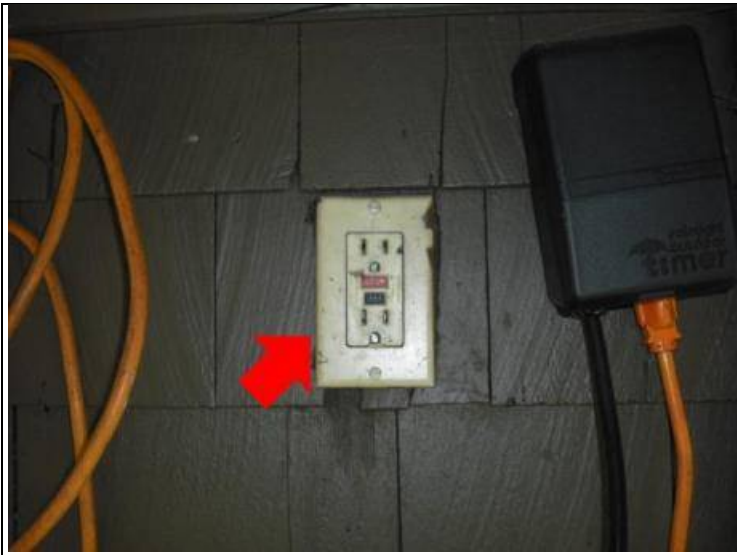
Action Necessary -  
An internal grade  
outlet has  
incorrectly been  
used outside. This  
requires changing as  
soon as possible to  
an external grade  
outlet.

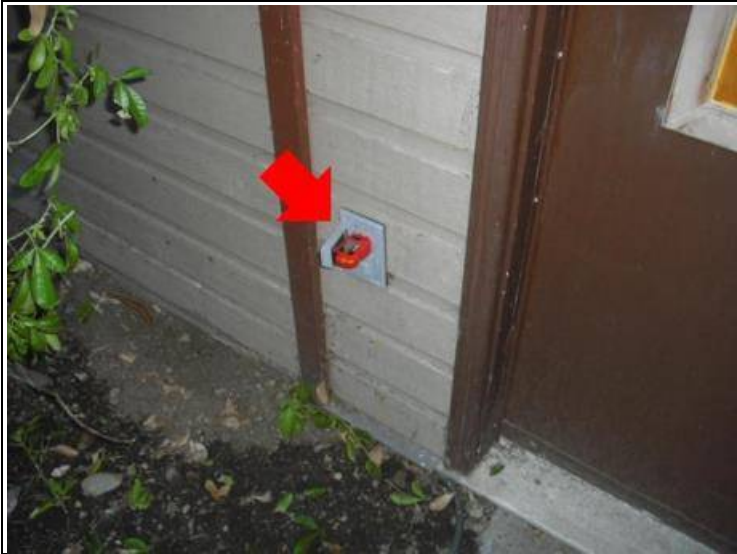
Action Necessary -  
Not all of the  
external sockets are  
GFCI protected.

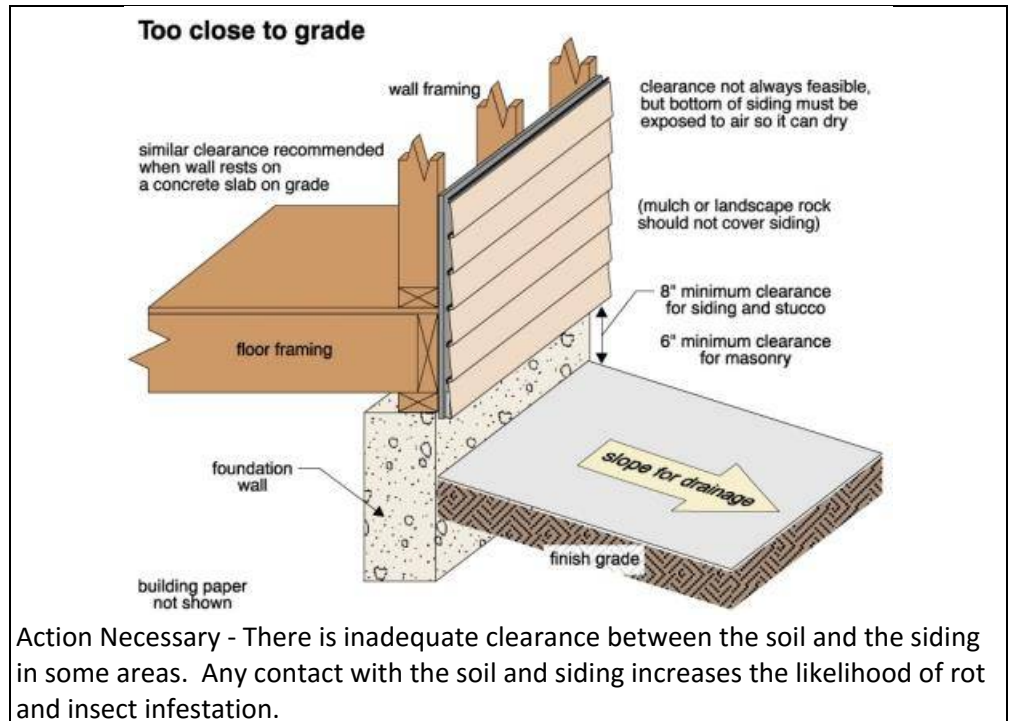
Action Necessary - There is inadequate clearance between the driveway and the siding. The driveway is higher than the top of the foundation wall. This increases the likelihood of rot and insect infestation in the framing.

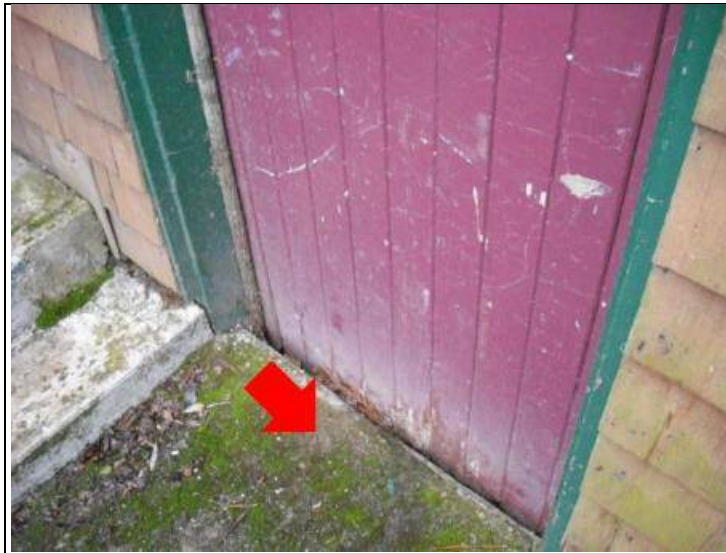
**Action Necessary -**  
There is no drain in the concrete floor of the basement walkout. This is required to eliminate or minimize the risk of water entry into the basement. Also there should be a minimum of a 4" step up into the basement from the outside (to prevent water entry).

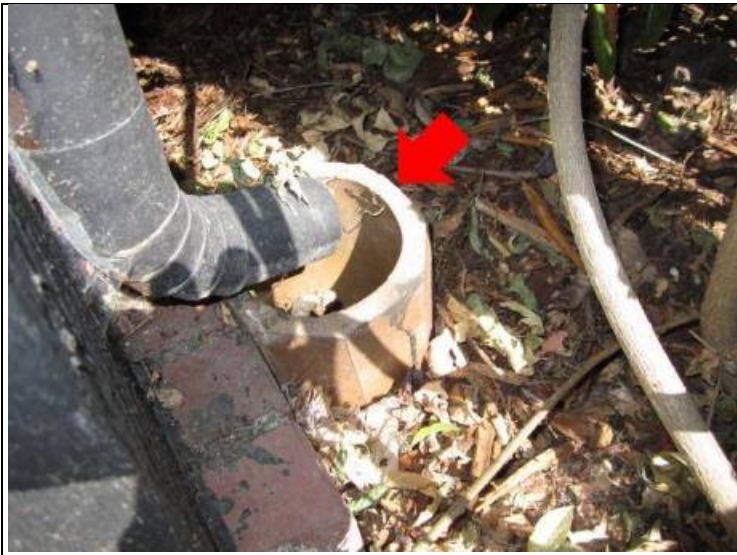
Action Necessary - the clay drain tile appears to be blocked. Recommend getting a specialist draintile company to clean out and scope the perimeter draintile to establish it's presence and condition.

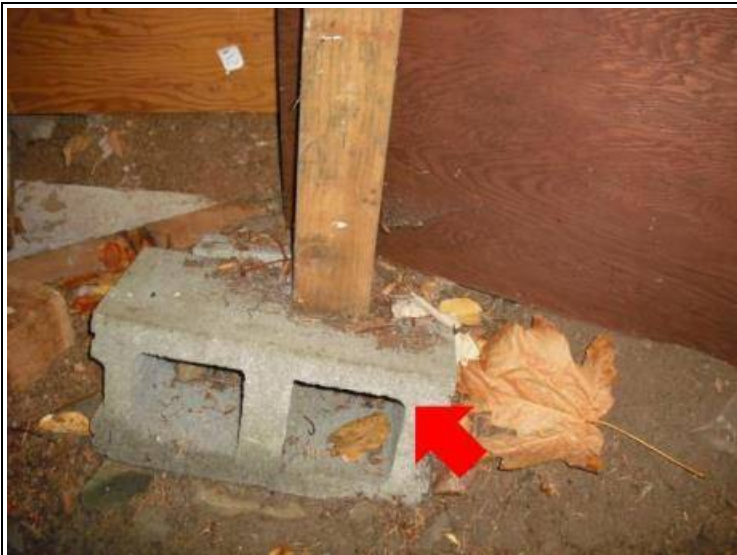
Action Necessary - the columns are poorly supported.

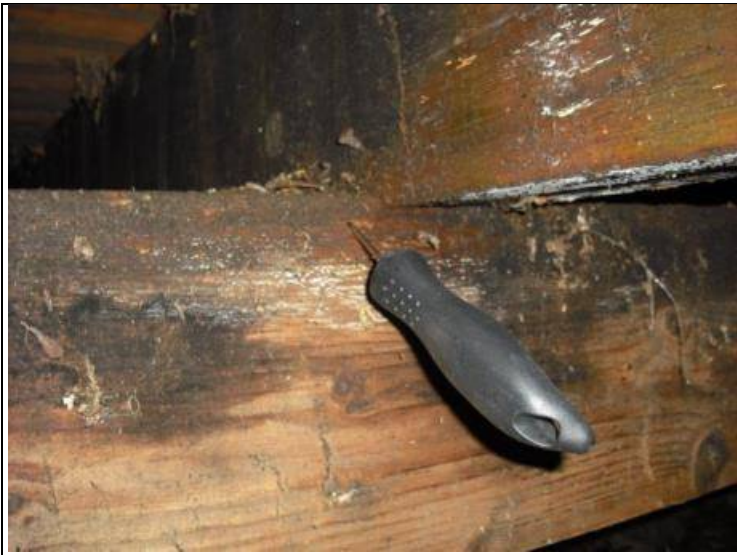
Action Necessary -  
The beams need  
repair or  
replacement. This is  
due to rotten  
sections.

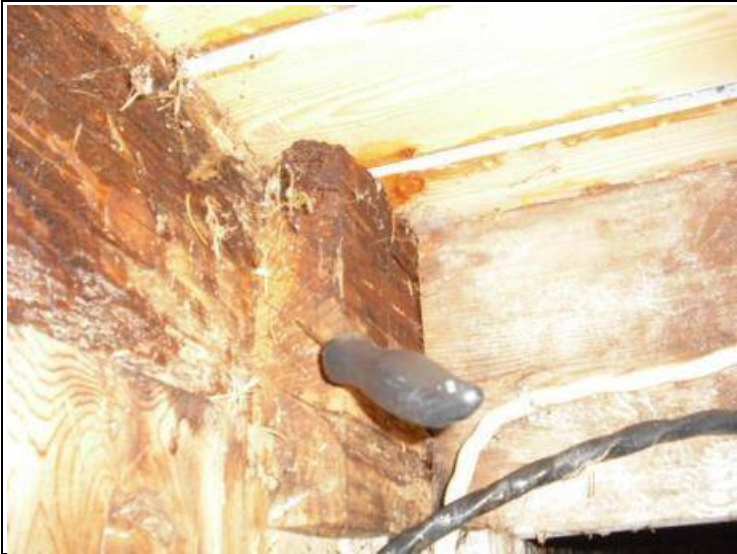
Action Necessary -  
The joists need  
repair or  
replacement. This is  
due to rotten  
sections.

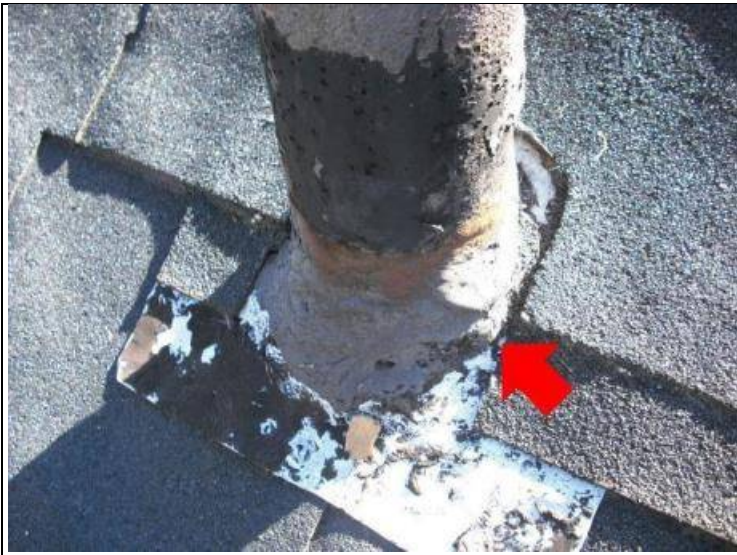
Action Necessary - the flashings are in poor condition and should be replaced when the house is re-roofed.

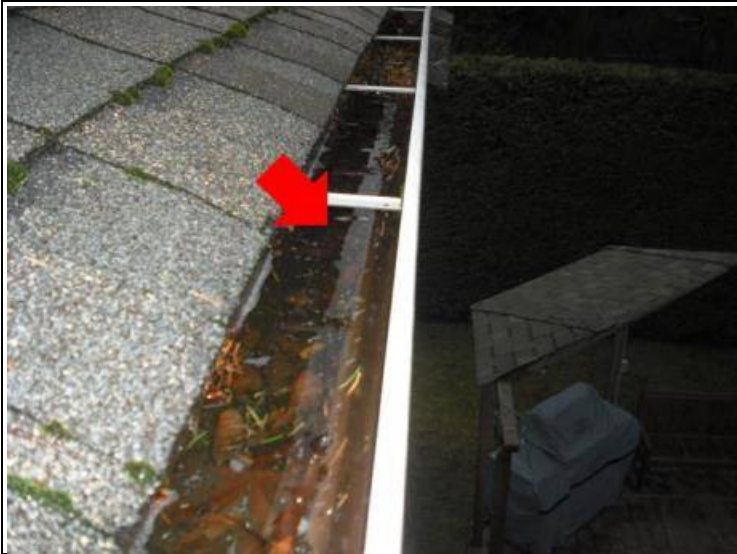
Action Necessary - The gutter system on the roof edge are inadequately sloped to carry the water to the downspouts.

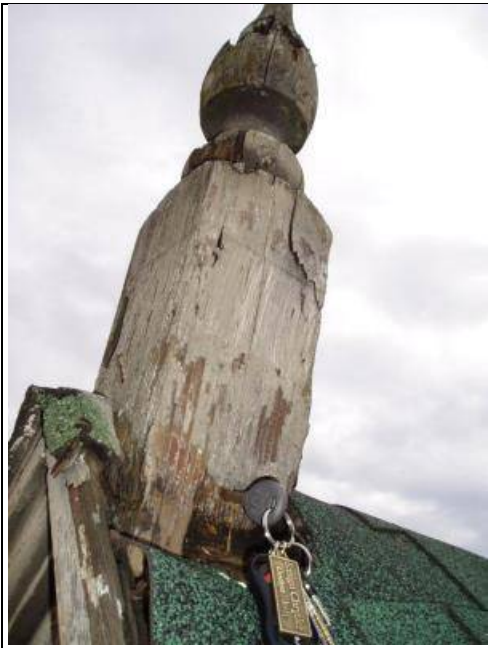
Action Necessary - The finials are rotting.

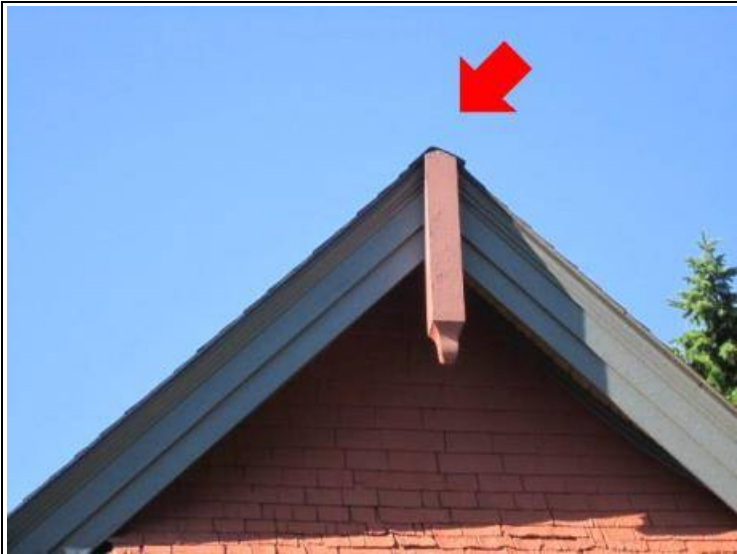
Action Necessary -  
Some sections of  
finials are missing.

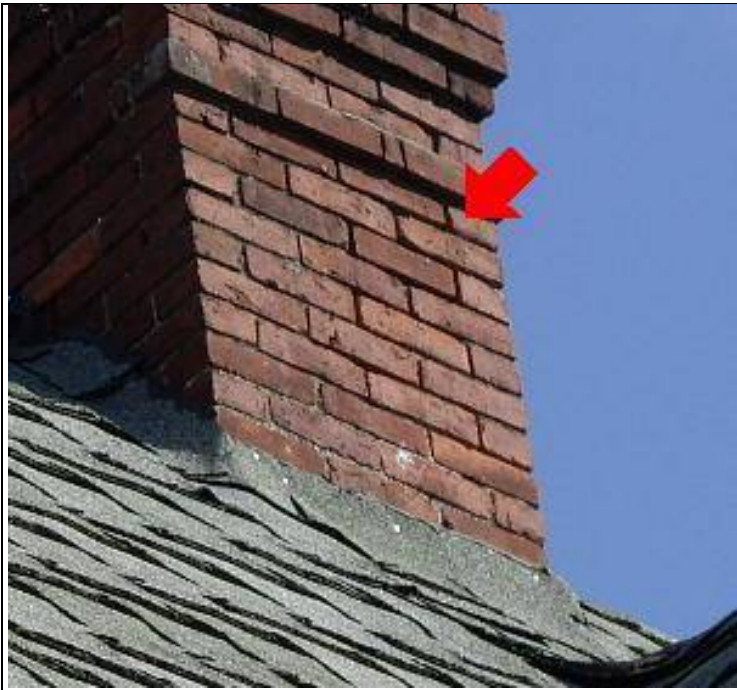
Action Necessary -  
The mortar joints  
need repointing.

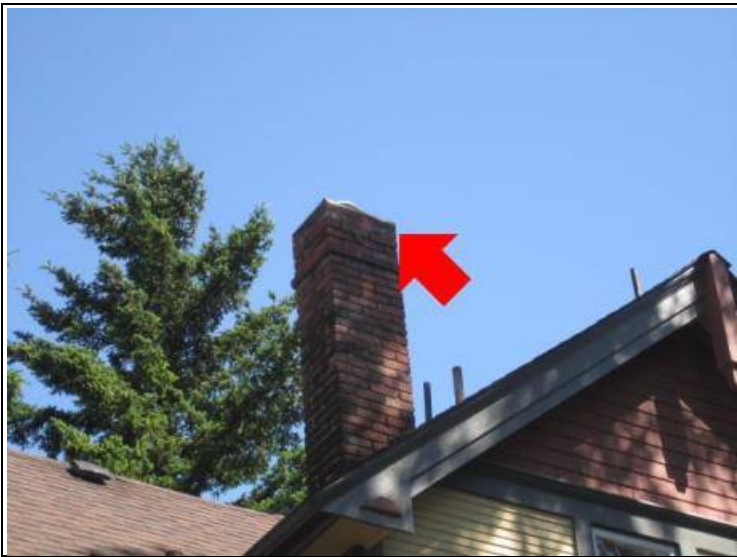
Action Necessary -  
There is no concrete  
crown at the top of  
the chimney stack.

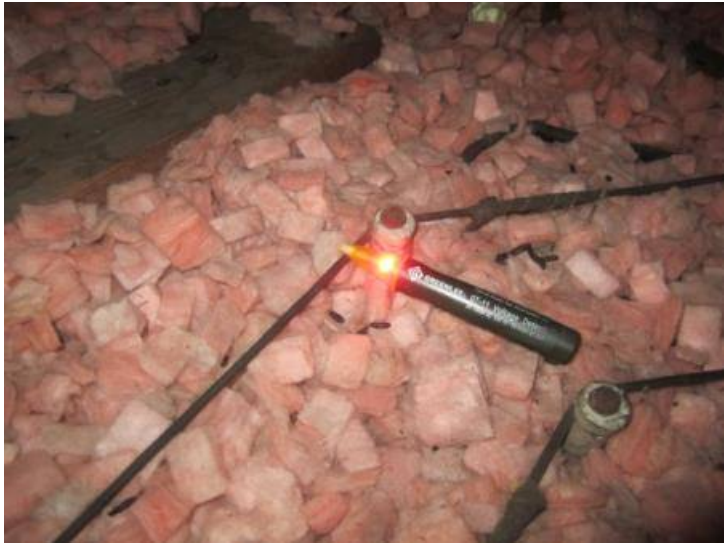
<div style="margin-left: 10px;"> <p>Sheathed Copper and Knob &amp; Tube wiring.</p> <p>Action Necessary - you need to be aware that some insurance companies will not insure a house with knob and tube wiring. Due to the potential for overload or deteriorated condition, some insurance companies will require an upgrade of the electrical system.</p> </div> </div>

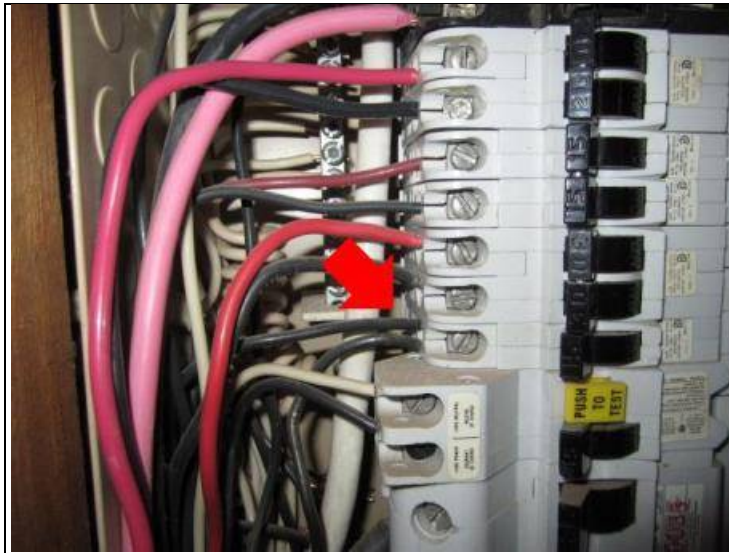
Action Necessary - There are two wires to a breaker. These need to be separated so that each wire will have its own breaker.

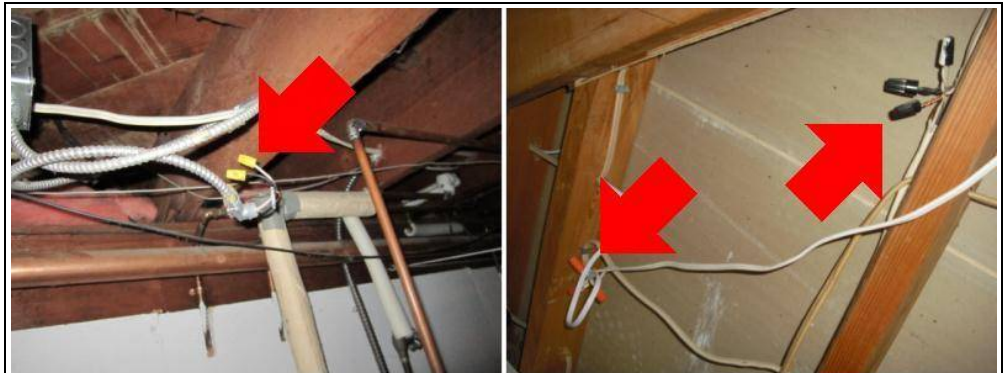
Action Necessary - I noted electrical cover plates missing, disconnected wires, untidy electrical installations etc that require the attention of a license electrician. The main areas were as follows: Basement.

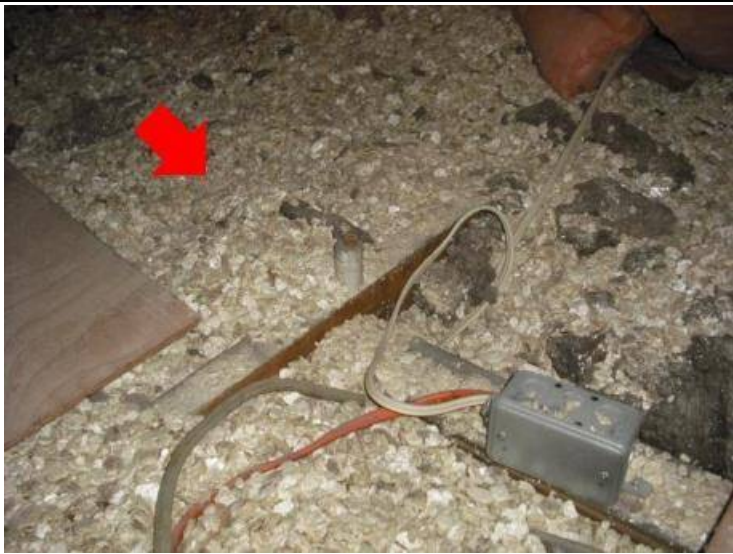
</div><div><p>Whilst inspecting the attic the insulation was sampled in several locations and it was found to be: Vermiculite</p><p>Action Necessary - most types of Vermiculite insulation contain asbestos. It is recommended that this type of insulation is not disturbed. If it becomes a requirement to disturb it then chemical analysis will be required to determine if it contains asbestos. In which case, if it does, specialist asbestos removal contractors will be required.</p></div></div>

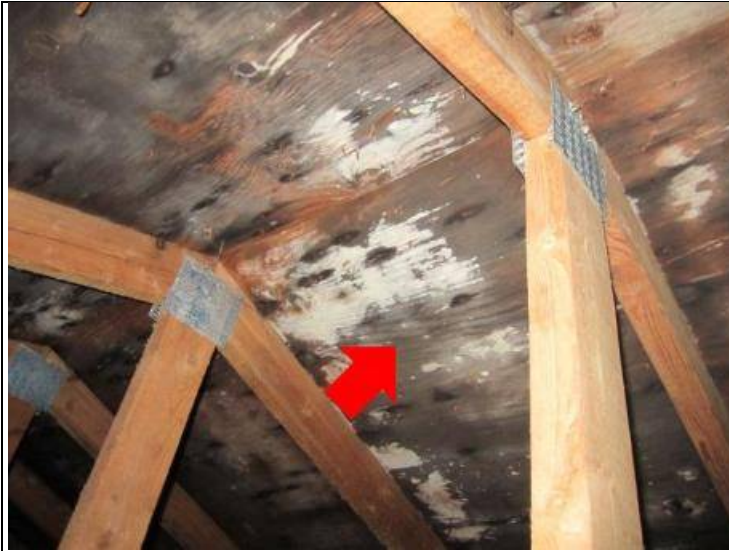
**Action Necessary -**  
There either is or has been a moisture problem in the attic that requires attention. This is evidenced by staining on the underside of the roof sheathing and on the trusses/rafters and rusty nails where they penetrate the sheathing. **It is strongly**

**recommended that the services of an environmental consultant are used to identify the staining (could be mould etc) and what course of action should be undertaken. You should also establish where the moisture is coming from.**

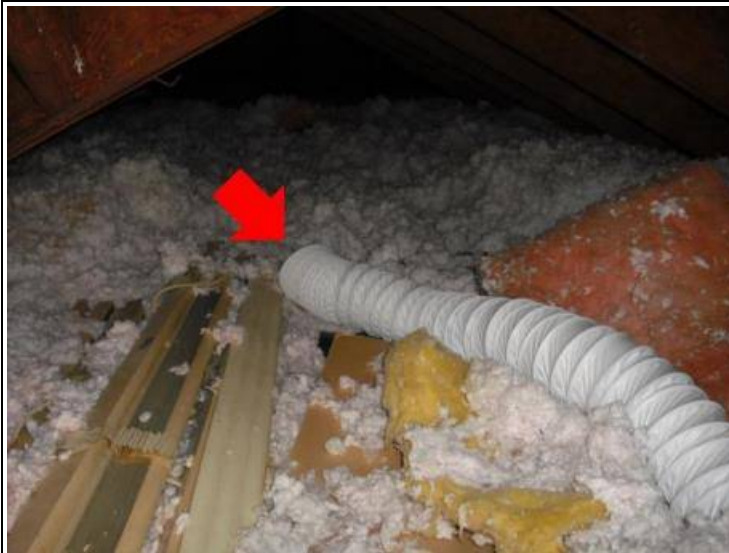
**Action Necessary -**  
There is at least one bathroom ventilation fan that is allowing moist air to enter the attic. It is essential to direct all vent ductwork to the outside so that additional moisture is not introduced into the attic space and insulation.

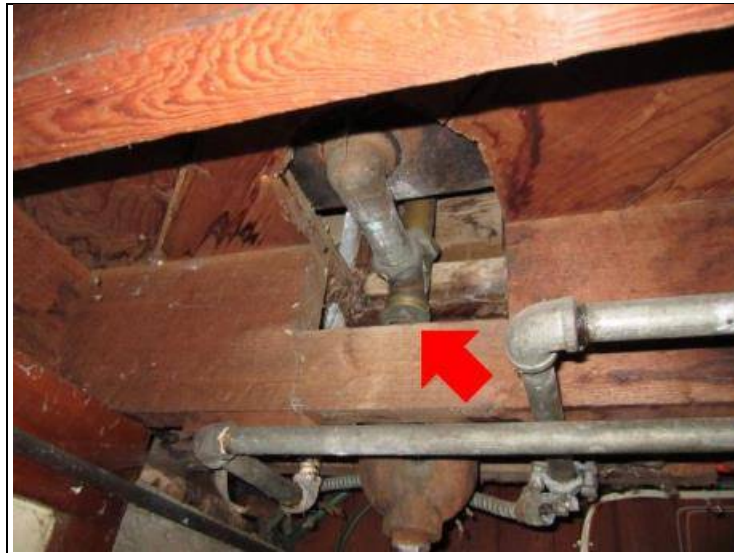
Action Necessary -  
At least one joist has  
been weakened by a  
large notch/hole.

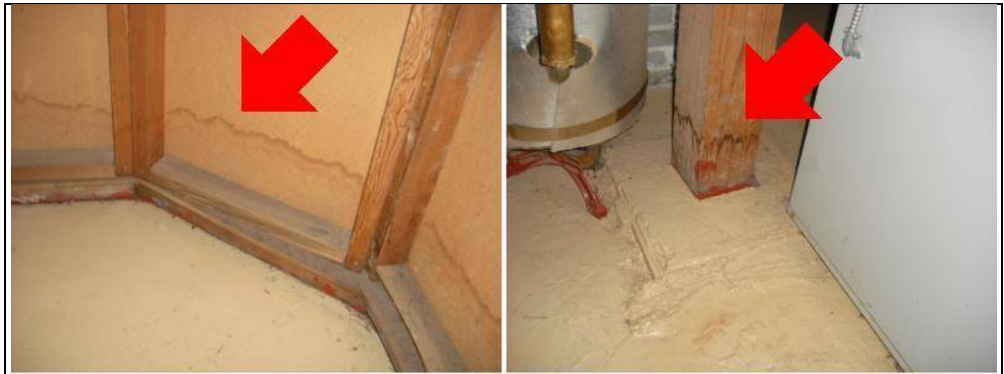
Action Necessary - There is evidence of water entry in the basement level.

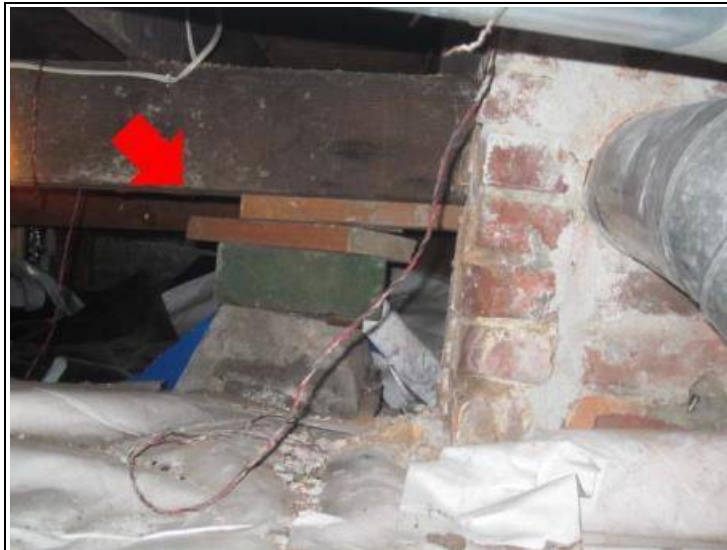
Action Necessary - Several columns are unprofessionally constructed.

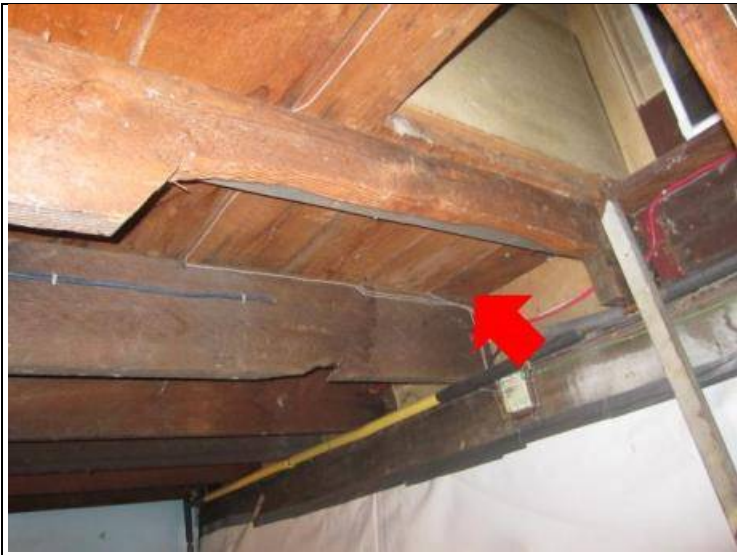
Action Necessary - Large notches/holes have been made in some of the joists which has weakened them.

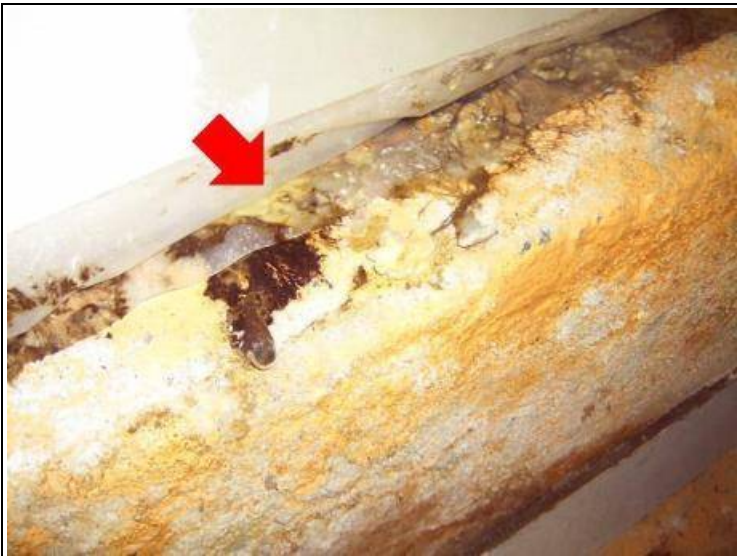
Action Necessary - Due to the high soil levels sections of the perimeter wall framing were rotting. Most of the framing was not visible due to being partly concealed by drywall. However, fungal growth could be seen growing out from the wall down the surface of the inside of the concrete foundation

wall.

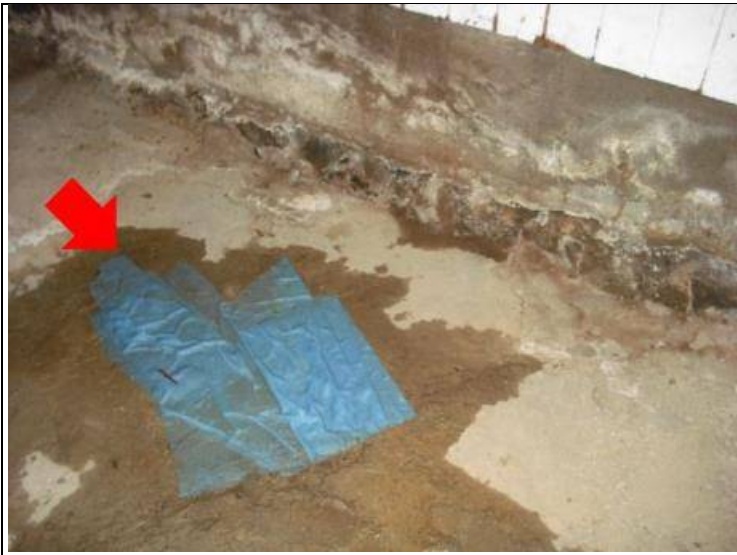
Action Necessary -  
At the time of the inspection there was water present.

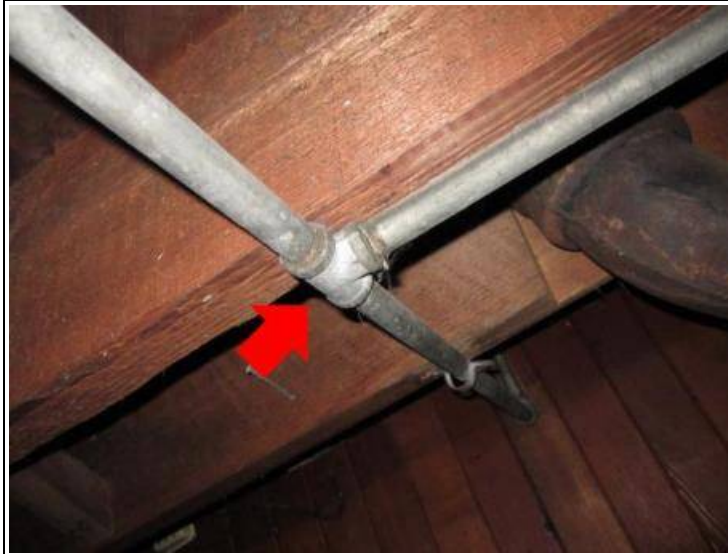
The visible sections of internal supply piping are made of: copper, plastic, galvanized steel.

Action Necessary - Galvanized steel piping is prone to rusting on the inside, particularly around the joints, which subsequently leak. Many insurance companies require

this type of piping to be replaced.

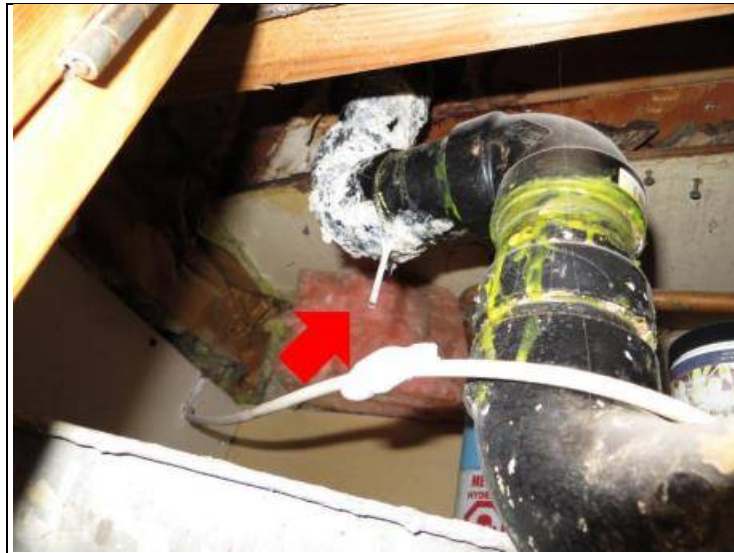
Action Necessary - There is evidence of a leak in the drain/waste piping system. Location - basement.

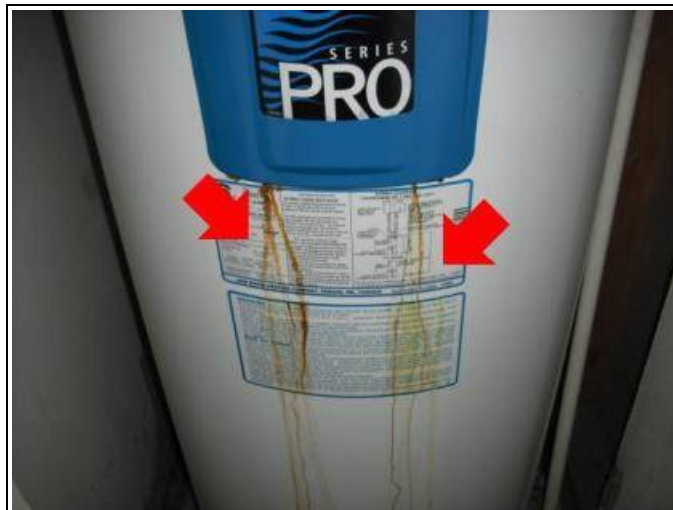
Action Necessary - The tank is leaking. Replacement is recommended.

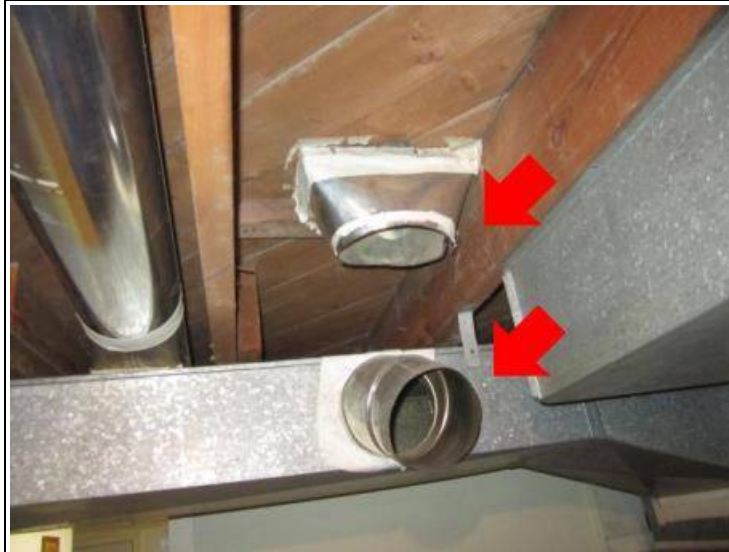
Action Necessary -  
There are  
disconnected  
sections of  
ductwork.

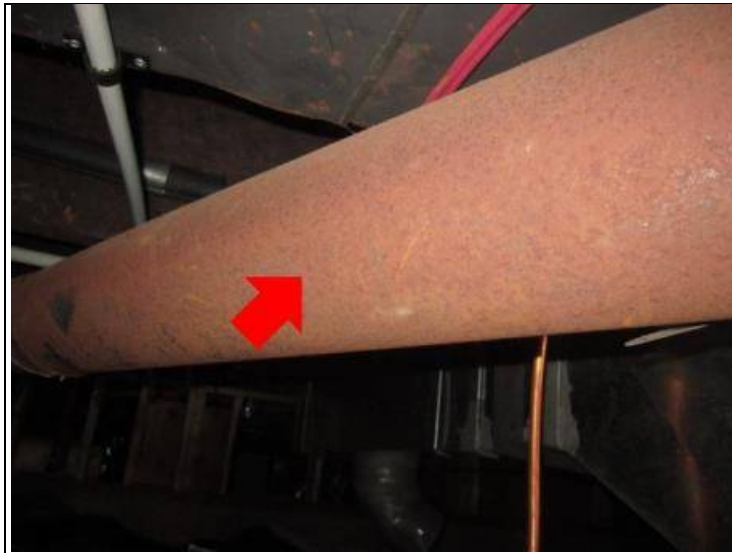
Action Necessary -  
Rust was noted on  
sections of  
ductwork.

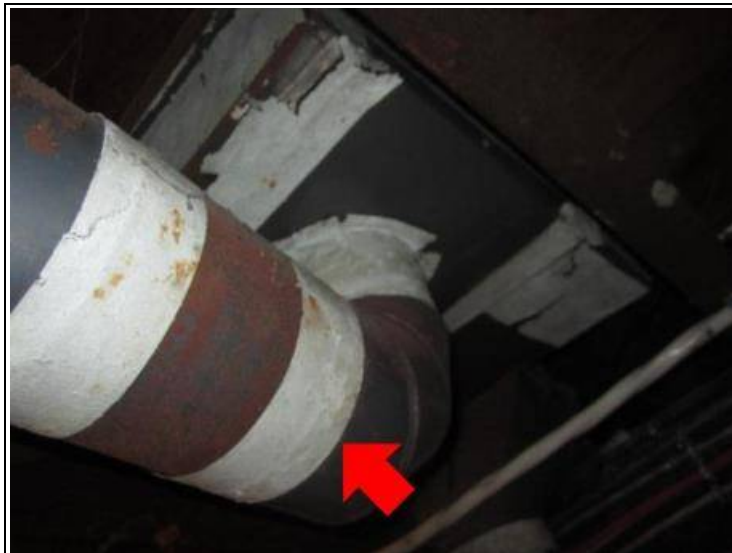
Attention Needed -  
Asbestos containing  
material was visible  
on the ductwork. It  
was commonly used  
on ductwork,  
around heat  
registers and as  
separators between  
ductwork and  
wooden framing. It  
is acceptable to  
leave asbestos in  
place provided it is  
not disturbed.

However, if it  
becomes loose or damaged, or if the ductwork is likely to be knocked and  
disturbed, it would be prudent to either encapsulate the asbestos or have it  
removed.

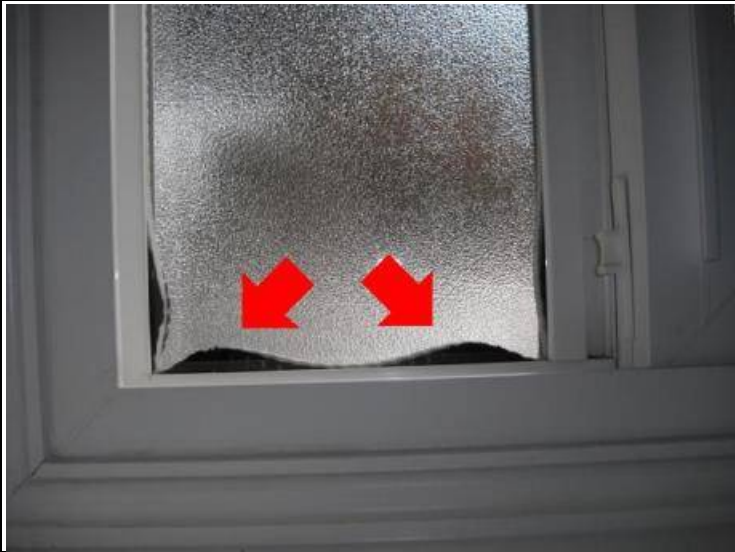
</div><div>Action Necessary - The following issues were identified: buckled spacers between the window glazing.</div></div>
Electrical Outlets:	Satisfactory - The sampled accessible outlets tested in this room are correctly wired and grounded.

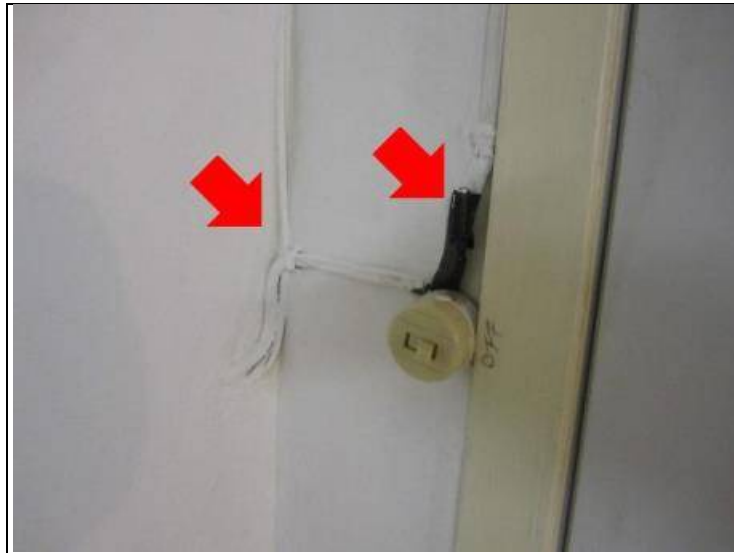
Action Necessary - unprotected surface mounted electrical cables were visible.

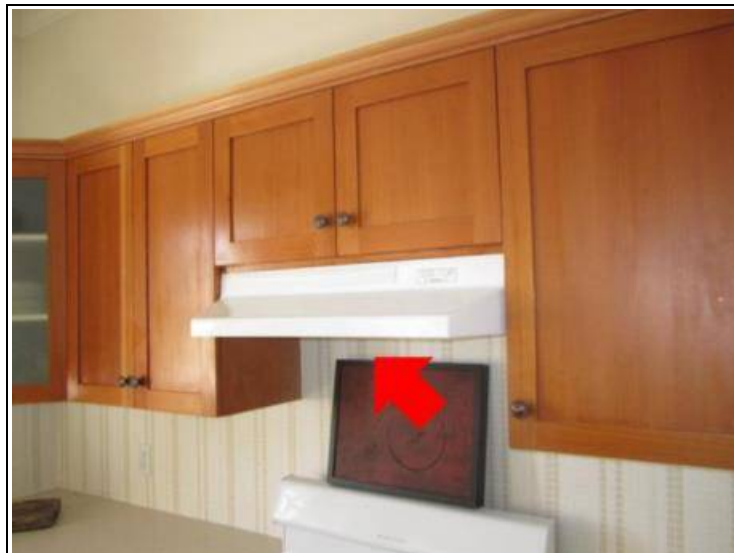
Action Necessary - The range hood isn't working.

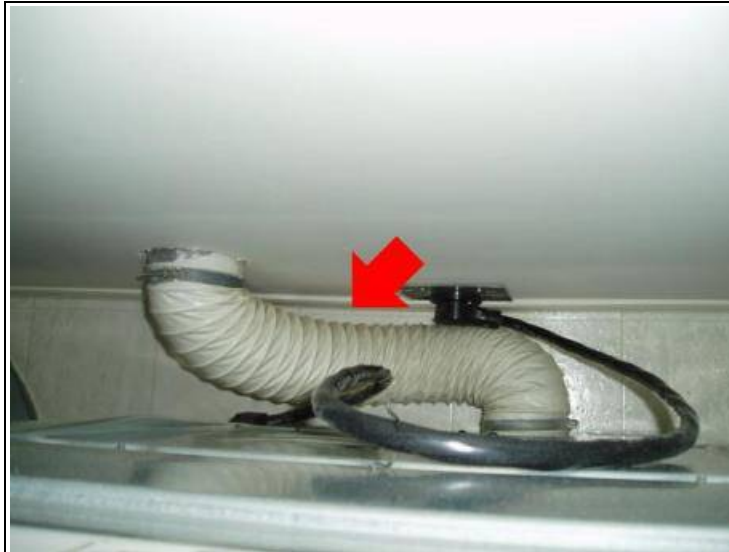
The dryer has a plastic vent. For safety reasons it is prudent to change this to metal to reduce the risk of fire which could be caused by a build up of lint inside the vent.

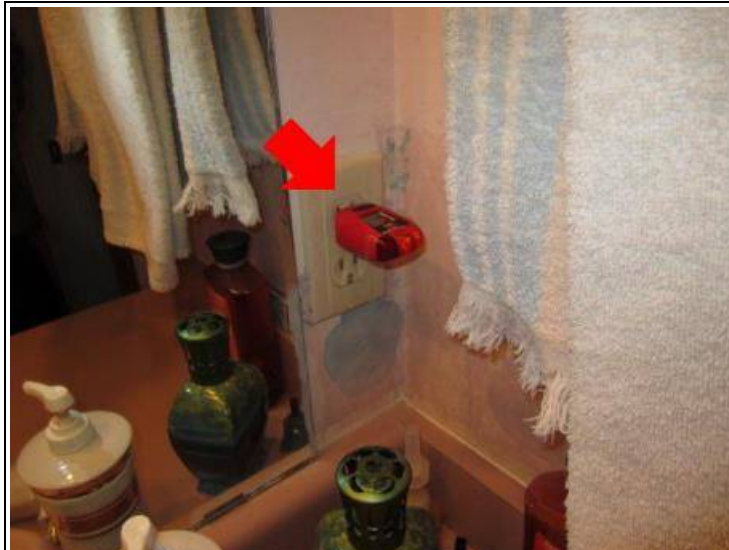
Action Necessary - The outlet in the bathroom is not correctly GFCI protected. Recommend getting either a GFCI outlet (or GFCI breaker at the panel) installed by a qualified electrician.

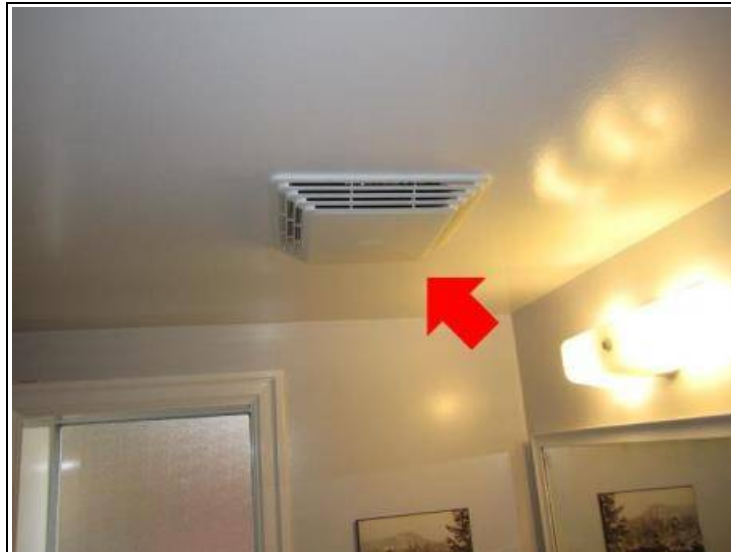
Action Necessary - There is an exhaust fan installed, but it would not activate using normal controls. Repair or replacement is necessary.
