BUILDING INSPECTION

Address of Property: 31 Uttoxeter Road, Victoria

Client: Mr.B.Uyer

Inspector: Lee Ottewell

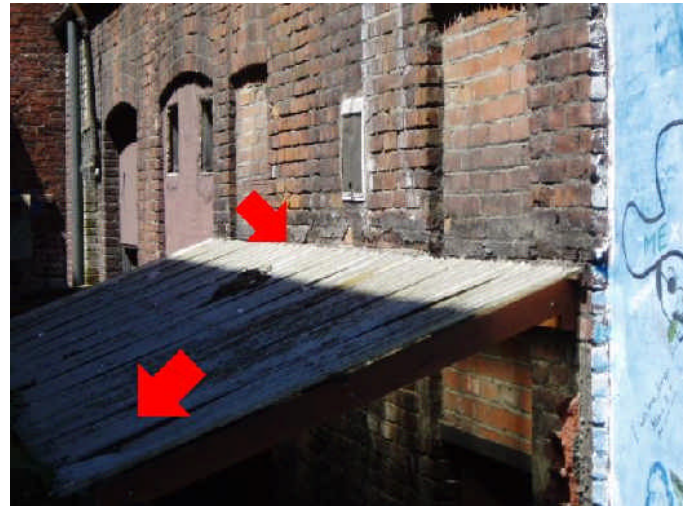
Action Necessary - there was some minor damage to the corrugated plastic roof and there was no flashing between the roof and the wall.

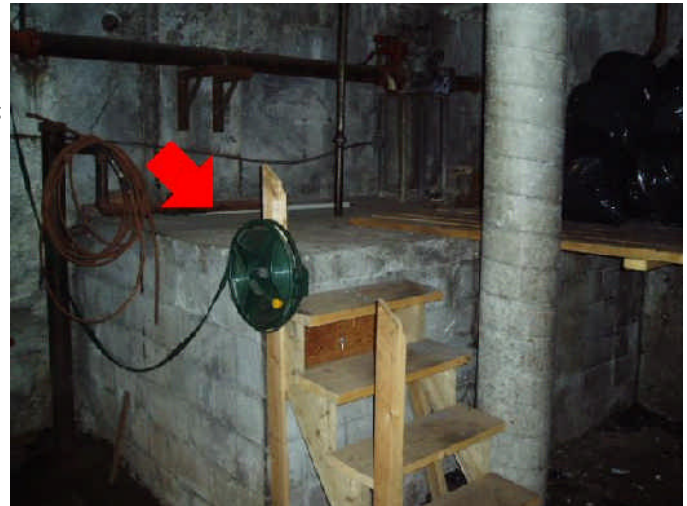
An old oil tank exists in the basement. It is enclosed in a concrete blockwork surround. It should be checked to ensure that it doesn't contain any oil and that there isn't a risk of spillage.

Action Necessary - the oil tank is no longer in use. It is enclosed in concrete blocks and it's condition is unknown. It is also unclear if it is empty of oil.

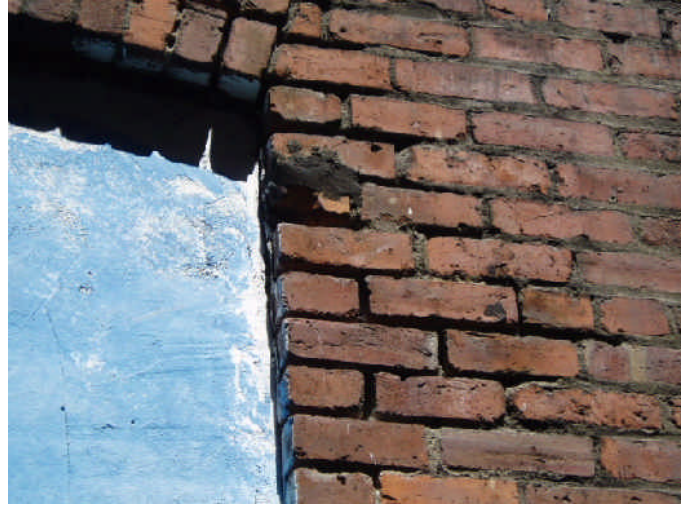
The brickwork is in poor condition, sections have spalled, sections are damaged and the all the mortar joints require repointing.

Action Necessary - the brickwork requires the mortar repointing.

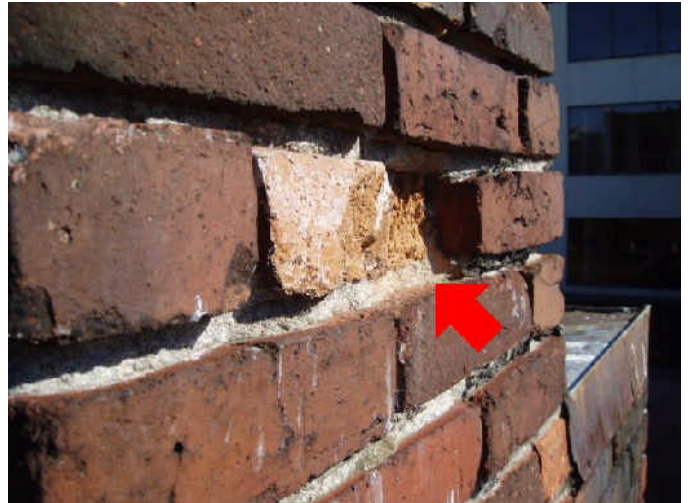
Action Necessary - surfaces of the brickwork are spalling in many areas.

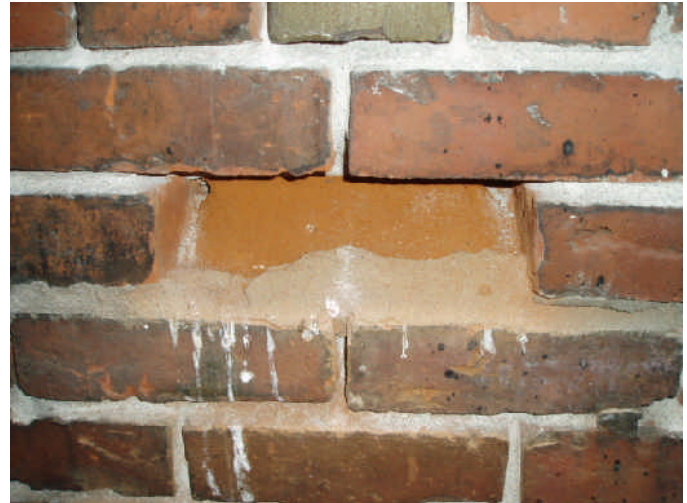
Action Necessary -
sections of brickwork
are damaged.

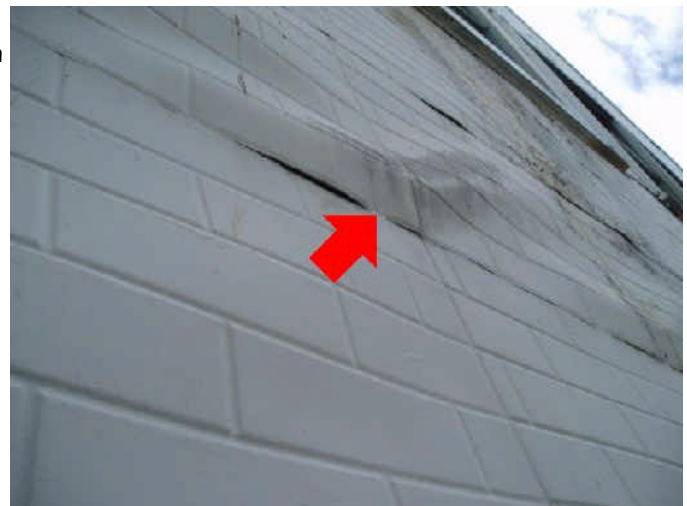
The vinyl and metal siding on the lightwell walls is in poor condition and sections of the metal siding are buckled.

Action Necessary - the
metal siding (located in
the lightwell) is
buckled.

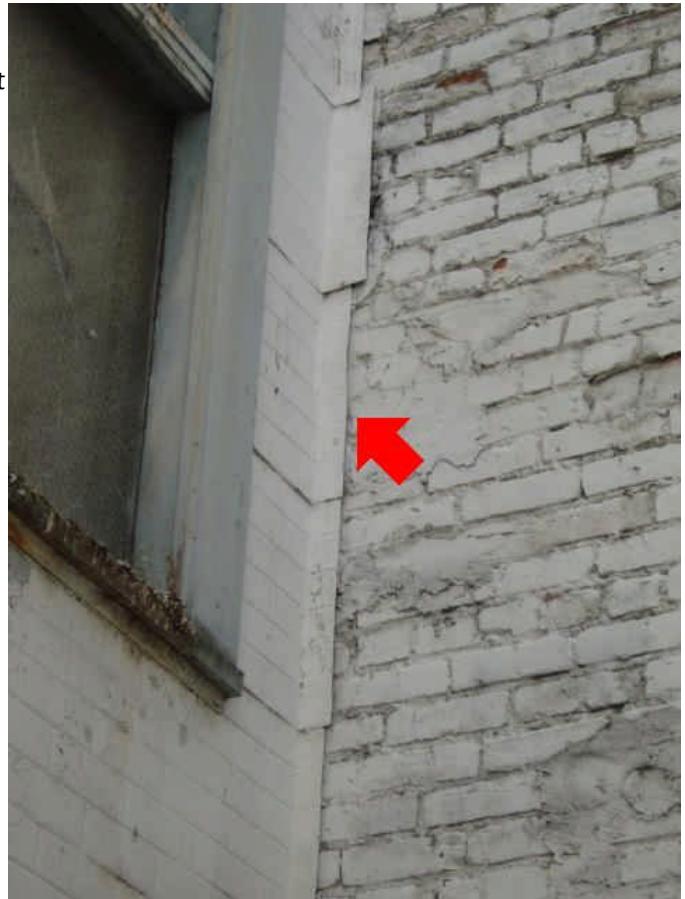
Action Necessary - the junction of the metal siding and the adjacent wall is poor.

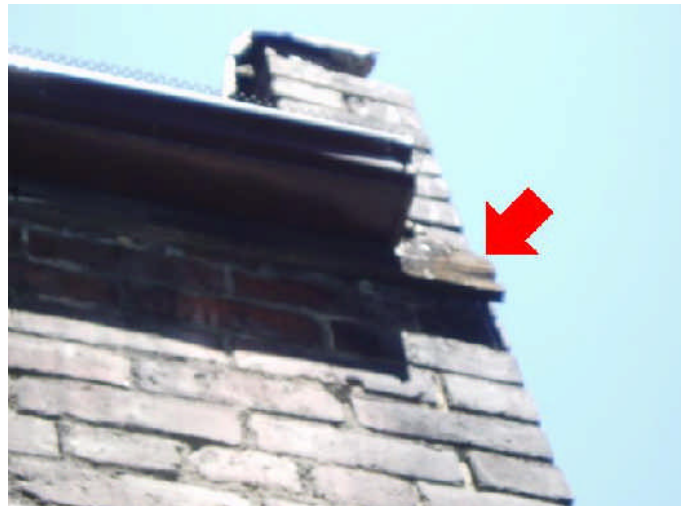
Action Necessary - The fascia boards are rotting.

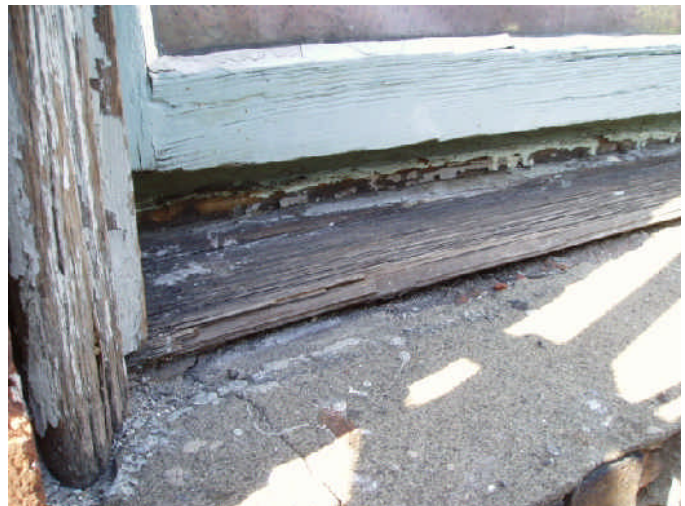
The windows and some door frames are in very poor condition - sections are rotting and other sections are missing.

Action Necessary - many of the windows are in poor condition with rotting and damaged frames.

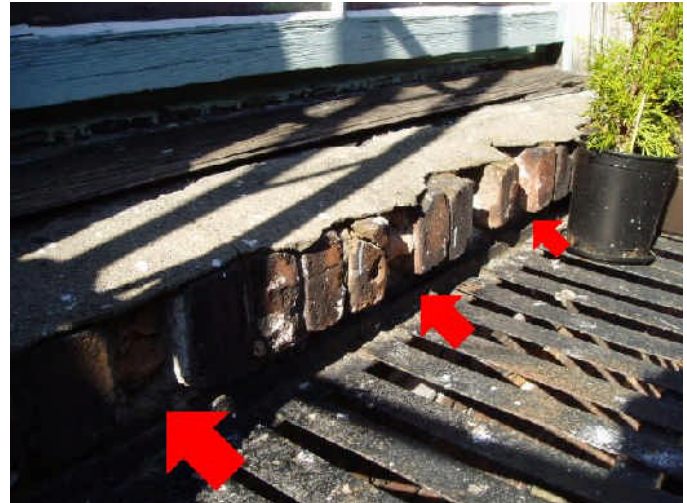
Action Necessary - the brick cills underneath some windows are in very poor condition.

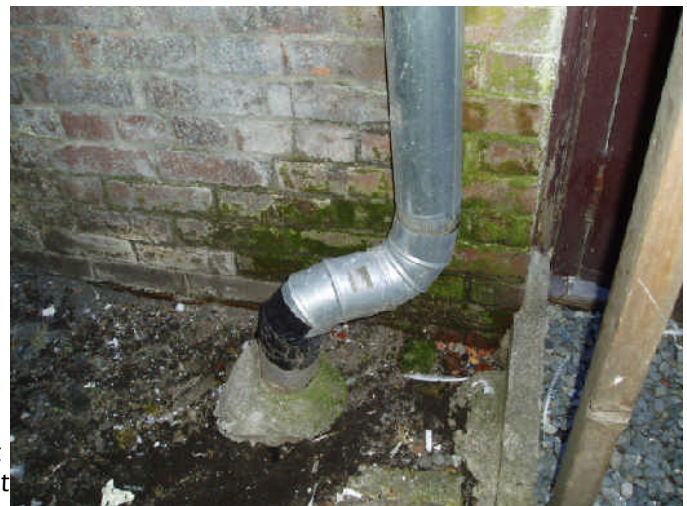
Action Necessary - Some downspouts are not discharging their run-off water correctly. Run-off water needs to flow away from the side of the building at least 6 feet. This will allow the run-off to get far enough away to not interfere with the foundation. Alternatively downspouts could be connected into drains.

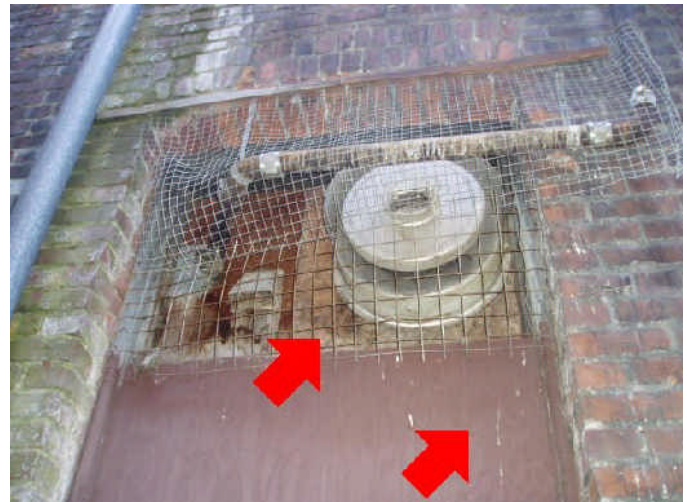
Action Necessary - at the rear of units 705 and 707 voids above windows, around vent ductwork etc have been filled in with a combination of bare plywood, painted plywood and plywood with a stucco finish. All have been poorly undertaken.

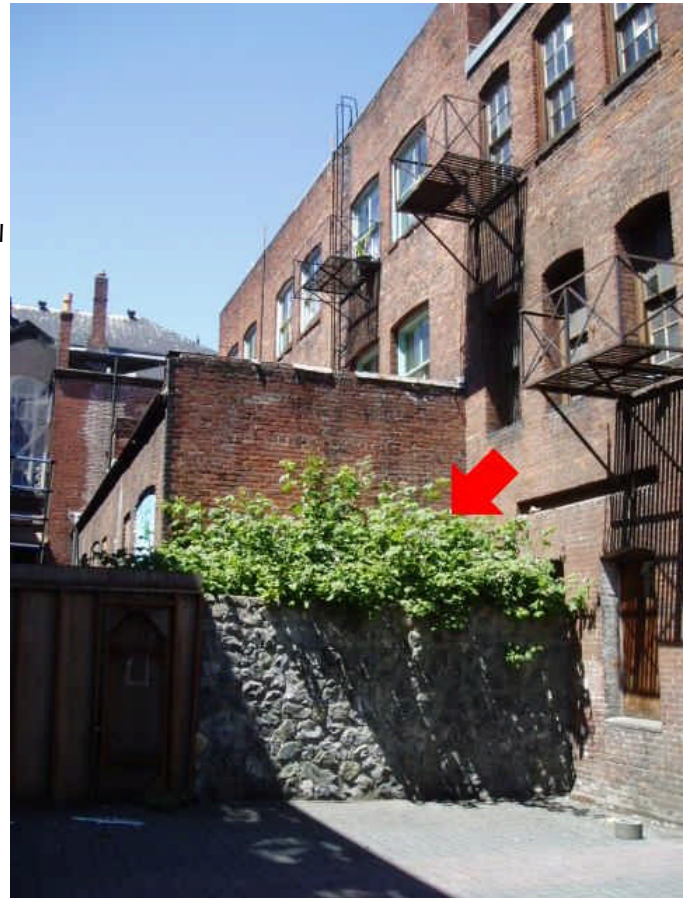
A planter at the rear of the building should be further investigated to establish if there is an adequate water proof membrane between the soil and adjacent walls.

Planters	Action Necessary - there is a large stone walled planter against the building. It is located at the rear against the left hand flank wall to unit 707. The planter is full of soil and is over grown. There is a risk of water penetration through the flank brick wall.
-----------------	--

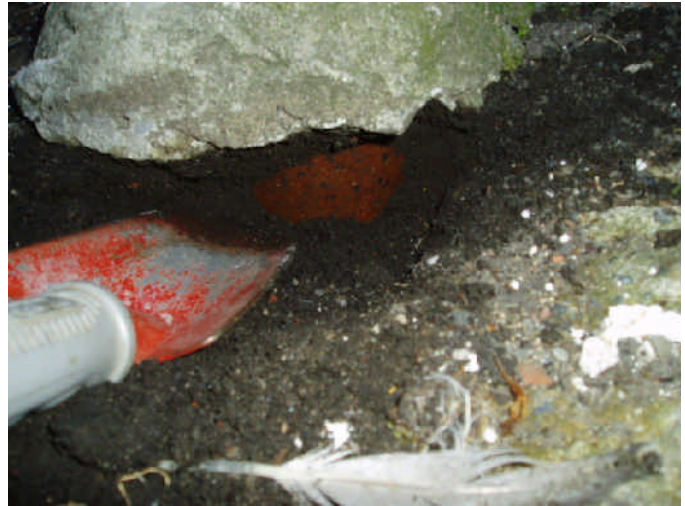
I noted an exposed section of an older style clay perimeter draitile. This will need cleaning out and an invasive draitile survey to establish if it is still functioning. However, based upon the age of the building the likelihood is that it will require replacing.

A clay section was
visible at the rear of
unit 705.

Action Necessary - due to the age of the building and the fact that the draitile appears to be an old concrete/clay version - I recommend an invasive draitile survey (using a company such as Roto Rooter) to establish presence and condition of the drainage tile.

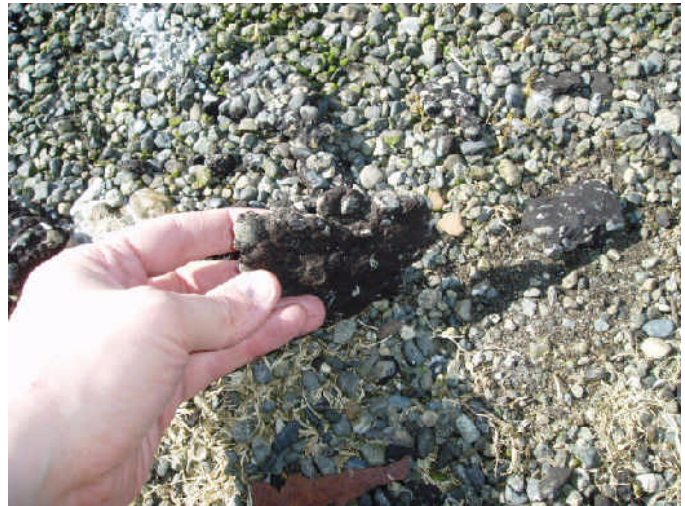
Action Necessary - sections of the asphalt have broken up.

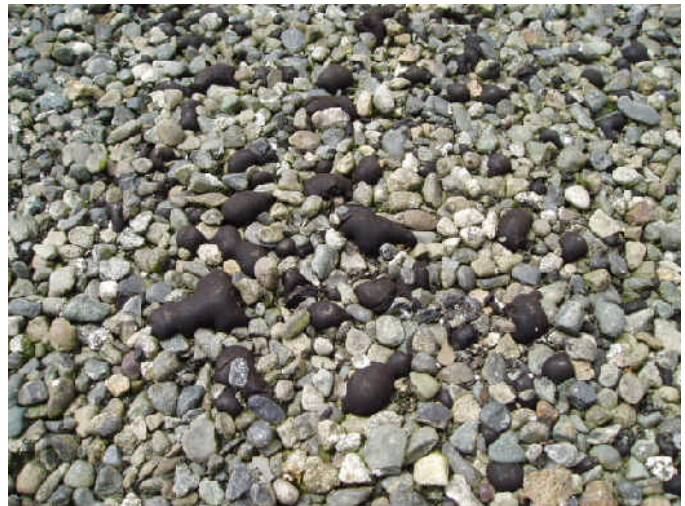
Action Necessary - sections of the asphalt have bled through the gravel.

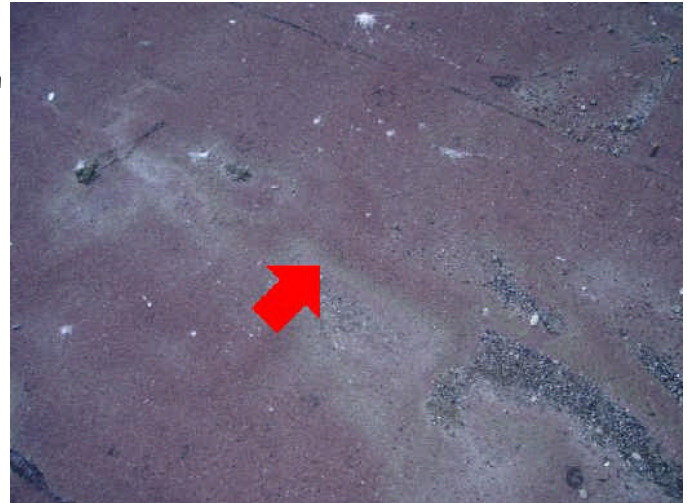
The lower level roofs are torch-on asphalt and are also in poor condition. I noted soft spots and ripples in the asphalt. There is inadequate drainage on the lightwell roof (only one roof scupper).

Action Necessary -
there were soft spots
and ripples in the torch
on asphalt on both the
lower roofs.

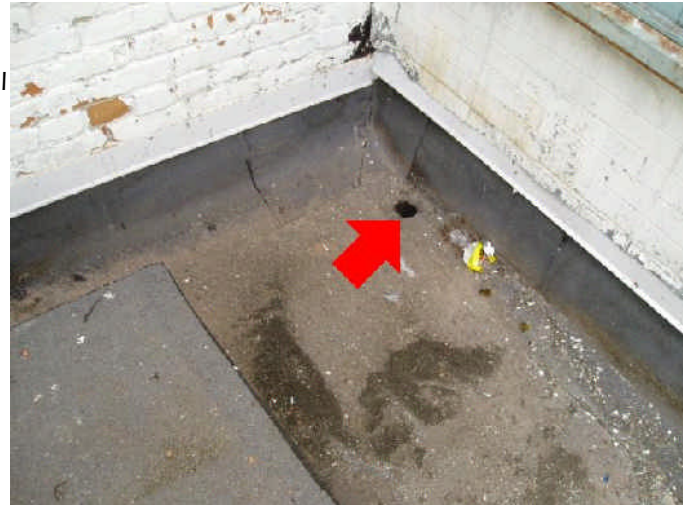
Action Necessary -
there is only one
scupper to the lightwell
roof.

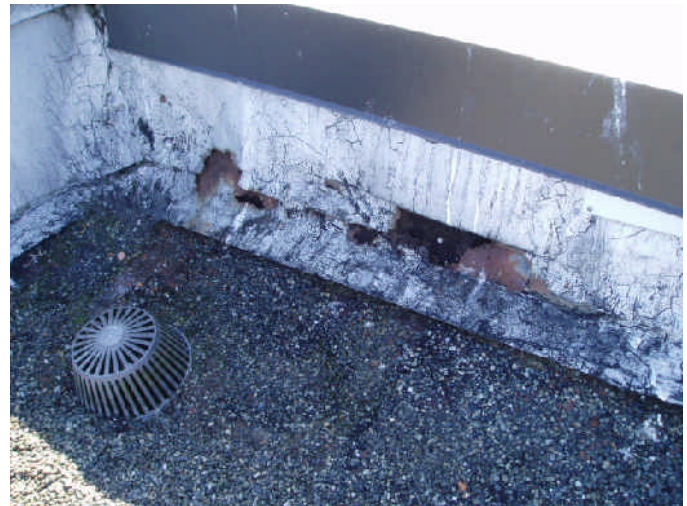
cracking and blistering. The cap flashings at the junction of the roof and the parapet walls have rusted through in many areas.

The majority of the
perimeter cover
flashings were in poor
condition. This
photograph shows a
section that has rusted
through.

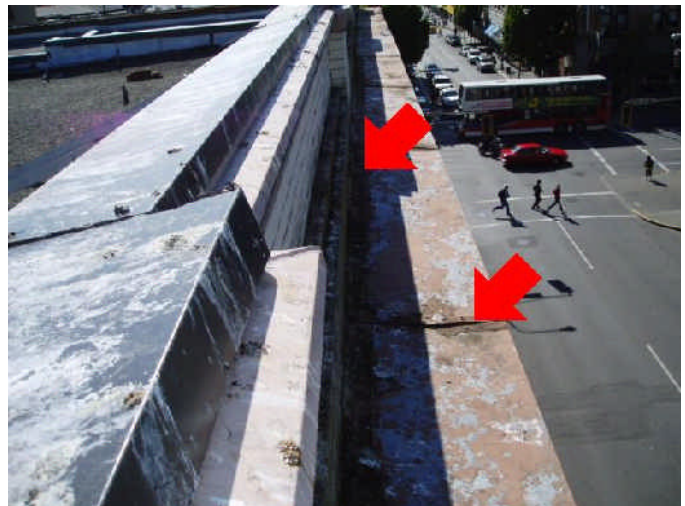
Action Necessary - the flashing above the front cornice is in poor condition at the joints eg where it adjoins the building facade and the overlapping joints.

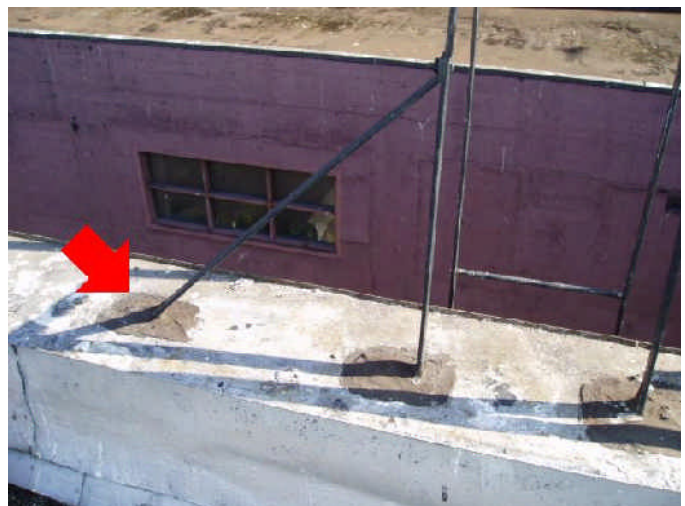
Action Necessary - the fire escape metal bracing is loose.

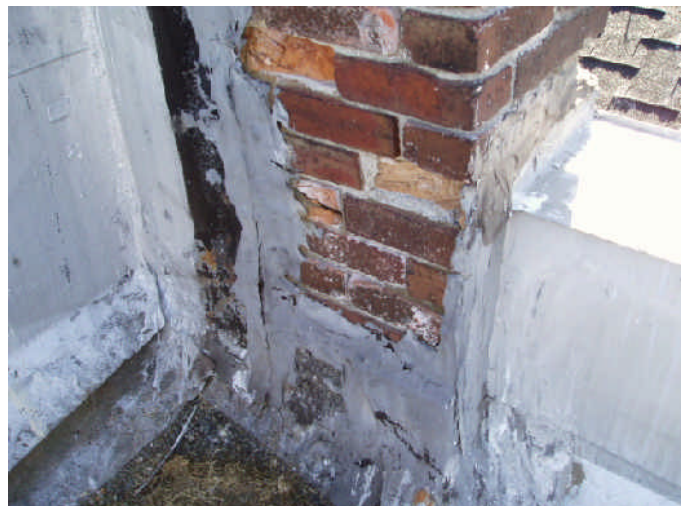
Location:	Middle of the property.
Exterior Stack Material:	The exterior fireplace stack is made of masonry.
Exterior Stack Condition:	Action Necessary - The exterior stack has a condition that calls for repair. The chimney shows evidence of brick spalling. Cause is due to moisture getting into the bricks then freezing which flakes off the surfaces of the bricks.
Flue Condition From Roof:	<p>The chimney was capped off and not in use.</p> <p>Action Necessary - the cap was not secured to the chimney stack and could blow off.</p>
Flue Lined:	No - The flue is not lined.
Chimney Height and Clearance:	Yes - The chimney installation appears to meet clearance requirements.
Flashing:	Action Necessary - The flashing installation is poor. Repair or replacement is needed to prevent water entry.

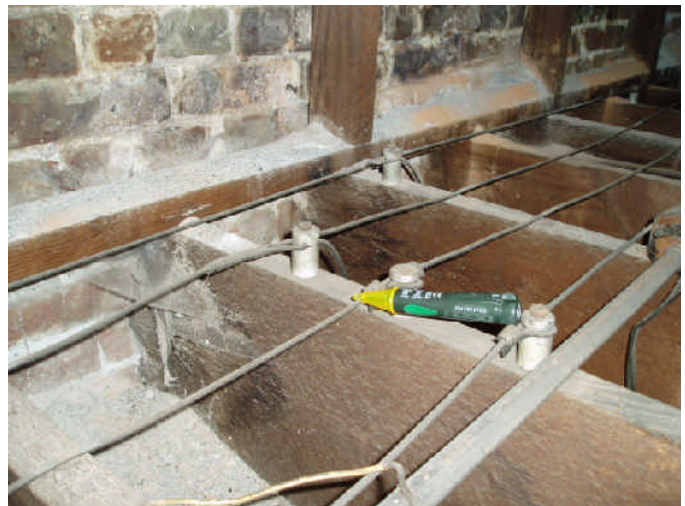
Knob and tube wiring was also visible, in the attic space. However when tested it didn't show any current running through.

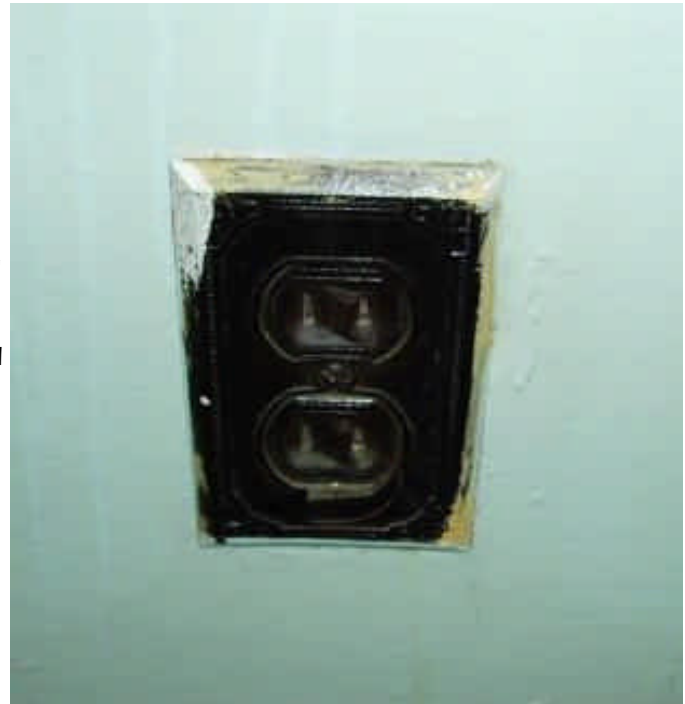
Action Necessary - although during the inspection I didn't note any active 'knob and tube' wiring I did note several ungrounded 3 pin outlets. This could be an indication of some active, remaining knob and tube wiring in the building (this type of wiring only had a hot and neutral - no ground wire). Recommend having this checked out further by a licensed electrician.

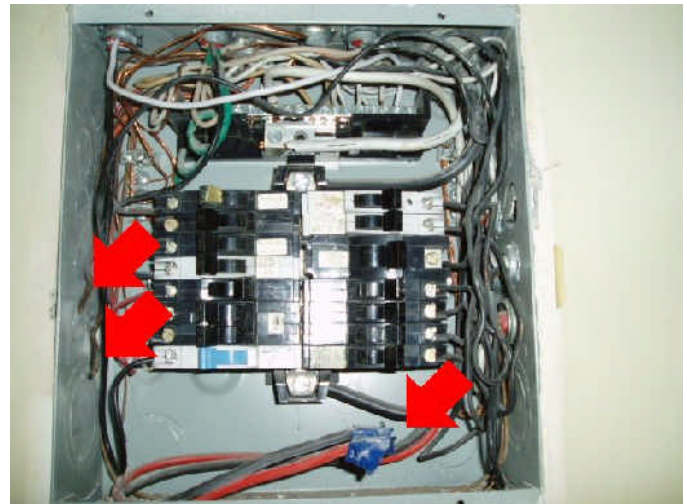
Location:	Store Room off reception.
Panel Type:	Breaker type power panel.
Panel Cover Removed:	Yes.
Panel Condition:	Satisfactory - The power panel, as a container for safely covering electrical circuitry and components, is functioning as intended, minimizing the risk of electrical shock.
Breaker/Fuse to Wire Compatibility:	Satisfactory - The breakers/fuses in the main power panel appear to be appropriately matched to the circuit wire gauge.
Legend Available:	Yes - Identification of the breakers and the appliances or areas they control are clearly marked. This inspection does not verify the accuracy of this legend.
Panel Cover Removed:	Yes.
Condition of Wiring in Panel:	Action Necessary - There were some poorly terminated wires.

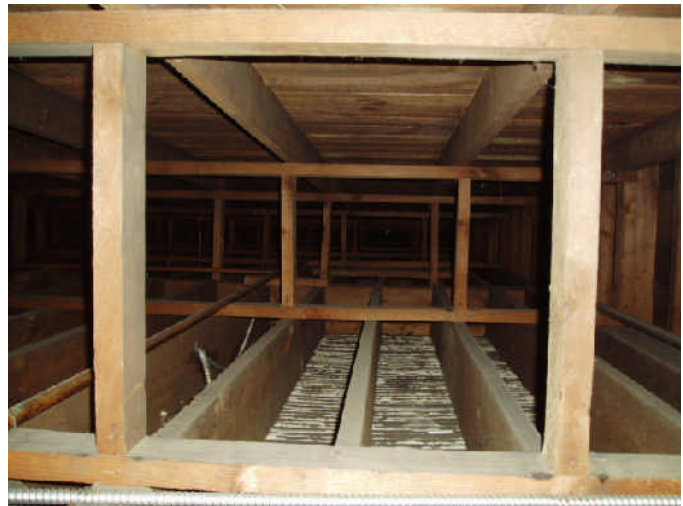
There was no vapour barrier noted in the attic cavity.

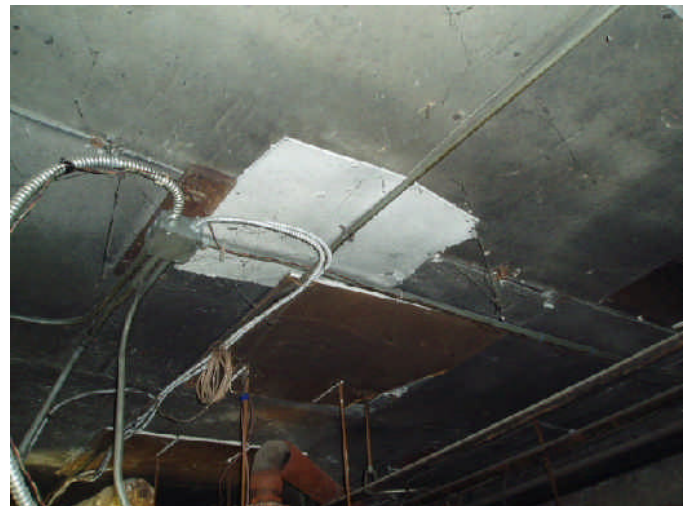
Action Necessary - the ceiling was panelled. The panelling was loose in areas, the material is likely to be asbestos.

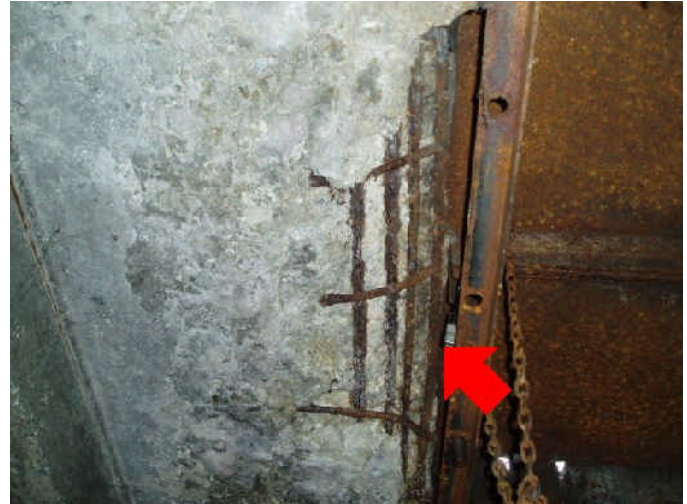
Action Necessary - I noted spalling concrete and rusting rebar around the side walk (former coal hatch). The hatch was also allowing water ingress into the basement area.

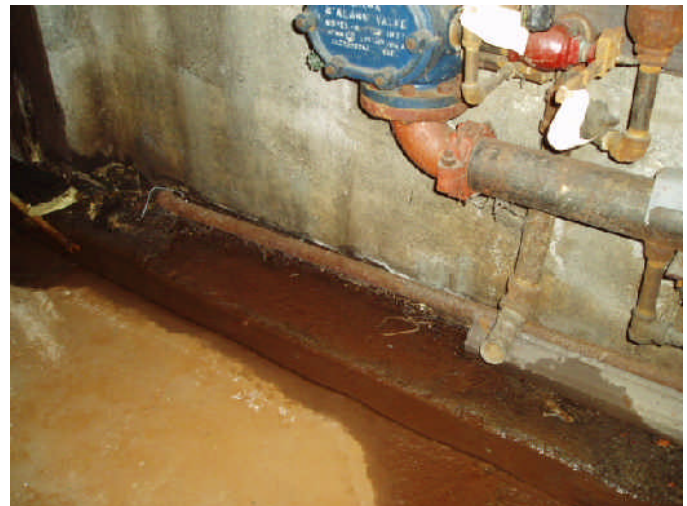
Action Necessary - At the time of the inspection there was water present.

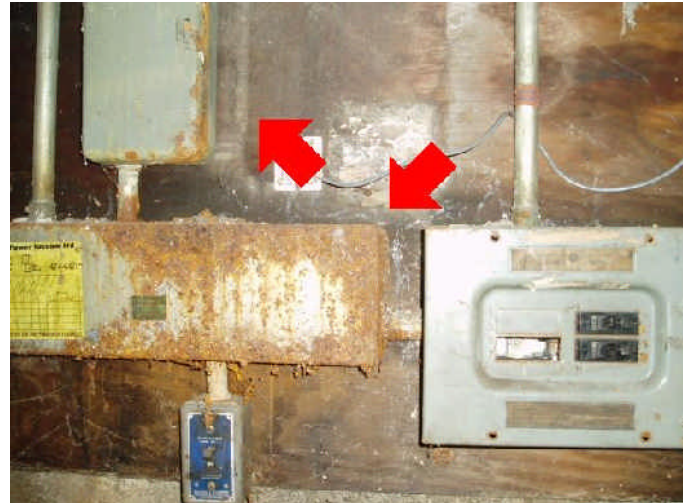
Action Necessary - that due to the high moisture levels a distribution box and fuse box were rusting.

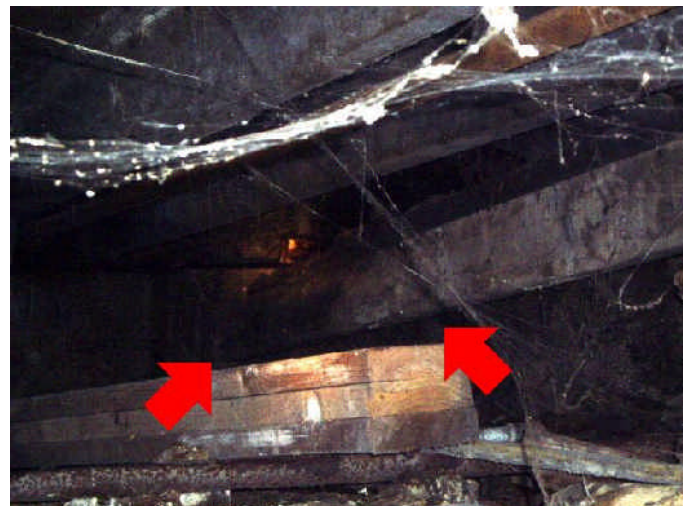
Action Necessary - I noted a rotten joist hanging down - located at the front section of the building.

I strongly recommend that several access holes are cut in both the ground floor retail units to enable access into the crawlspace areas to check the concealed framing below.

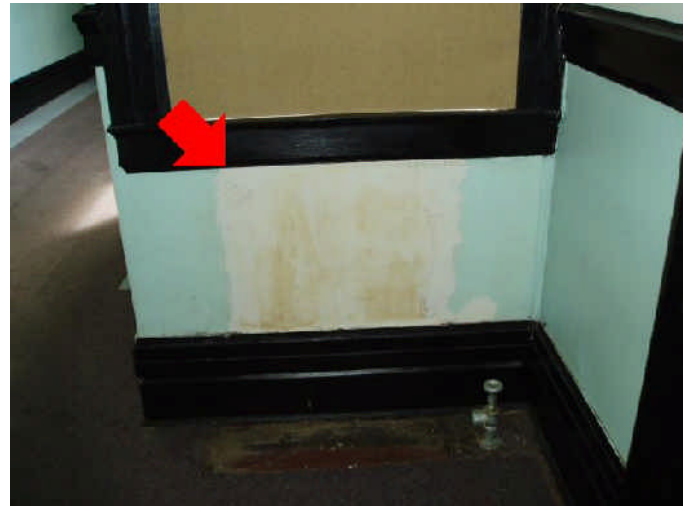
Action Necessary - I noted a missing radiator on the 3rd floor corridor.

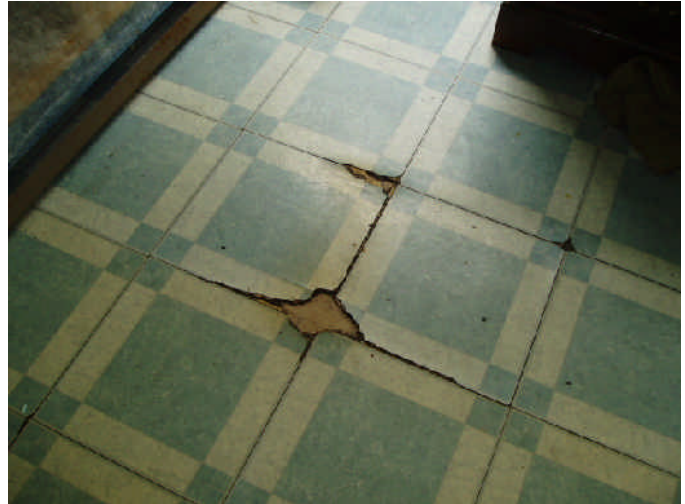
Location:	2nd floor, front right side of building looking into the lightwell.
Entry Door:	Satisfactory - The entry door to this room is functional.
Walls:	Satisfactory - The walls in this room appear to be satisfactory.
Ceiling:	Satisfactory - The ceiling is functional and as expected.
Floor:	Attention Needed - The floor tiles in this room are damaged in places.

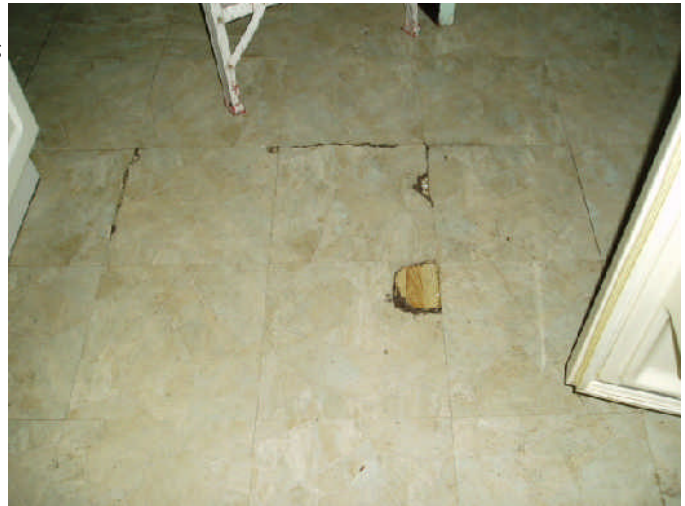
Attention Needed -
The floor in this room is damaged in places.

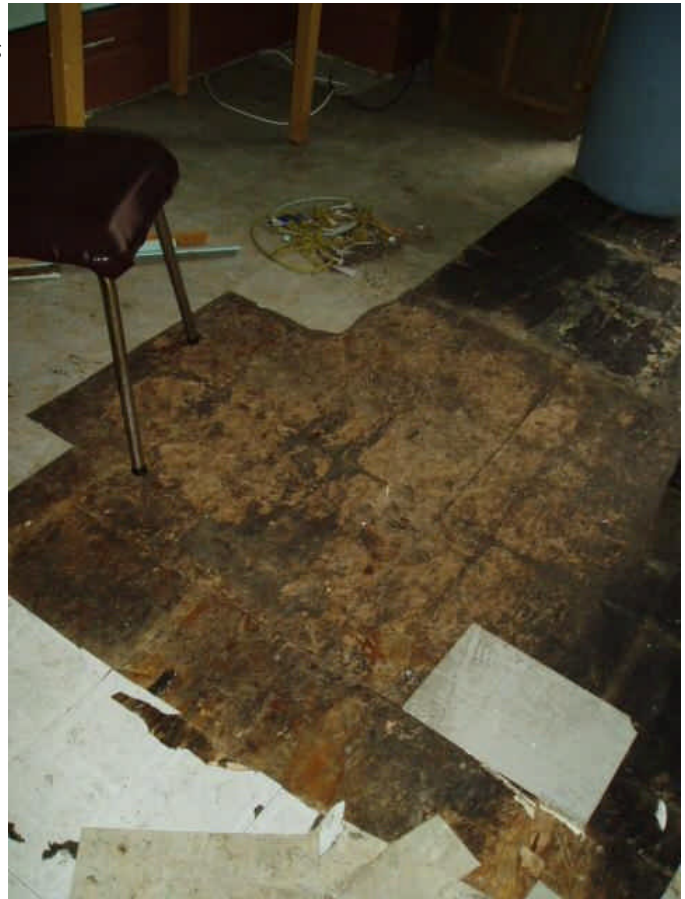
Attention Needed -
The floor in this room is damaged in places.

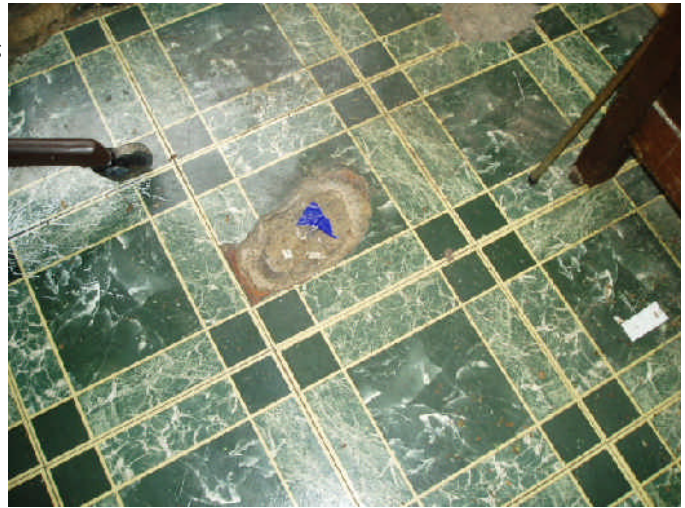
Attention Needed -
The floor in this room is damaged in places.

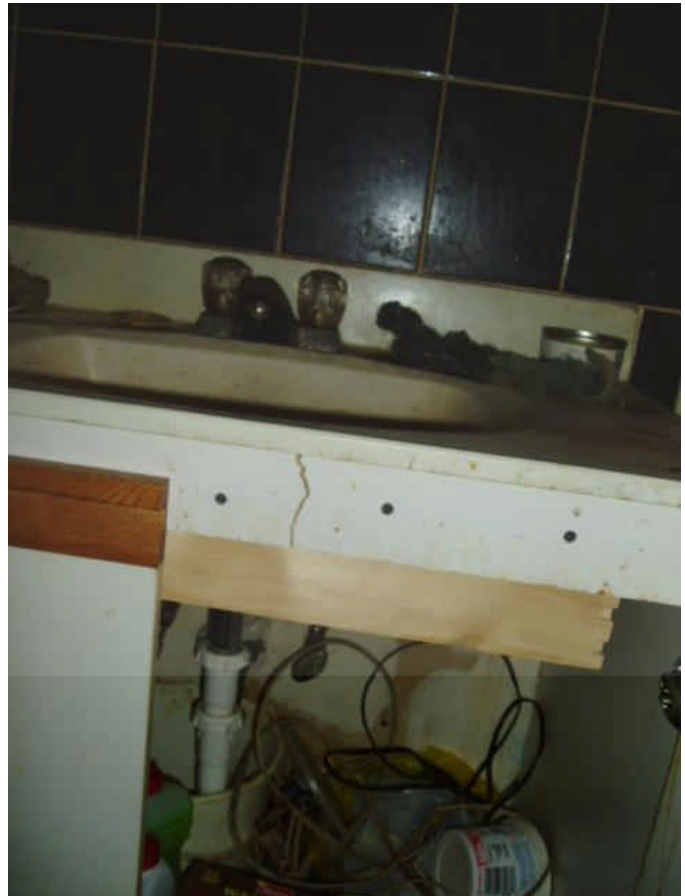
Action Necessary - the vanity unit is damaged.

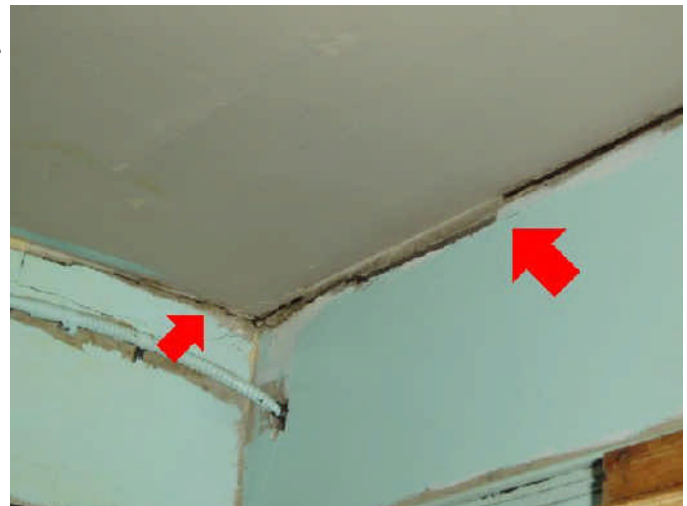
Location:	2nd floor, rear looking forward over the lightwell.
Entry Door:	Satisfactory - The entry door to this room is functional.
Walls:	Action Necessary - movement cracks were noted.

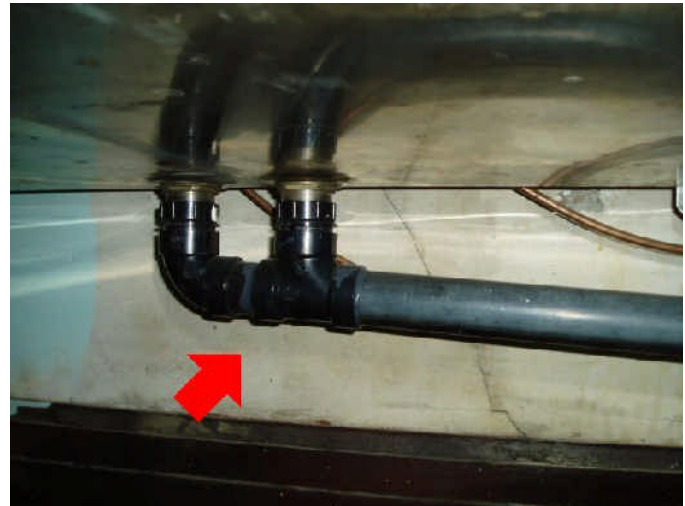
Comment: Action Necessary - there was no trap on the sinks.

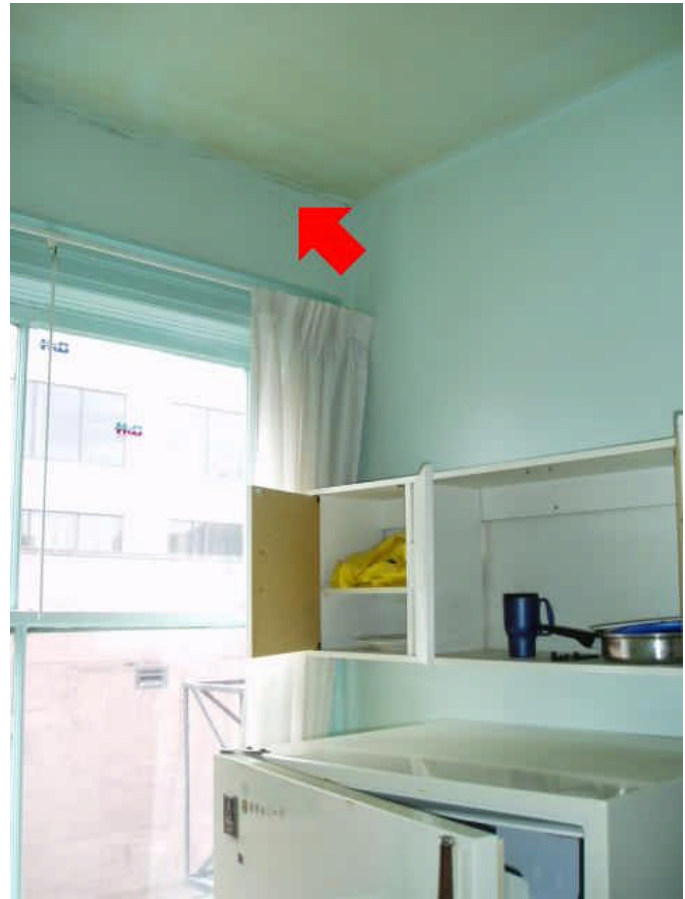
Attention Needed -
Some cracks were noted.

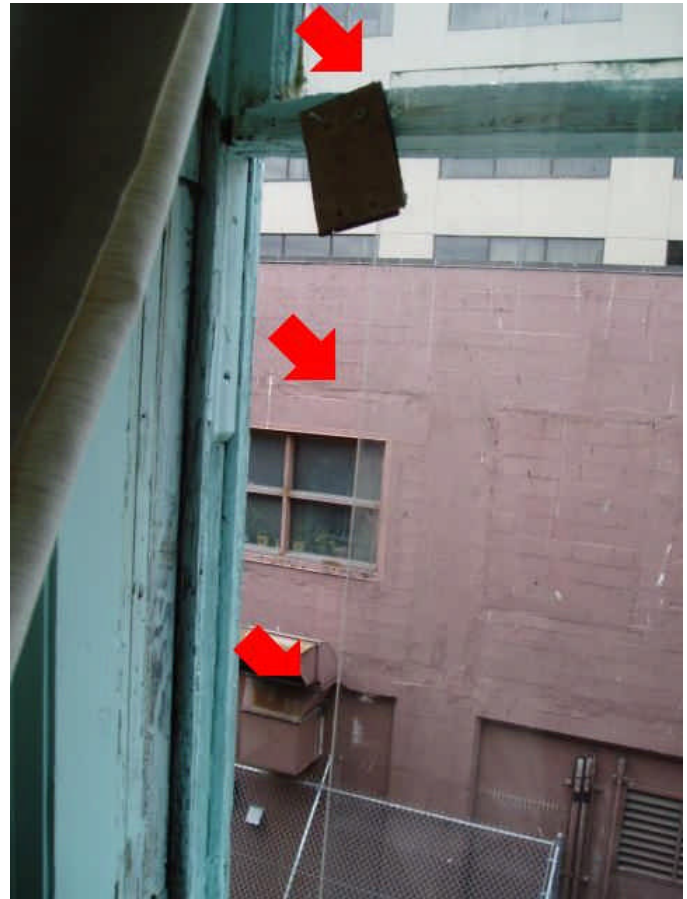
Action Necessary - the bottom sash of the window was missing and a section of clear plastic (too narrow), has been used to secure the hole.

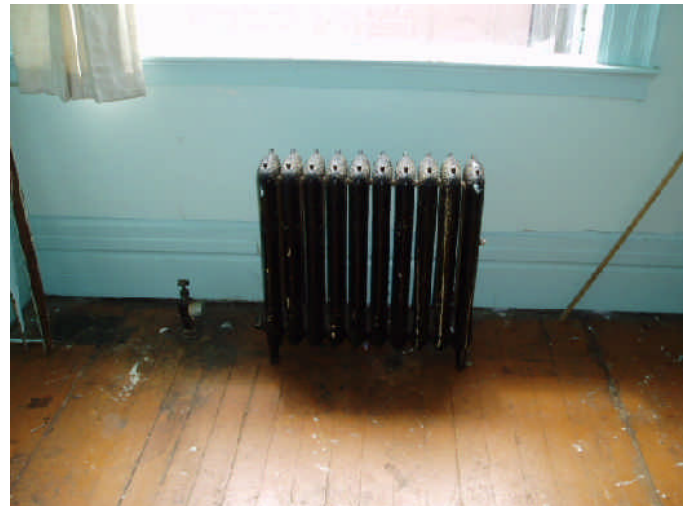
Action Necessary - a radiator was disconnected.

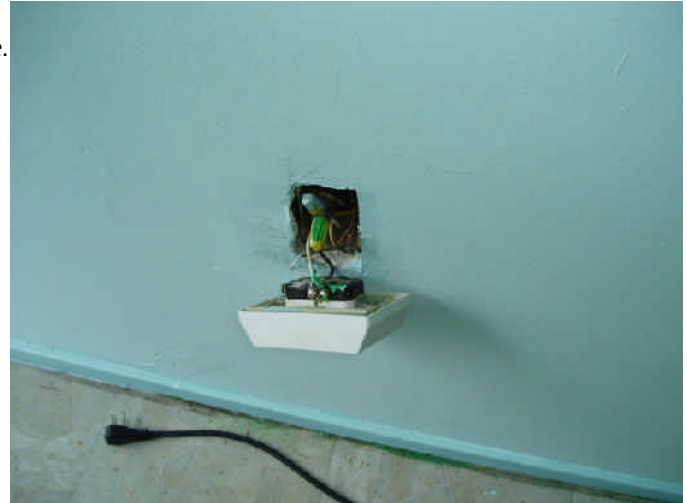
Electrical Outlets: Action Necessary - the socket is hanging loose.

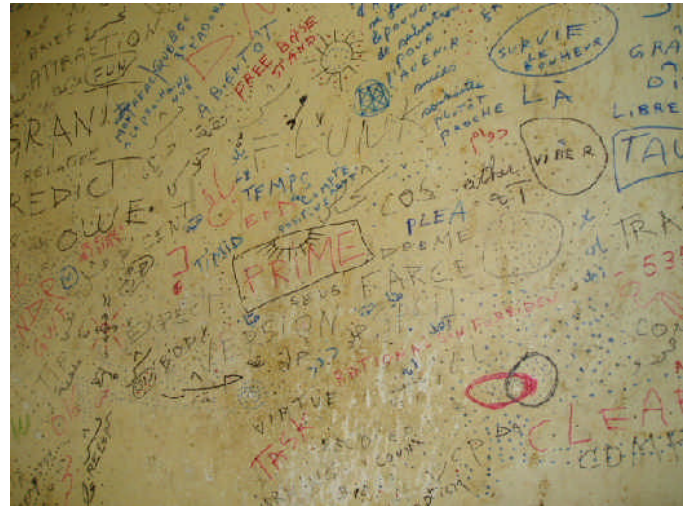
Attention Needed -
There is some damage
to the wall surface.

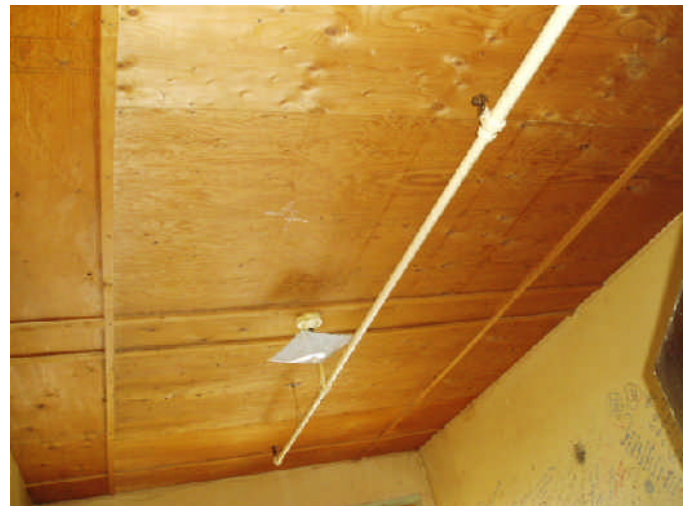
Action Necessary -
there is no finished
ceiling, merely
plywood.

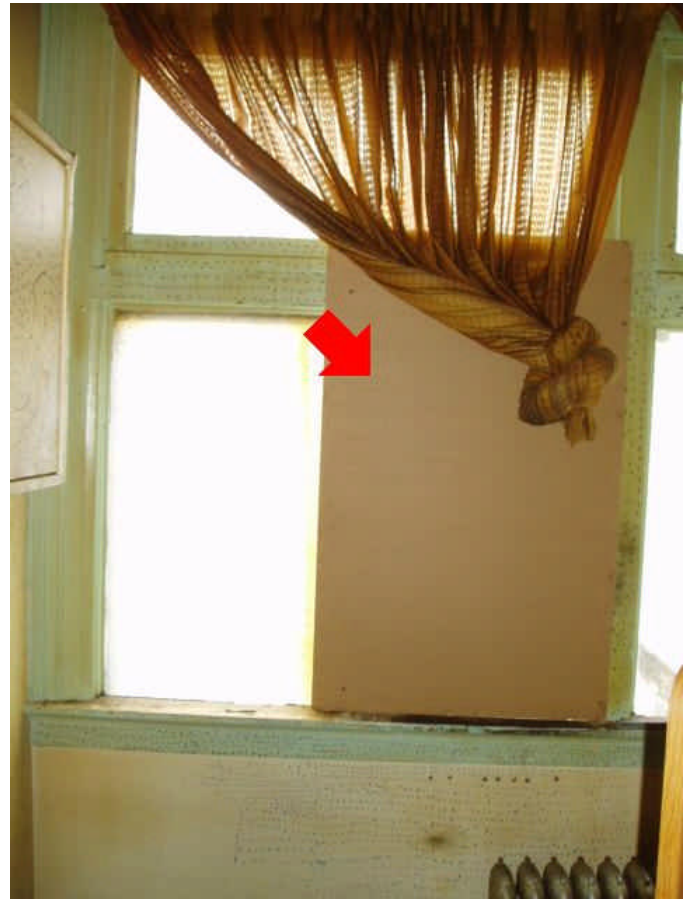
Action Necessary -
There is at least one
broken window pane.

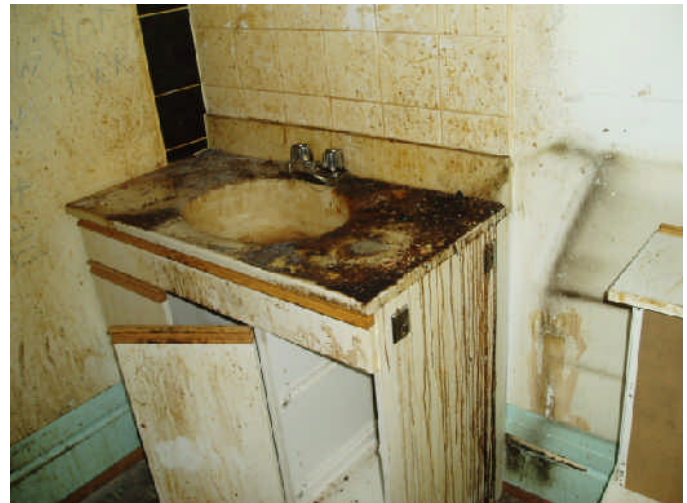
Action Necessary - the
washand basin and
sink were in a poor
state.

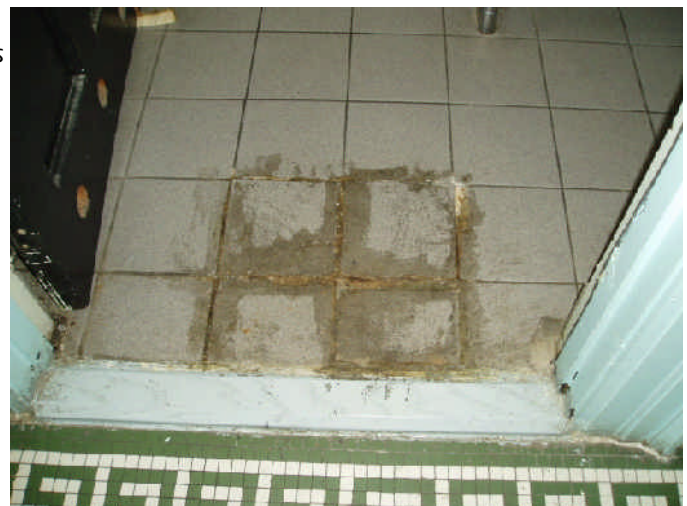
Location:	2nd floor.
Entry Door:	Satisfactory - The entry door to the bathroom is as I expected, and it is functional.
Walls:	Satisfactory - The walls in this room appear to be satisfactory.
Ceiling:	Satisfactory - The ceiling is functional and as expected.
Floor:	Attention Needed - The floor in this room is damaged in places.

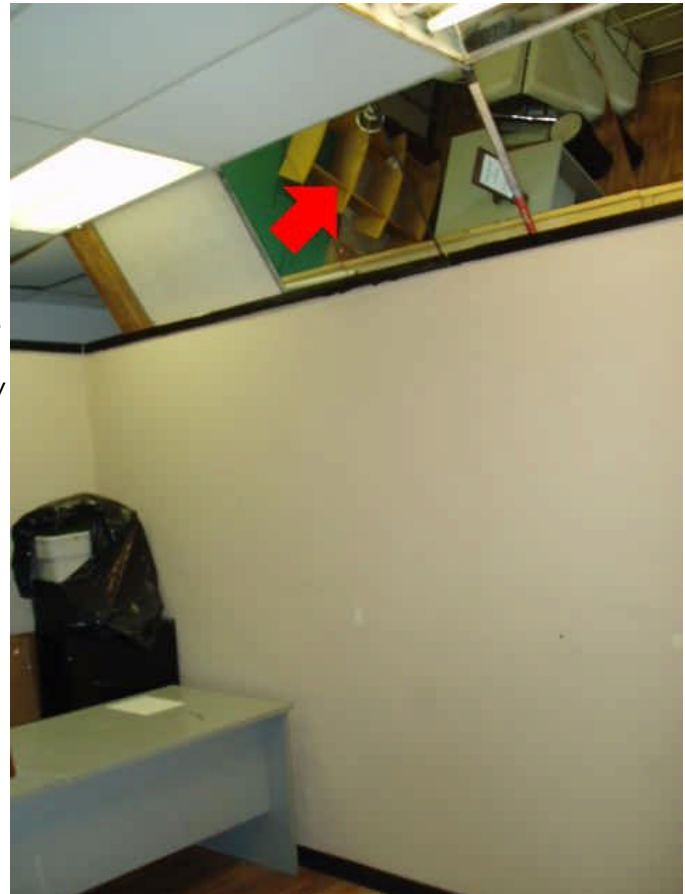
Entry Door:	Satisfactory - The entry door to this room is functional.
Walls:	Attention Needed - there are sections of mirrored glass leaning down from the wall, these are held in place by drawing pins. Recommend removing from a safety perspective. Attention Needed - the internal walls to this room have been poorly framed and drywalled.

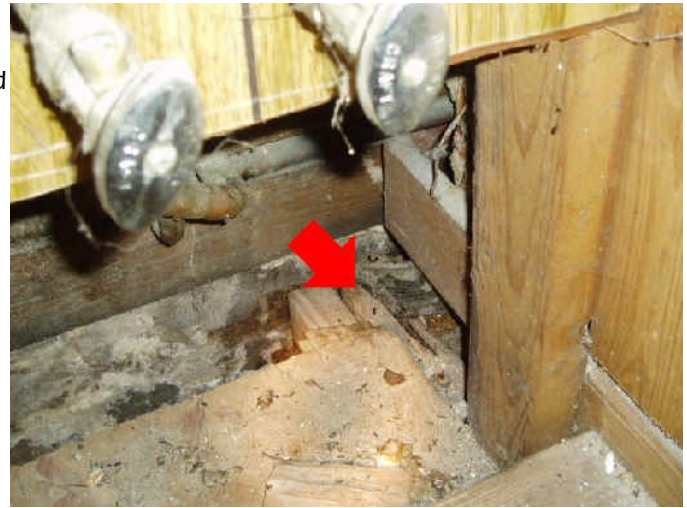
Action Necessary - where the sink had been removed exposed framing was visible. I noted that there was rot in the ends of the joists.

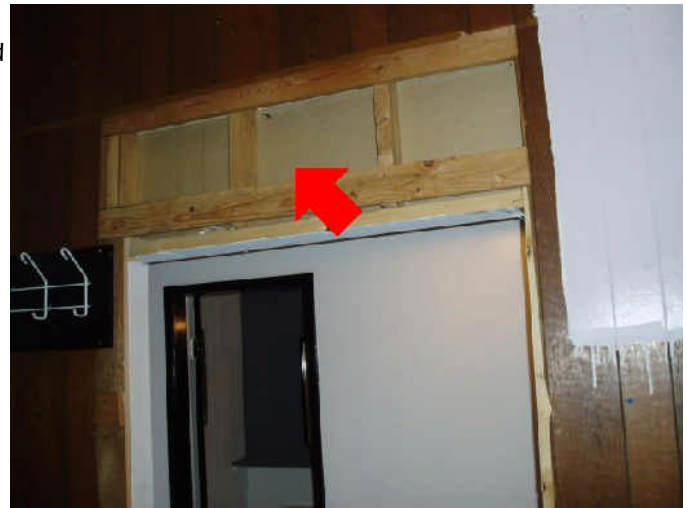
Action Necessary - the walls are poorly framed and sections are unfinished.

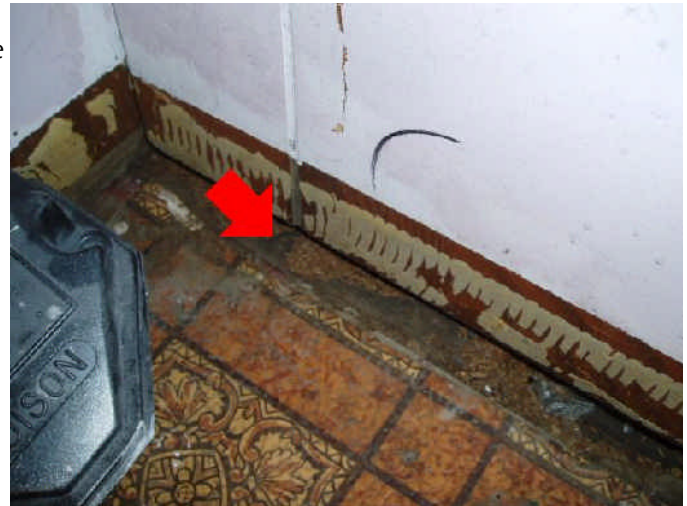
Action Necessary - sections of the floor are rotten and sloping.
