BUILDING INSPECTION

Address of Property: 31 Uttoxeter Road, Victoria

Client: Mr.B.Uyer

Inspector: Lee Ottewell

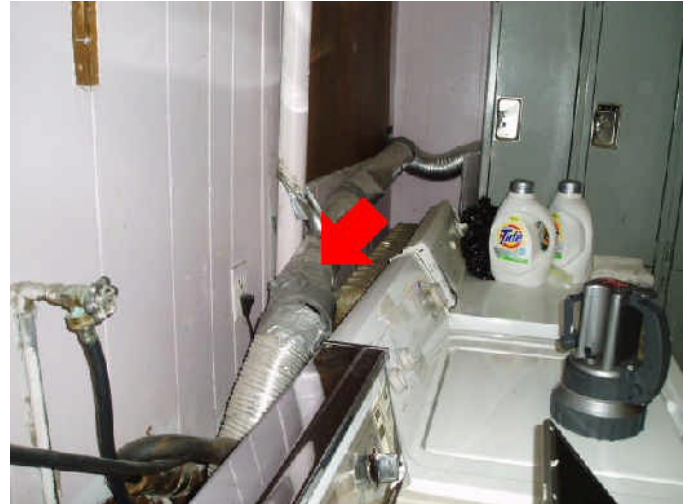
Action Necessary - The dryer vent ductwork is in poor condition.

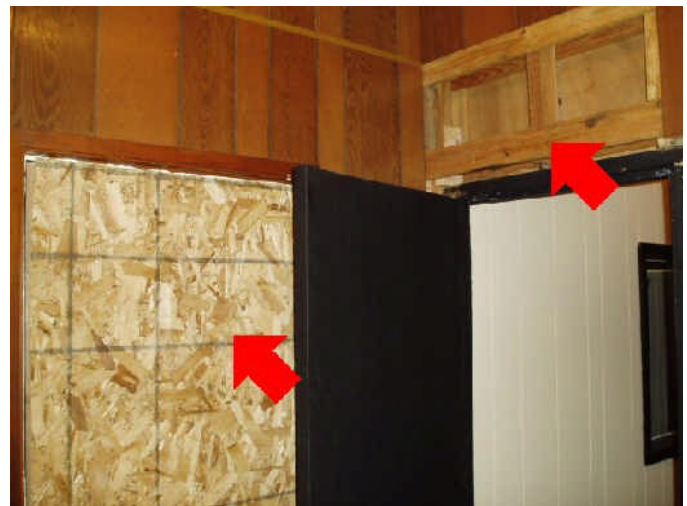
Action Necessary - the walls are patched.

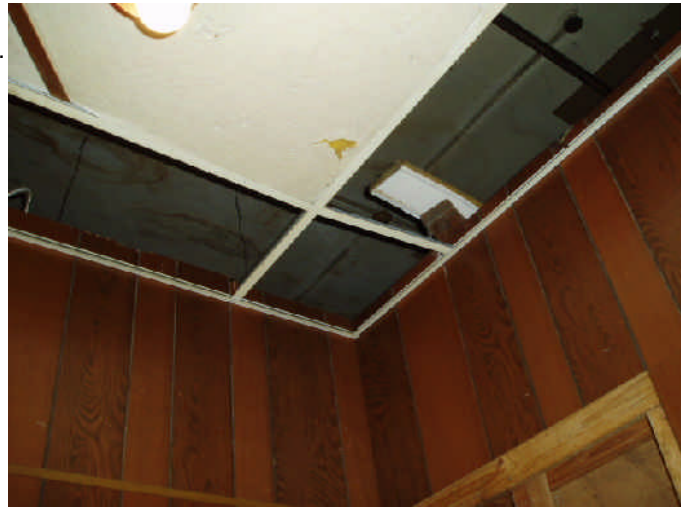
Action Necessary - the ceiling has missing tiles.

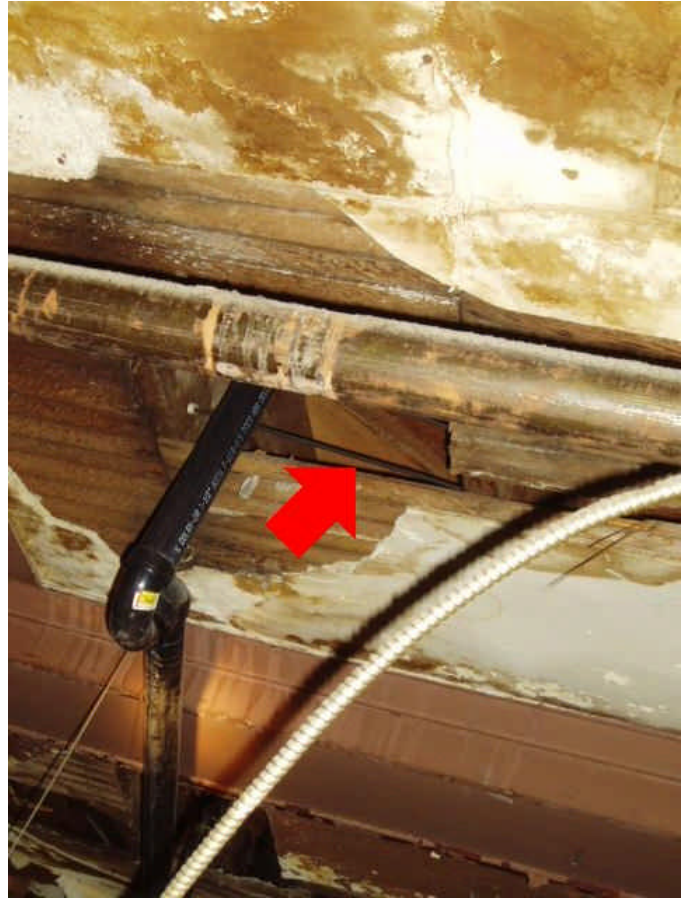
Action Necessary - I noted holes in the lath and plaster ceiling.

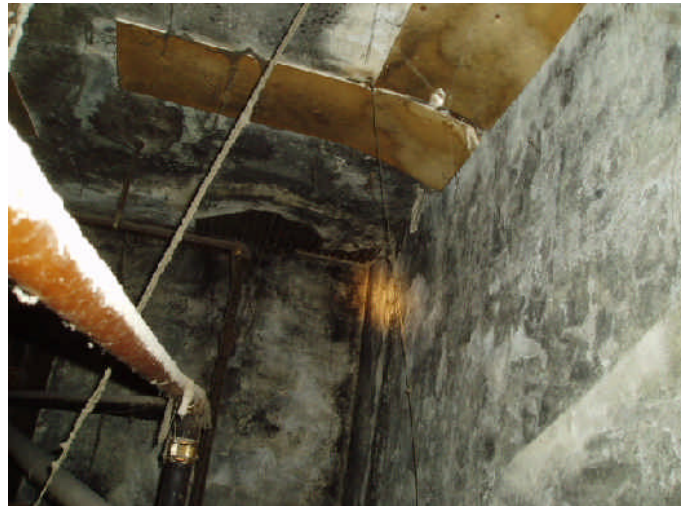
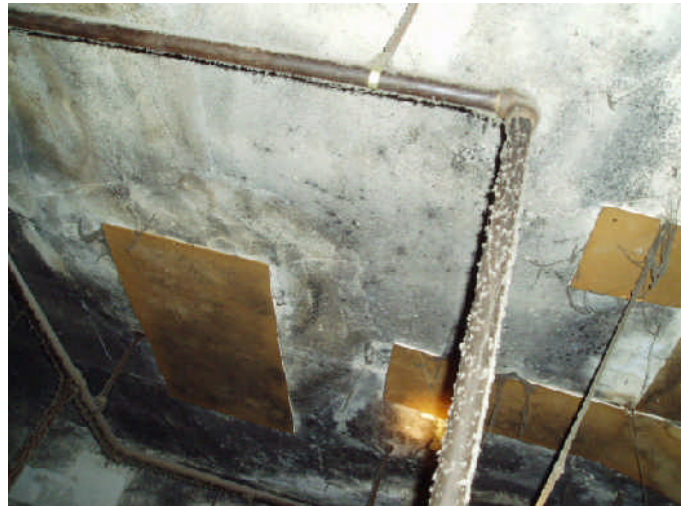
Action Necessary - Staining was noted on the walls and ceiling above the rear section of this unit. The staining could be mould.

Comment: Another photograph showing the staining.

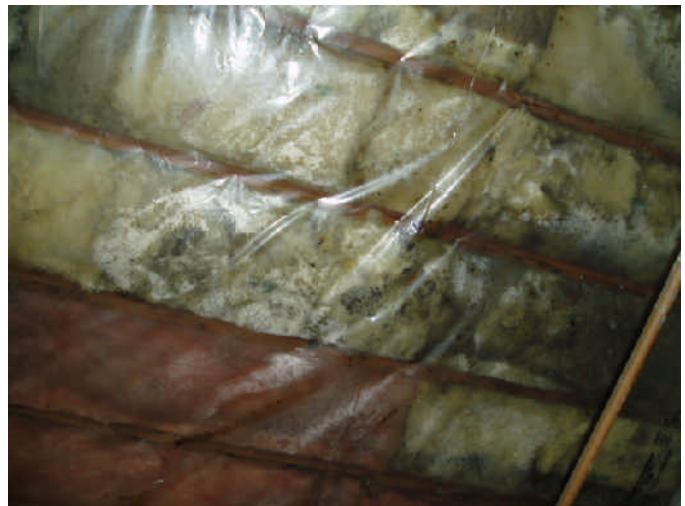
Comment: Action Necessary - I noted insulation in the what appears to be a former lightwell which was wet and appeared to have mould growth.

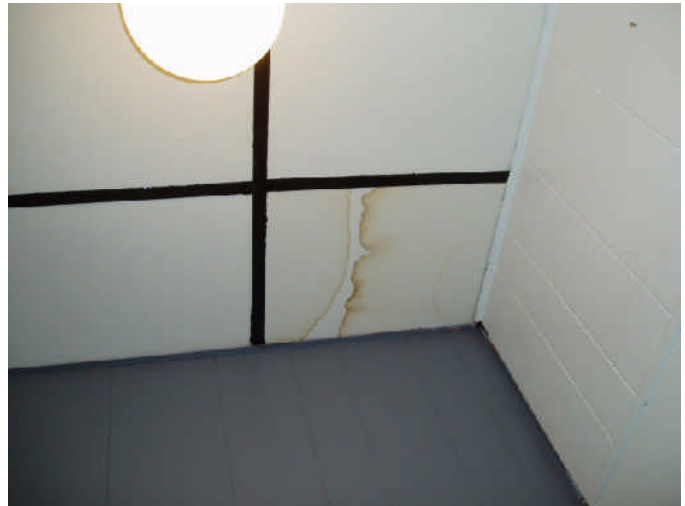
Entry Door:	Satisfactory - The entry door to the bathroom is as expected, and it is functional.
Walls:	Satisfactory - The walls in this room appear to be satisfactory.
Ceiling:	Action Necessary - water staining was noted.

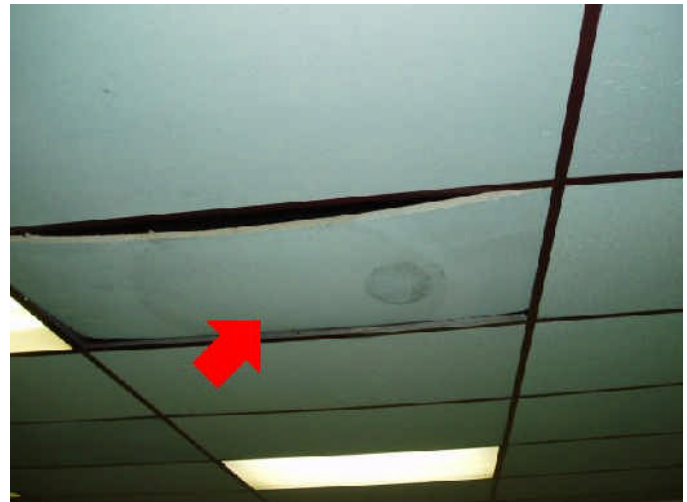
Entry Door:	Satisfactory - The entry door on the master bedroom is as I expected, and it is functional.
Walls:	Satisfactory - The walls in this room appear to be satisfactory.
Ceiling:	Action Necessary - sections of the suspended ceiling are sagging and some tiles are water stained.

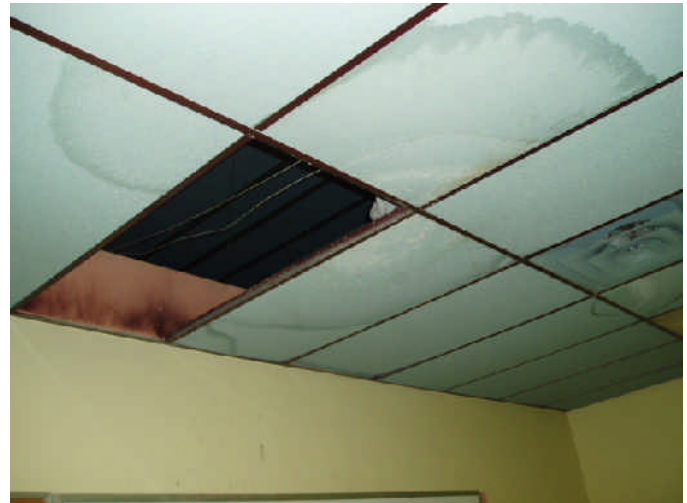
Outside Entry Door:	The outside entry door is satisfactory.
Entry Door:	Satisfactory - The entry door to this bedroom is as I expected, and it is functional.
Walls:	Satisfactory - The walls in this room appear to be satisfactory.
Ceiling:	Action Necessary - sections of the suspended ceiling are sagging and some tiles are water damaged.

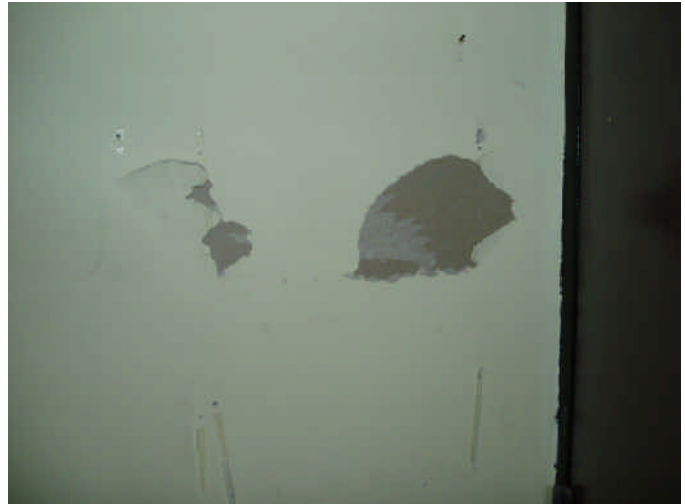
Attention Needed -
There is some minor damage to the wall surface.

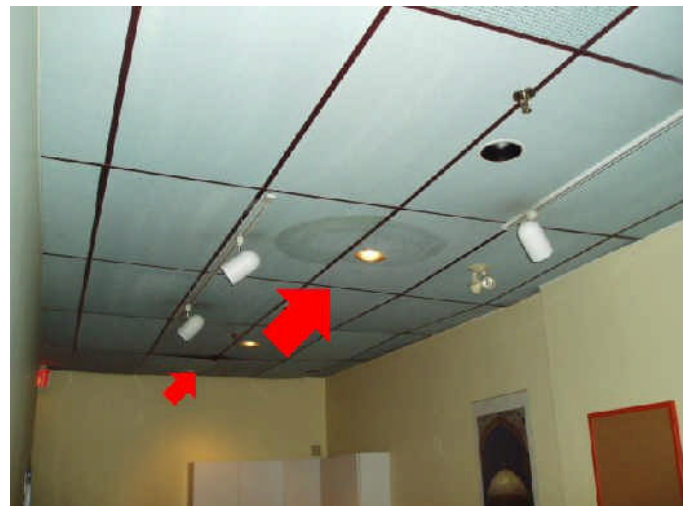
Outside Entry Door:	The outside entry door is satisfactory.
Walls:	Satisfactory - The walls in this room appear to be satisfactory.
Ceiling:	Action Necessary - sections of the suspended ceiling are sagging and some tiles are water stained.

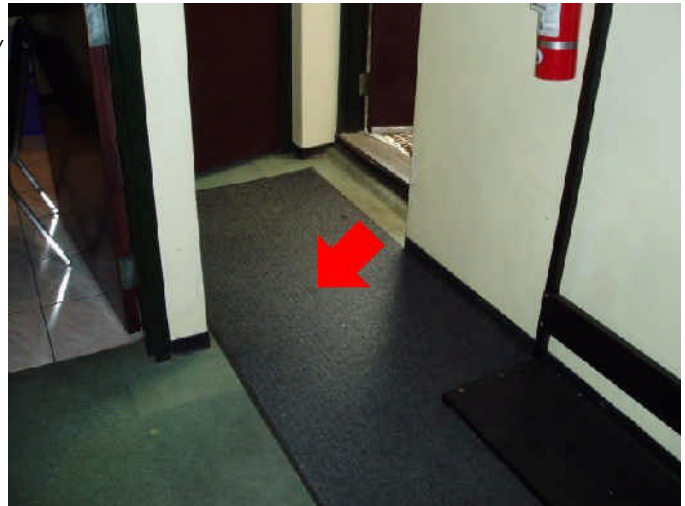
Action Necessary - I noted a significant sag/dip in the floor adjacent to the rear door.

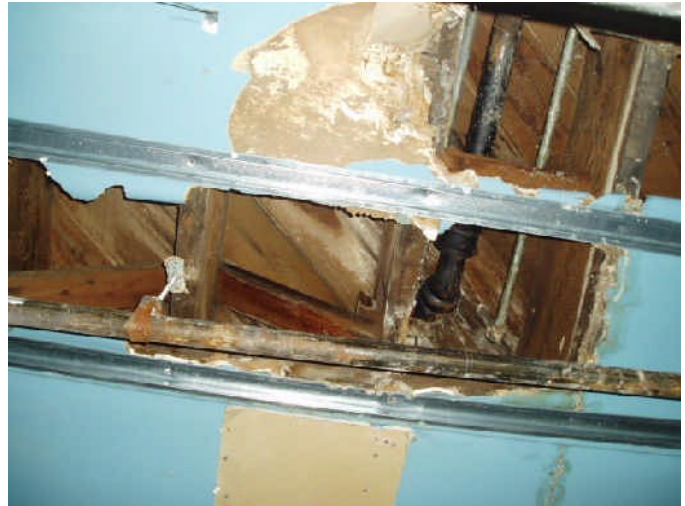
Action Necessary - I noted holes in the lath and plaster ceiling above the suspended ceiling.
