Building Inspection

31 Olive Street, Oak Bay

Date of Inspection: July 17th 2012

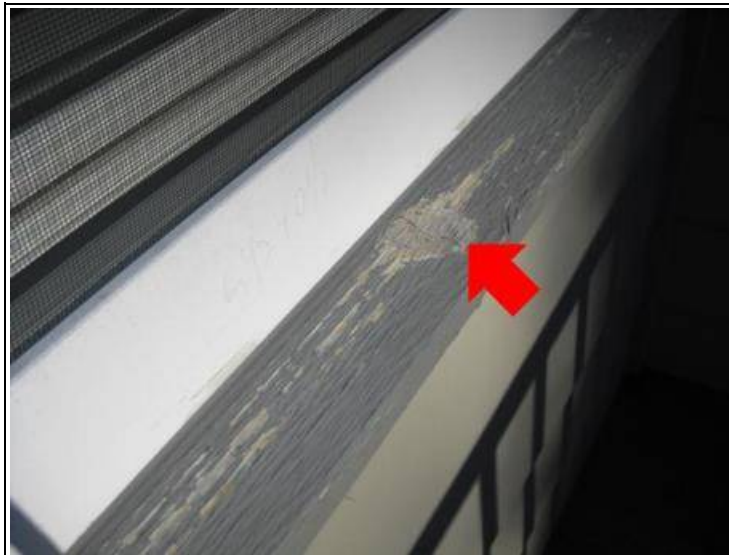
Painted Surfaces:

Attention Necessary
- Some exposed surfaces are in need of painting/staining.

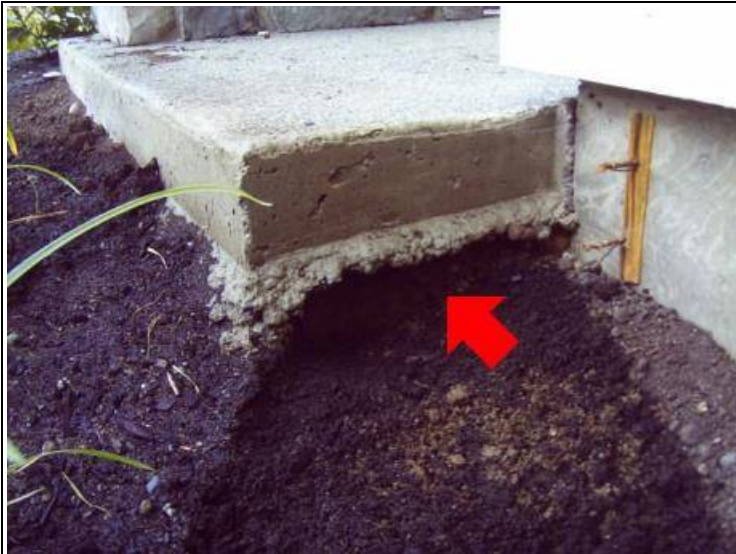
Flooring Material:

Action Necessary -
The edges of the concrete porch floor are inadequately supported. This will eventually cause the concrete to crack.

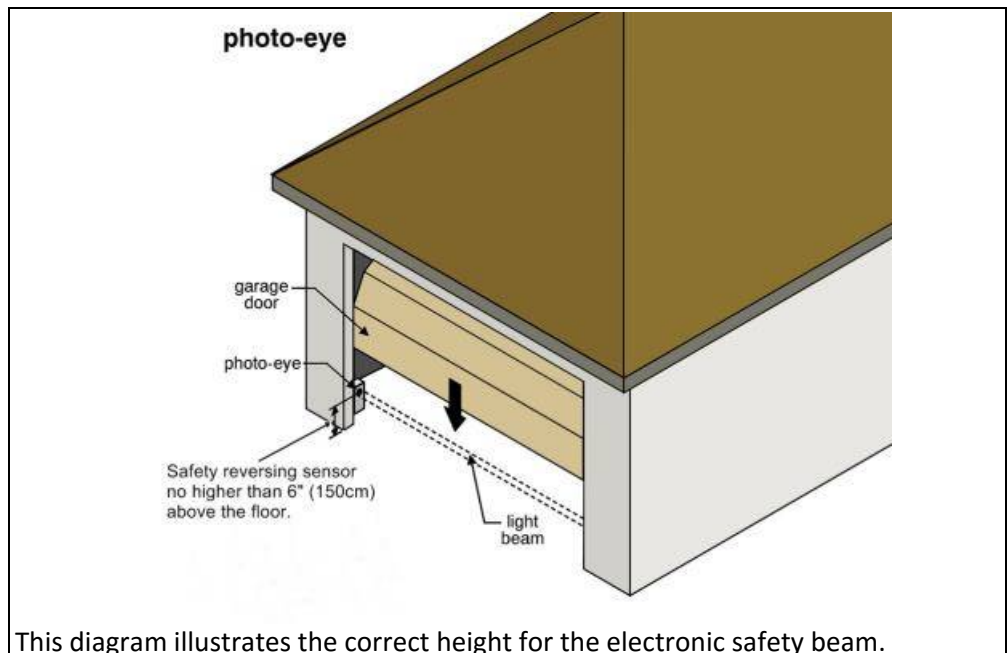
<i>Garage Type:</i>	Attached garage.
<i>Number of Vehicle Doors:</i>	There are two overhead doors.
<i>Vehicle Door Condition:</i>	Satisfactory - The vehicle door(s) is(are) in satisfactory condition.
<i>Vehicle Door Opener(s):</i>	The overhead door opener(s) appears to function appropriately.
<i>Safety Reverse Mechanism on Garage Door(s):</i>	Action Necessary - There is an electronic beam safety reverse system installed. However, it is mounted too high (should be within 6 inches of the floor) and will not adequately protect a trapped child underneath it.

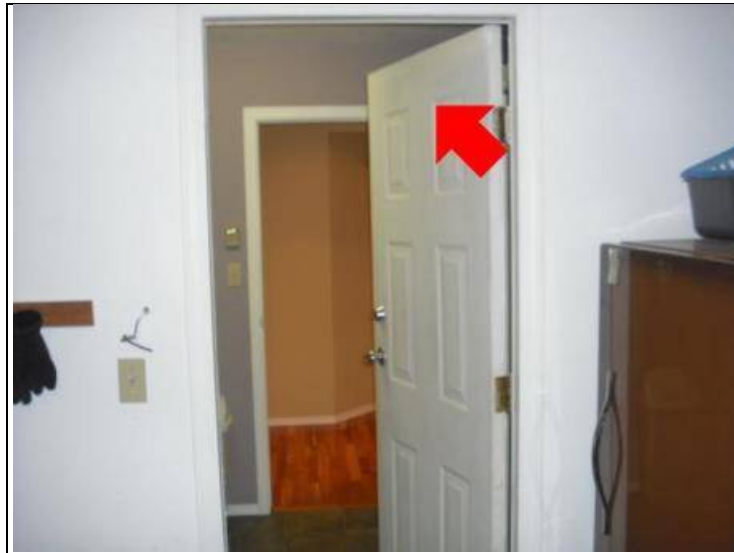
Fire Rated Entry Door to Structure:

Action Necessary - There is a self closing door between the garage and the house. However, the self closing mechanism needs adjustment/repair to enable it to operate correctly.

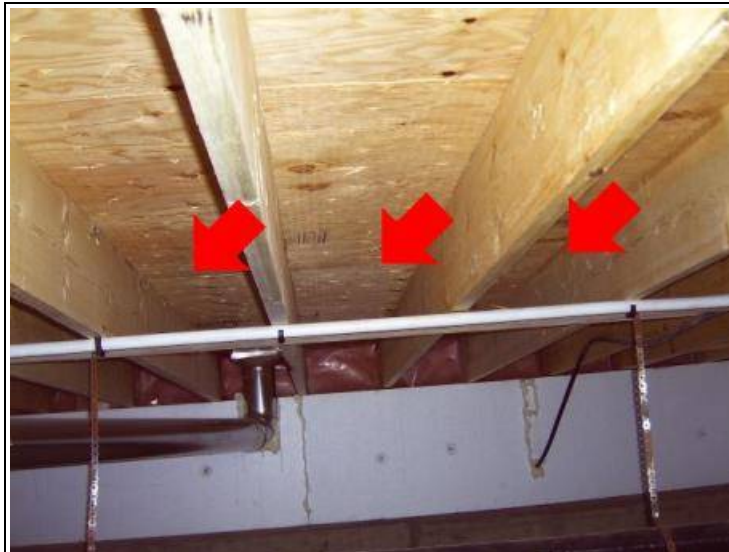
Floor Joists Condition:

Attention Necessary - some of the larger joists spans didn't have any cross bracing.

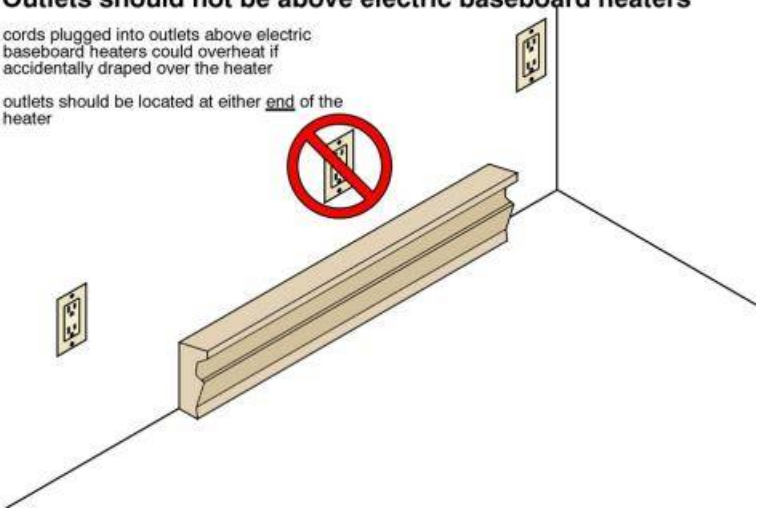
Outlets should not be above electric baseboard heaters

cords plugged into outlets above electric baseboard heaters could overheat if accidentally draped over the heater

It is poor practice to have electrical sockets located above electric baseboard heaters.

outlets should be located at either end of the heater

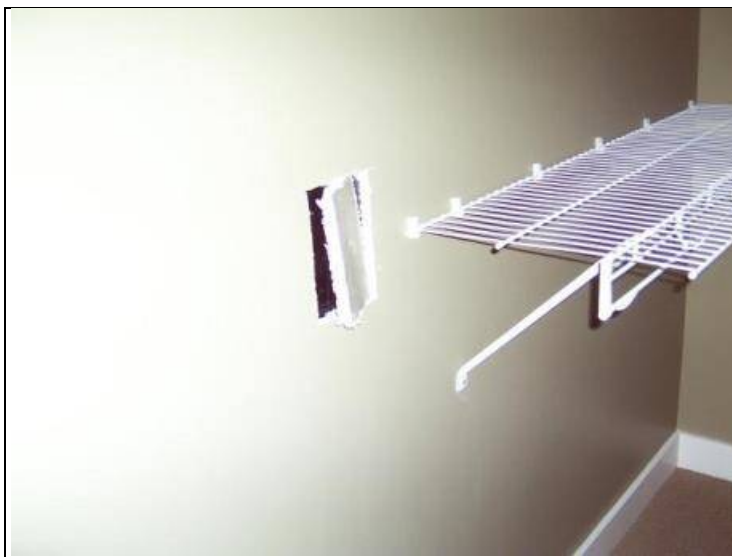
Closet(s):

Action Necessary -
The wall is
damaged.
