Building Inspection

1432 Anyroad, Anytown

Date of Inspection: April 30th 2006

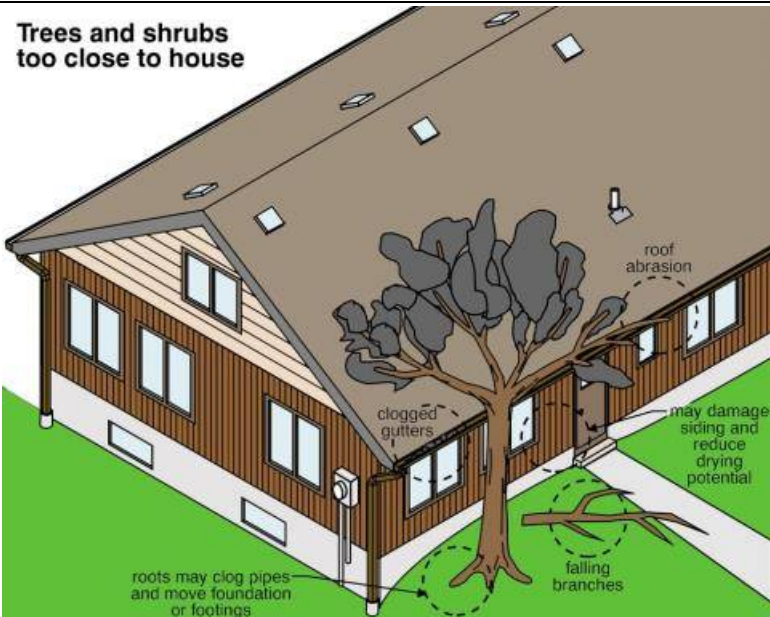
Trees & Shrubs

Trees and shrubs too close to house

Action Necessary - Trees/Shrubs are too close to the house. Implications include, encouraging rodents onto the roof, preventing the siding from drying out, risk of blocking the draintile with roots, risk of affecting the foundation, plugging gutters, roof abrasion etc.

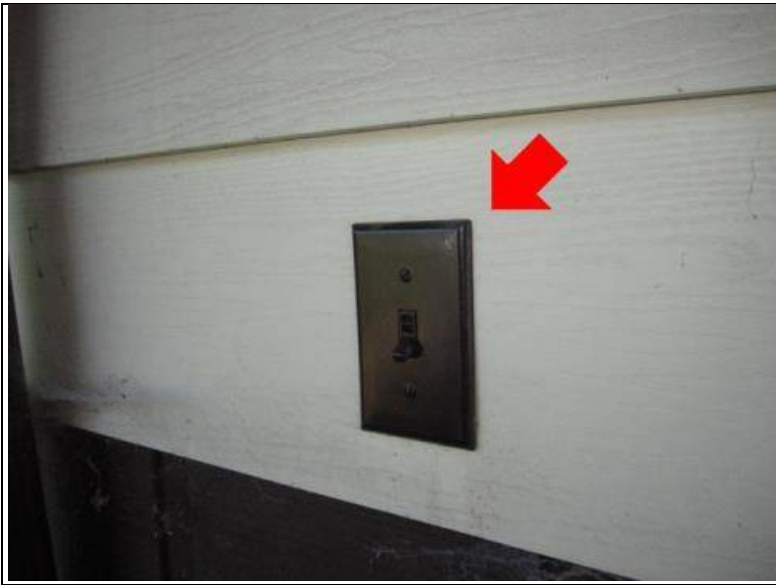
Exterior Lighting:

Attention Needed - an internal light switch has been used externally.

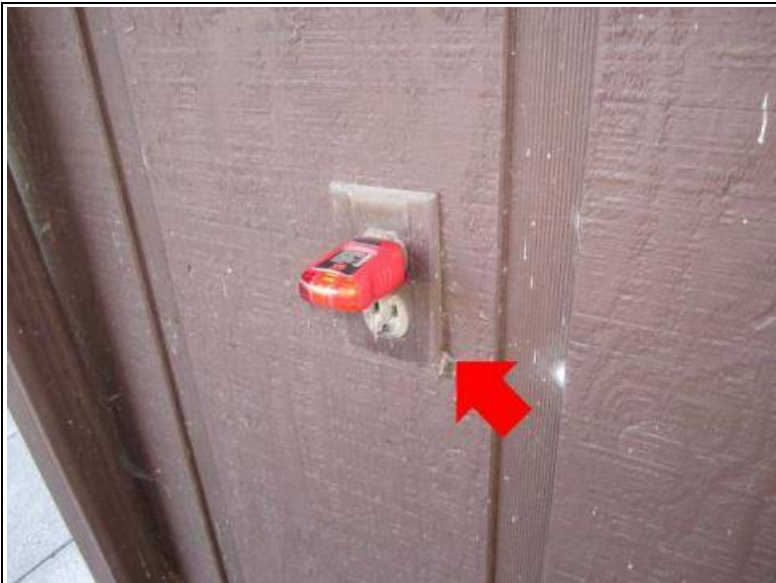
Ground Fault Circuit Interrupters (GFCI):

Action Necessary - The external outlets are not GFCI protected. This type of protection should be installed on all external sockets.

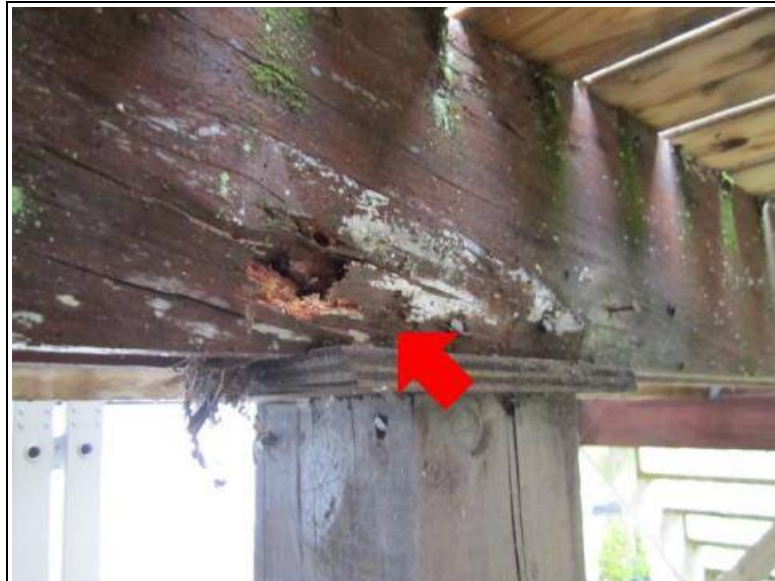
Supporting Beams:

Action Necessary
- Sections of the
beam(s) are
rotten.

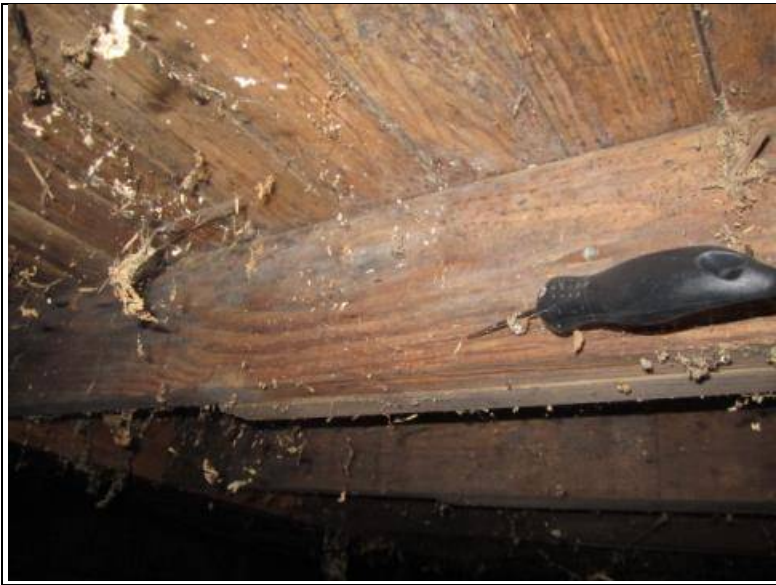
Supporting Joists:

Action Necessary
- Sections of the
joists are rotten.

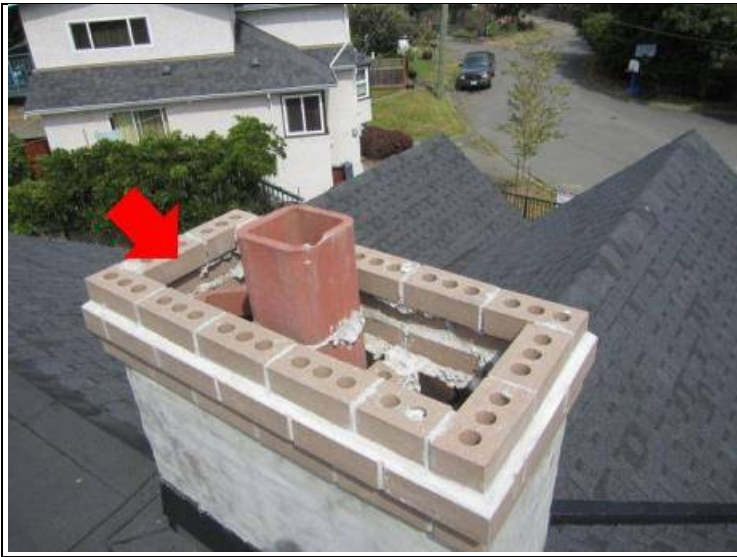
Chimney Crown (or Cap):

Action Necessary -
The crown is
unfinished.

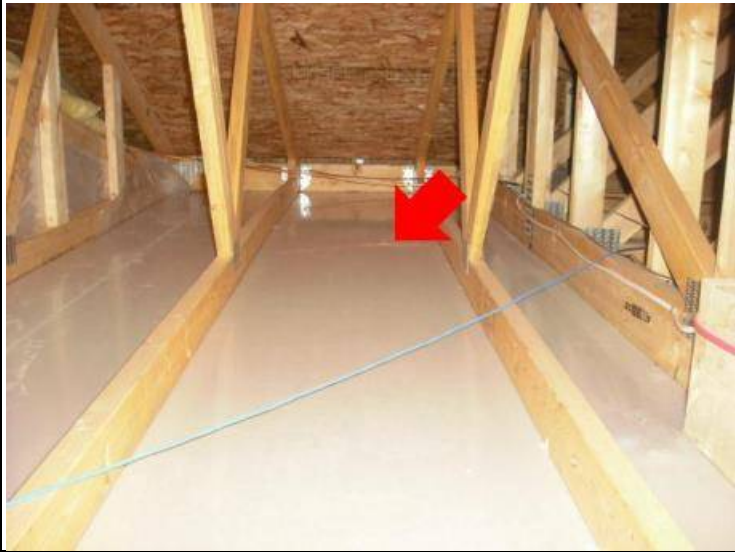
</div> <div>Action Necessary - There is no insulation in the rear attic space over the addition.</div>
Heat Recovery Ventilator:	None installed.

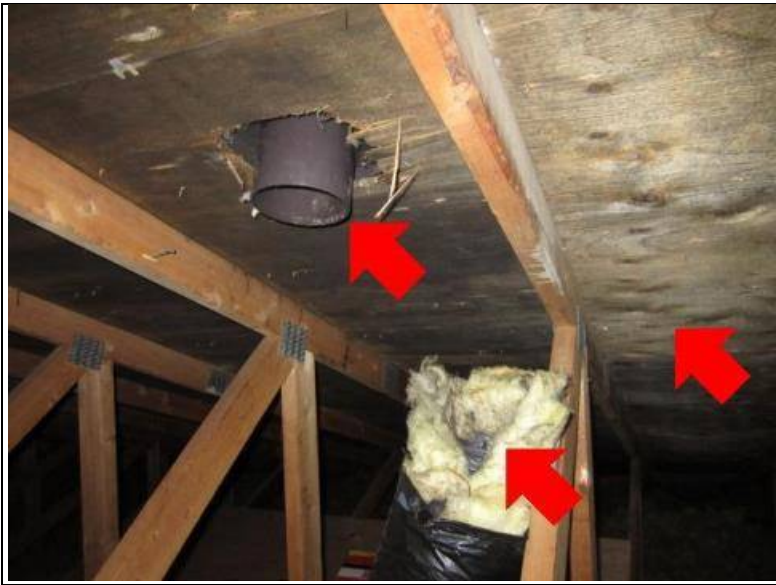
*Staining On The Underside Of
The Roof Sheathing:*

Action Necessary
- A dryer vent is
discharging into
the attic space.
Mould has
formed on the
underside of the
roof sheathing.
It is strongly
recommended
that the services
of an
environmental
consultant are
used.

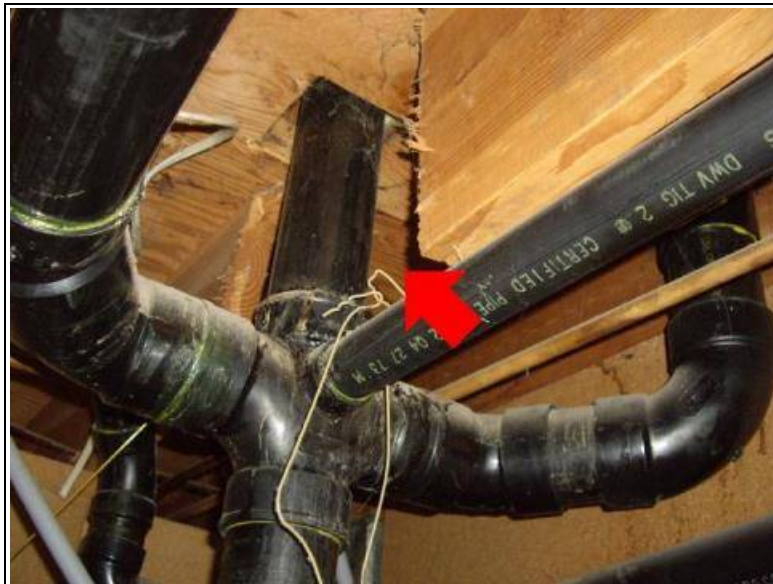
Ceiling Joists Conditions:

Action Necessary
- A joist has been cut to accommodate plumbing.

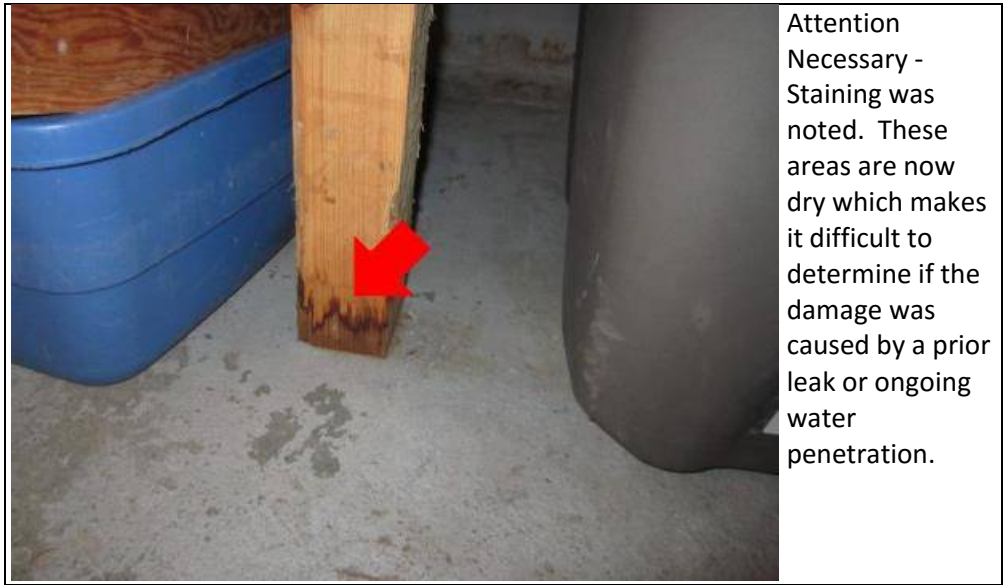
Evidence of Water Entry in the Basement:

Attention Necessary - Staining was noted. These areas are now dry which makes it difficult to determine if the damage was caused by a prior leak or ongoing water penetration.

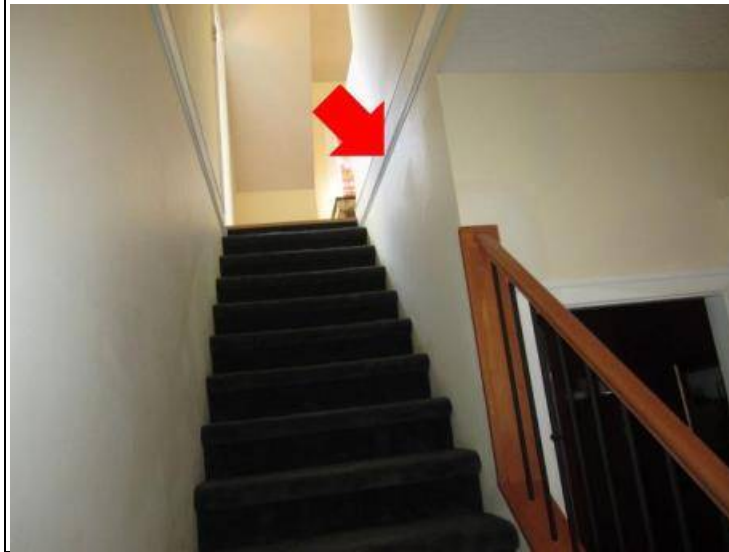
Staircase Condition:

Action Necessary -
Some sections of
the stairs do not
have handrails.

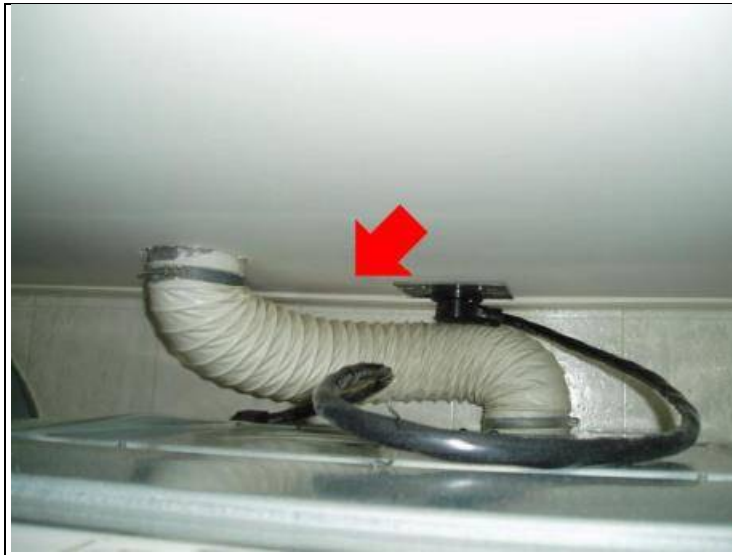
Dryer Ventilation:

Action Necessary - The dryer has a plastic vent. For safety reasons it is prudent to change this to metal to reduce the risk of fire which could be caused by a build up of lint inside the vent.

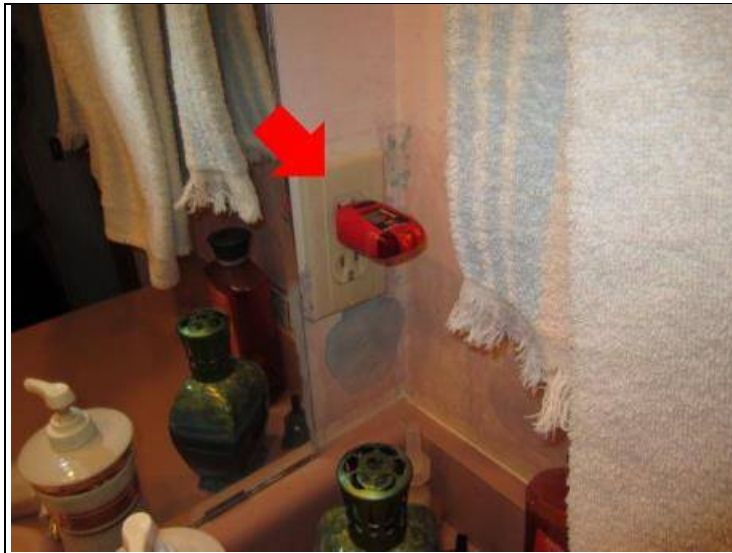
Electrical Outlets:

Action Necessary - The outlet in the bathroom is not correctly GFCI protected. Recommend getting either a GFCI outlet (or GFCI breaker at the panel) installed by a qualified electrician.

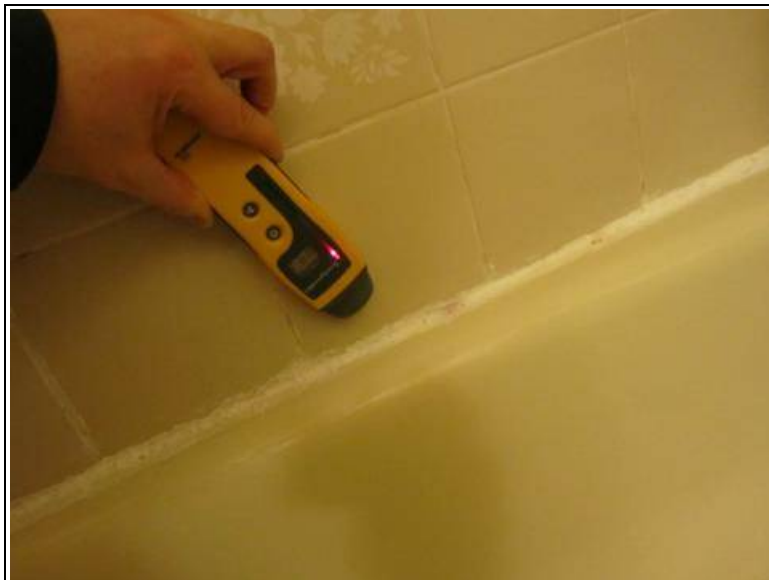
Tub & Shower Walls:

Attention Needed - The moisture levels were very high around the bathtub. There is likely to be concealed damage.
