BUILDING INSPECTION

Address of Property: 31 Uttoxeter Road, Victoria

Client: Mr.B.Uyer

Inspector: Lee Ottewell

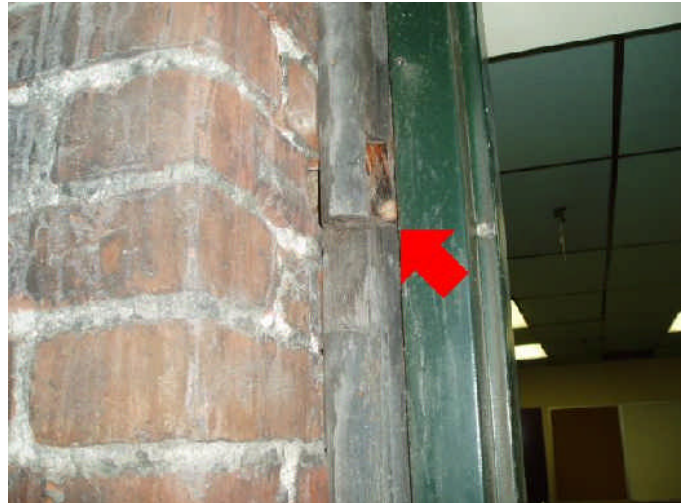
**Outside Entry
Doors:**

Action Necessary - The outside rear entry door frames to unit 707 are damaged.

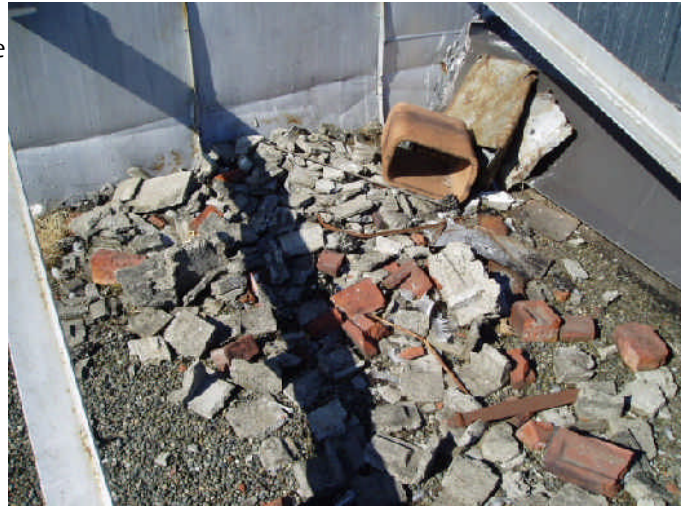
**Roof Framing,
Exterior, notes:**

Attention Necessary - there was debris on the upper roof.

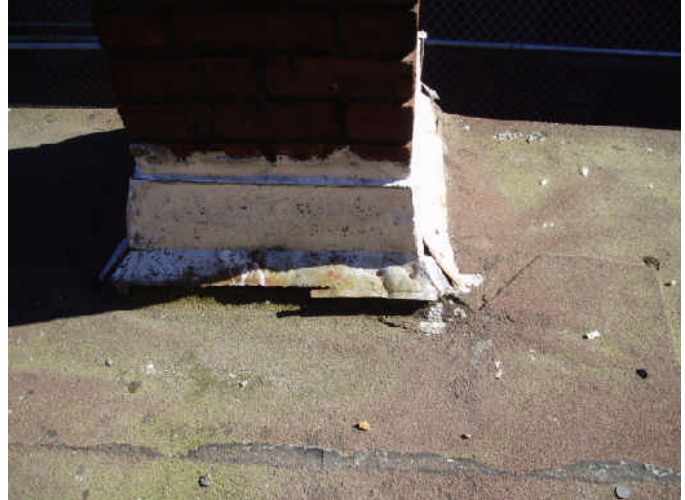
Flashing: **Action Necessary** - The flashing installation is poor. Repair or replacement is needed to prevent water entry.

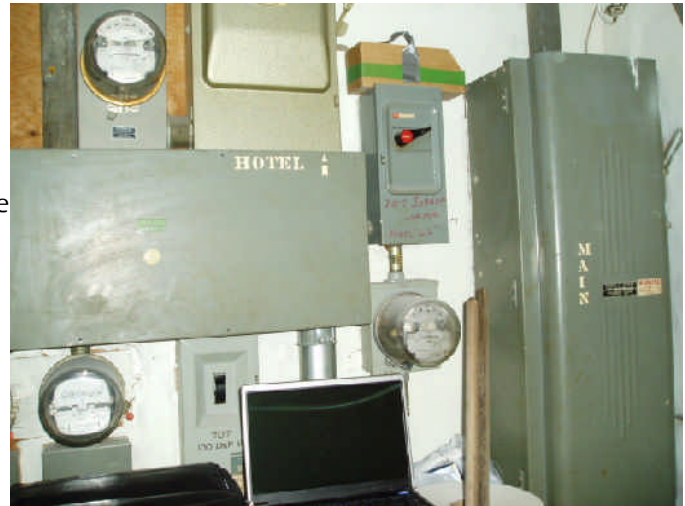
There is a 400amp overhead electrical supply to the building. The supply serves a distribution box which feeds the individual fuses and panels for the retail units and the hotel.

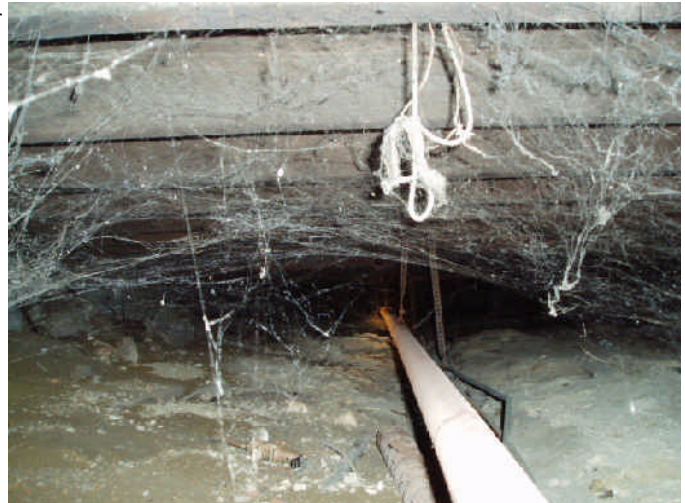
Vapour Barrier Installed:

No - There is no vapour barrier installed. Exposed soils in a crawlspace should be covered with a retardant material to prevent moisture or standing water from deteriorating wood framing above. Approved materials include: polyethylene.

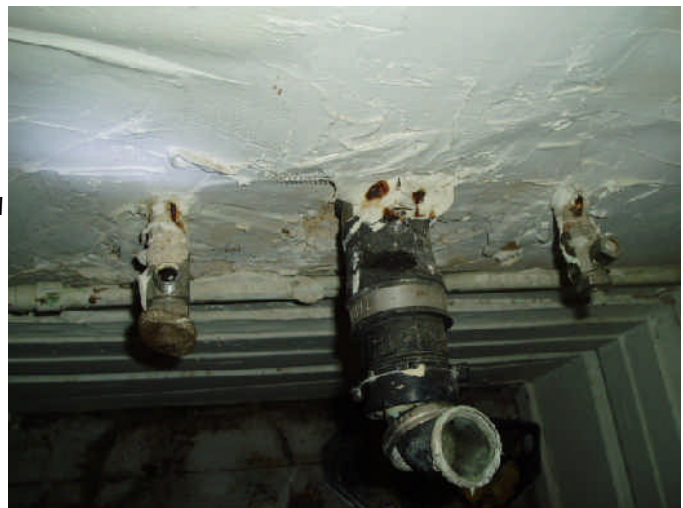
Comment: Action Necessary - a sink/washand basin has been removed and the plumbing hasn't been properly capped off (also note that galvanized piping is still in use here).

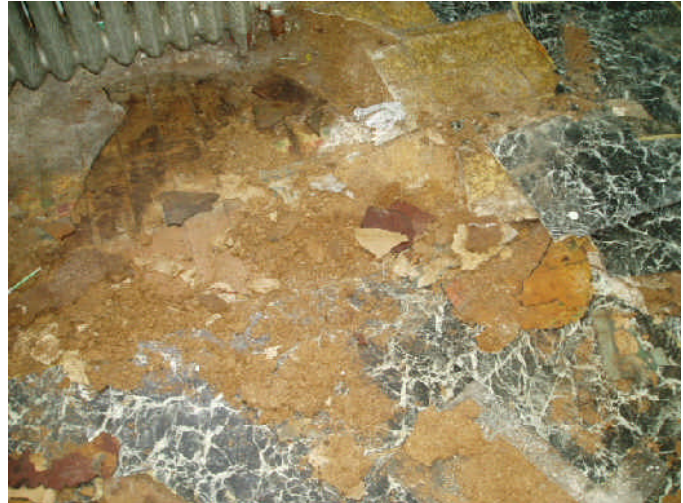
Floor: **Attention Needed -**
The floor surface in this room is damaged in places.

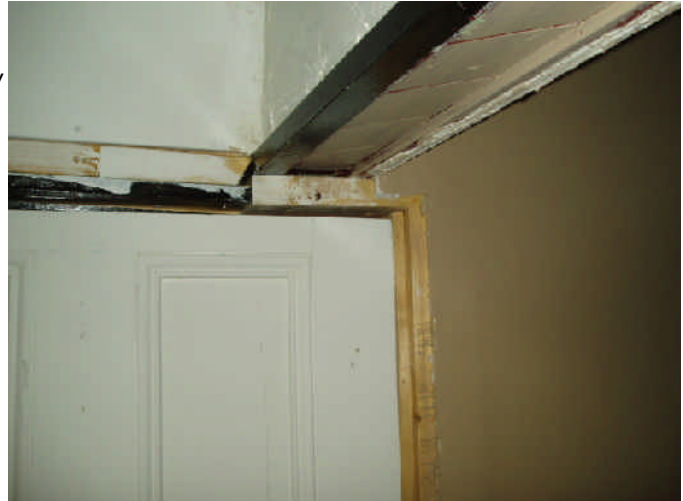
Entry Door:	Attention Needed - The entry doors to this room have been poorly installed.
--------------------	---

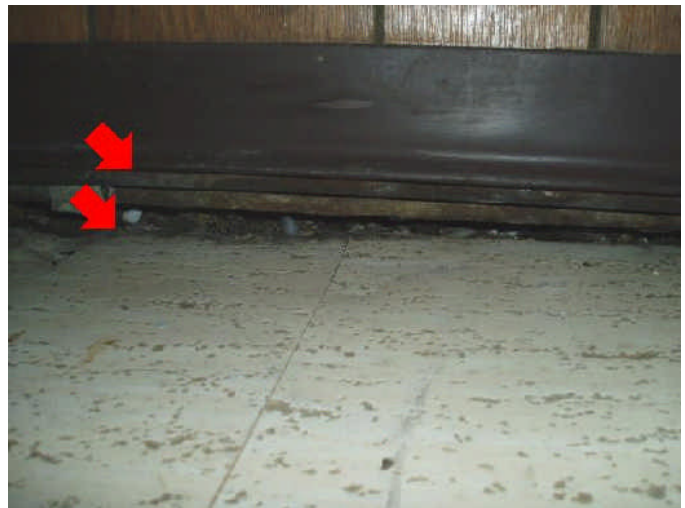
Floor:

Action Necessary - the floor is sloping and has separated from the baseboard.

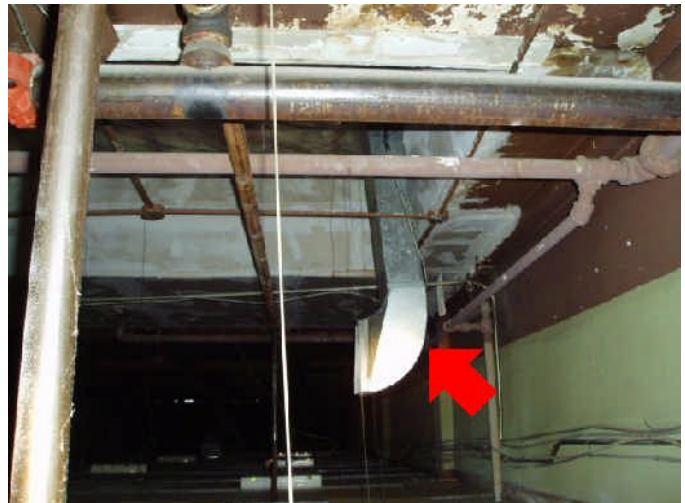
Comment: Action Necessary - I noted sections of what appeared to be redundant pieces of ductwork.

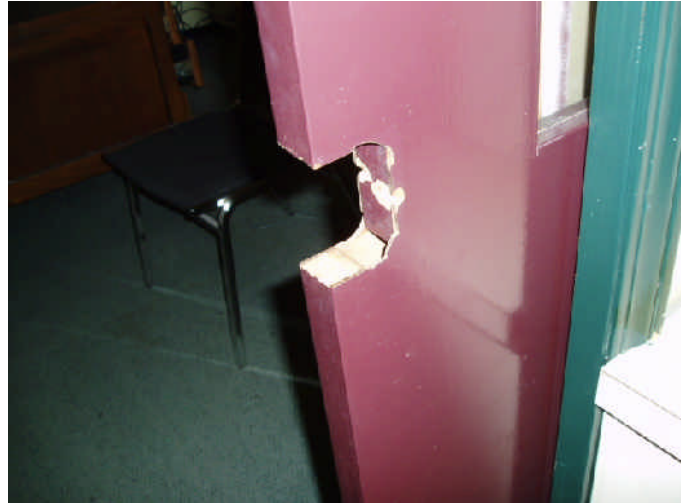
Entry Door:

Action Necessary - the hardware is missing off the sliding door leading to the reception area.

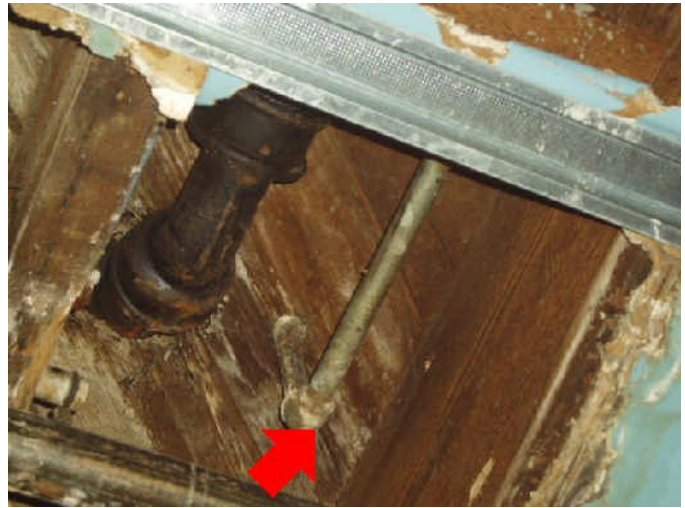
Action Necessary - I noted galvanized steel piping above some of the water stained ceilings. This is the likely cause of the water staining.
Satisfactory - The entry door to this bedroom is as I expected, and it is functional.

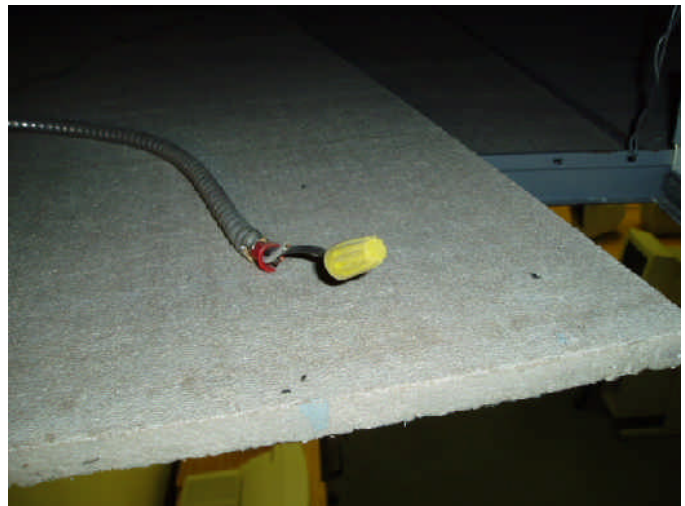
Action Necessary - I noted exposed wires not in junction boxes.

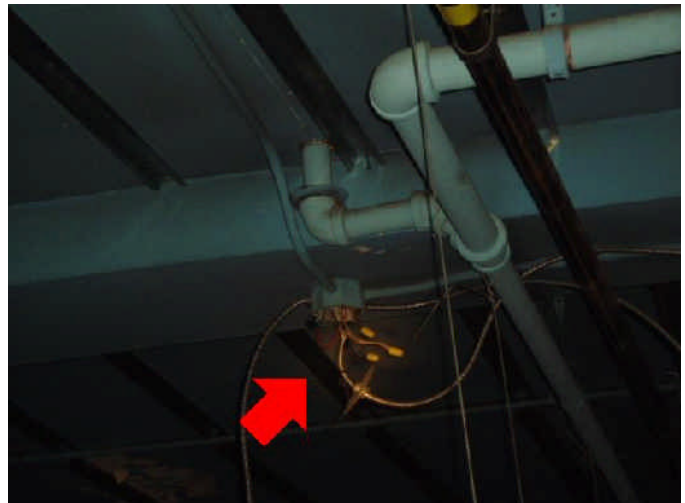
Action Necessary - I noted junction boxes with their covers missing.

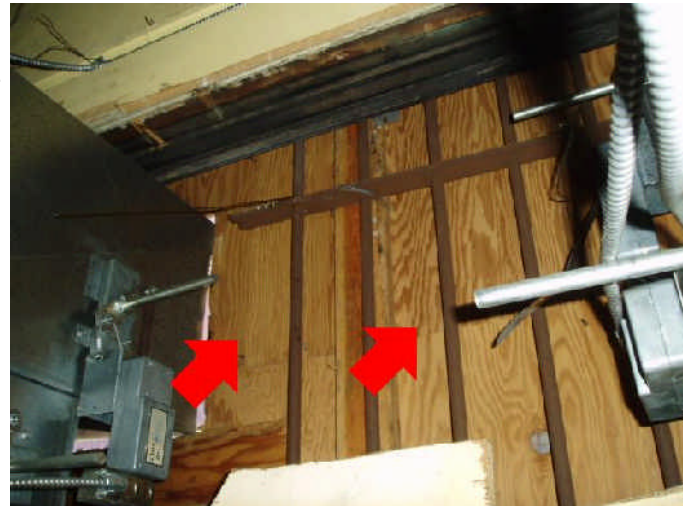
Attention Needed -
The wall infill around the rear fresh air intake grilles is poor. eg no framing members, no insulation etc.

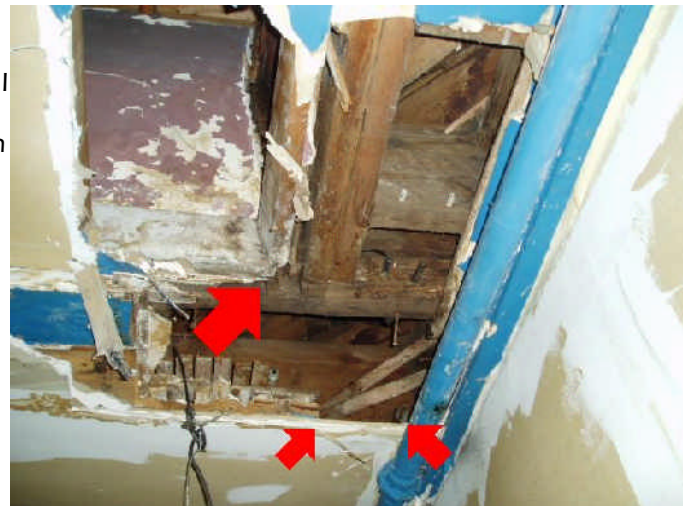
Action Necessary -
sections of the floor joists above are rotten, I also noted a section of framing hanging down (supported by the piping below the ceiling!)
